# Joint Report for Tsunami Field Survey for the Solomon Islands Earthquake of April 1, 2007

## PARI Tsunami Survey Team

May 2008

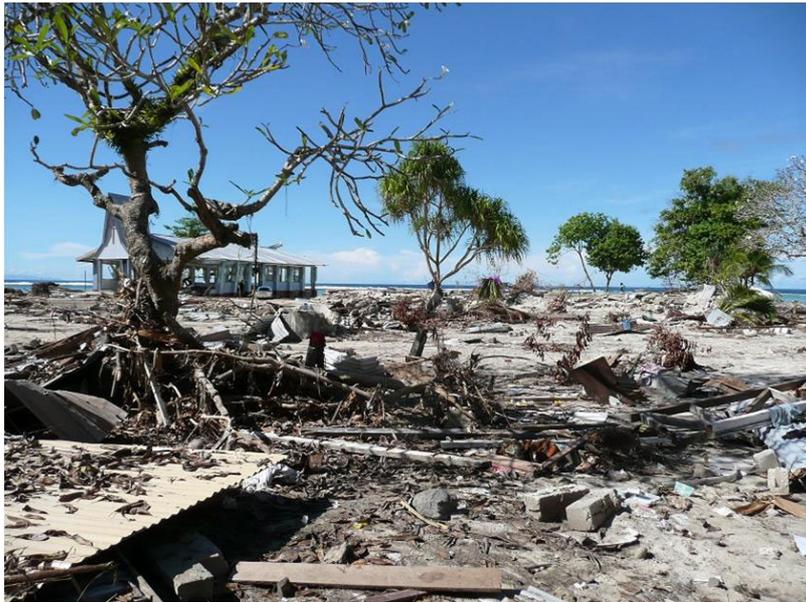
The tsunami caused severe damage in Titiana. As shown in Photo 3.1.2.2, most houses were swept and destroyed by the tsunami. A church was damaged but remained intact as shown in Photo 3.1.2.3. The front and back walls facing the tsunami flow direction were completely destroyed, but side walls had less damage. Photo 3.1.2.4

In this village 10 people were killed by the tsunami. Almost no houses were destroyed by the earthquake. According to the inhabitants' eyewitness accounts, the first wave was 3-5 m height, but the third wave was highest.

Photo 3.1.2.2 Destructive situation in Titiana

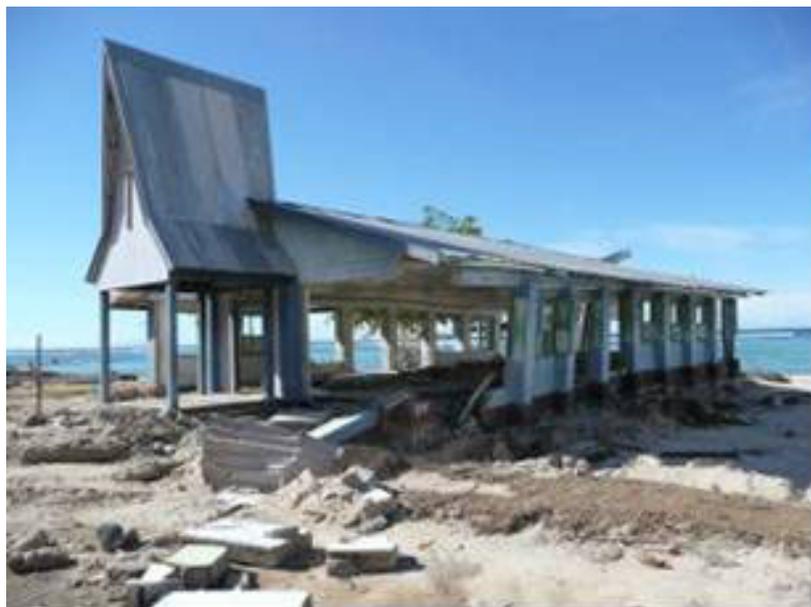
shows a broken section of the front wall, and a column more than 30 cm thick was broken.

Photo 3.1.2.3 Damaged church

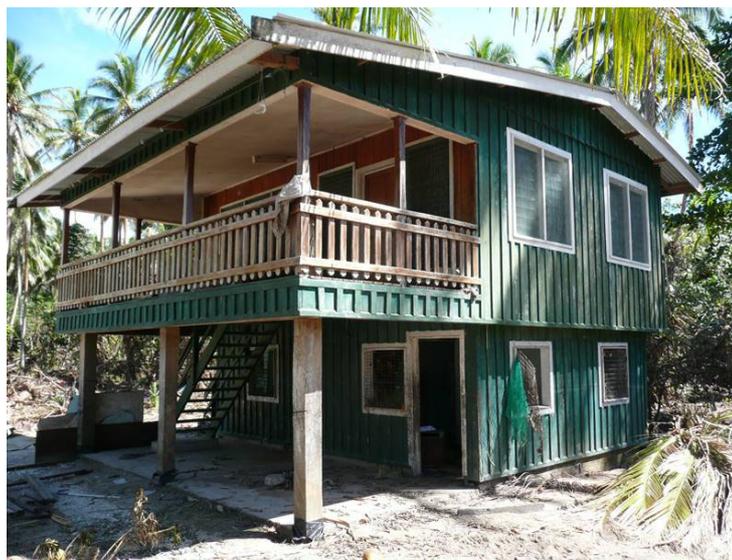
If the location of building was slightly different, the situation of tsunami damage was greatly different in the east side of the bridge in Fig. 3.1.3.2. A house remained as shown in Photo 3.1.3.1 and a nearby house was completely destroyed as shown in Photo 3.1.3.2.

Photo 3.1.3.1 House that withstood 2 m of tsunami inundation

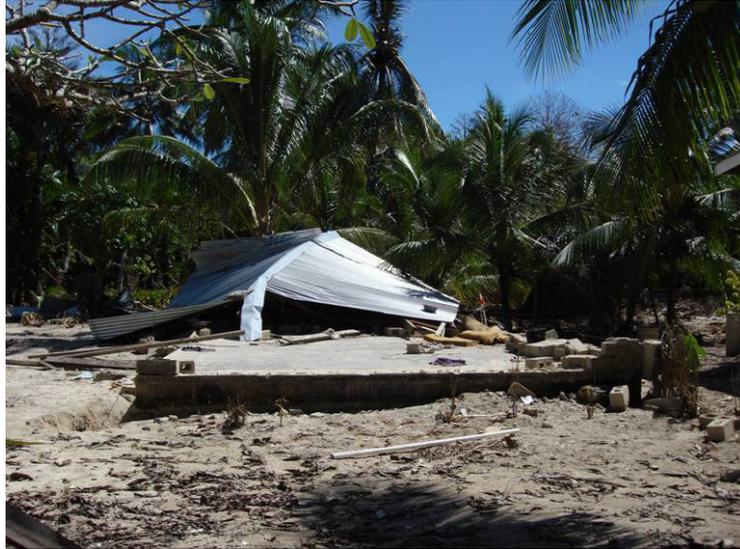
Photo 3.1.3.2 Destroyed house neighboring the house in Photo 3.1.3.1

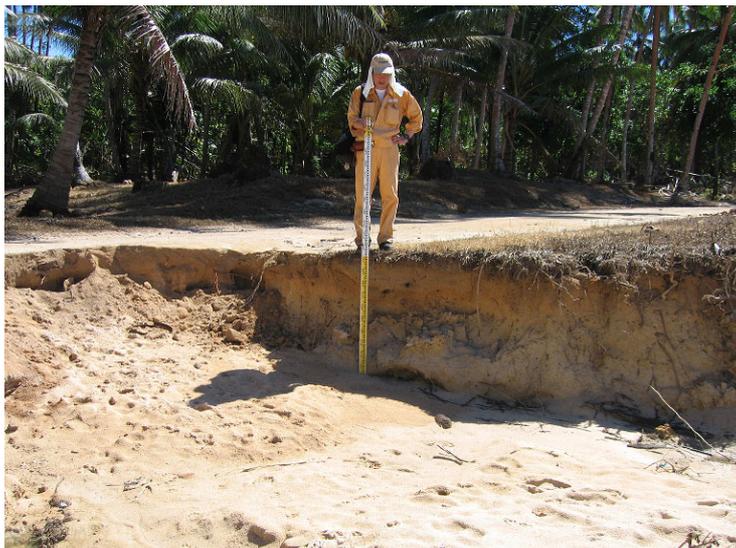
The tsunami caused beach erosion on the west side of a bridge in Fig. 3.1.3.2 and the erosion reached near a main road, as shown in Photo 3.1.3.4. The depths of erosion were measured at two points in New Manra, and they were 0.70 m and 1.05 m. The foundation of a damaged church in Fig. 3.1.3.2 was also eroded as shown in Photo 3.1.3.4, resulting in structural destruction originated by erosion as well as tsunami wave pressure.

Photo 3.1.3.3 Beach erosion in New Manra

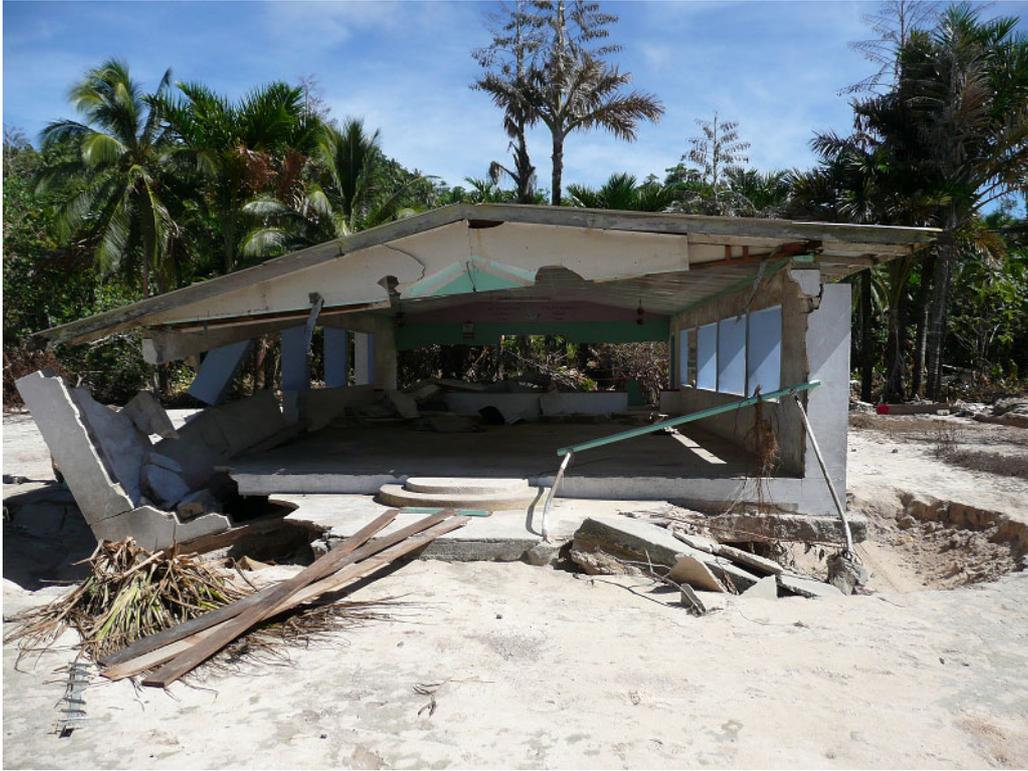
Photo 3.1.3.4 Erosion of foundation of structure in New Manra

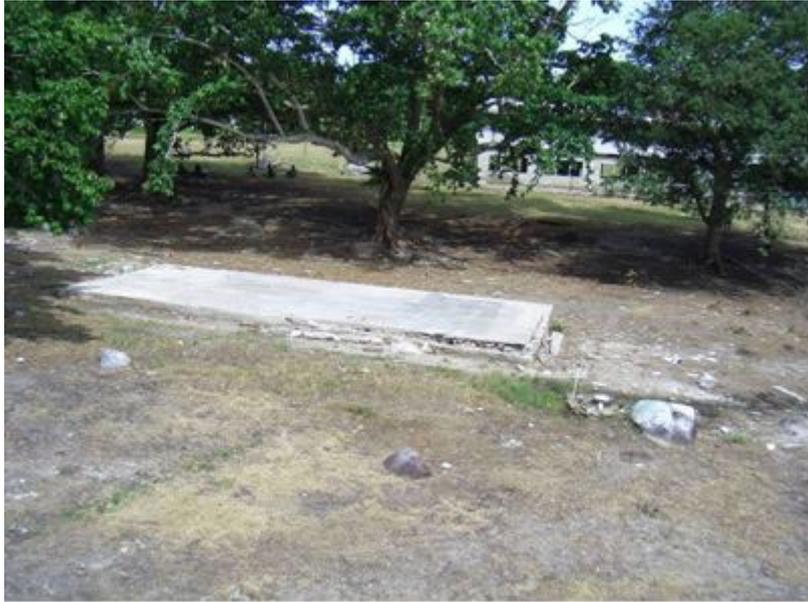
Photo 3.2.6.1 Building foundation of the school at Lengana, Simbo Island.

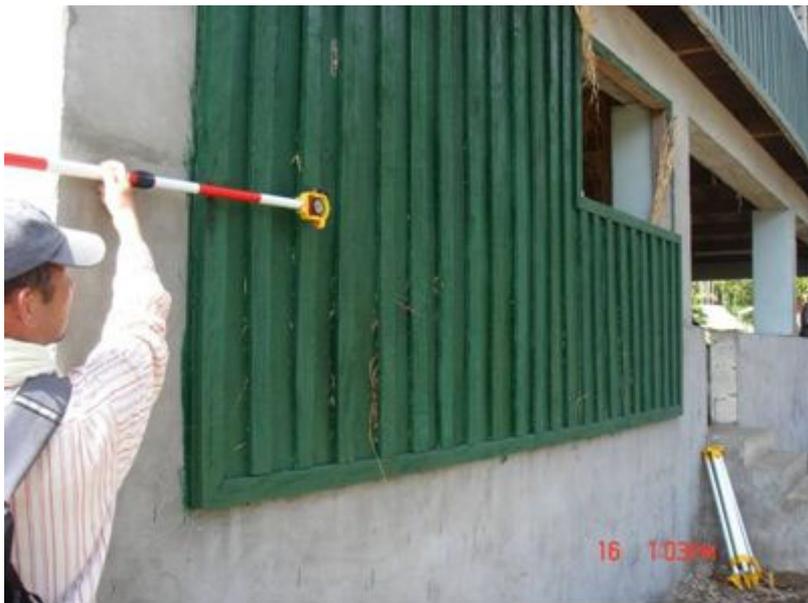
We measured the tsunami heights at four points in Lengana (Fig.3.2.6.1). Two are runup heights and the others are inundation heights. At Mark 71, the wall of "centenary hall" was inundated and there were scratches on a wall (Photo. 3.2.6.2). We regarded the top of the scratch as the tsunami height, and the height was 4.9 m (after correction of the astronomical tide). At Mark 70, we found the clear border line between living and dead leaves. The line was the limit of runup. The height was measured as 4.1 m (after correction of the astronomical tide). We measured the other two heights in the same way.

Photo 3.2.6.2 A line of water mark of scratches was traced on the wall of the centenary hall in Lengana.

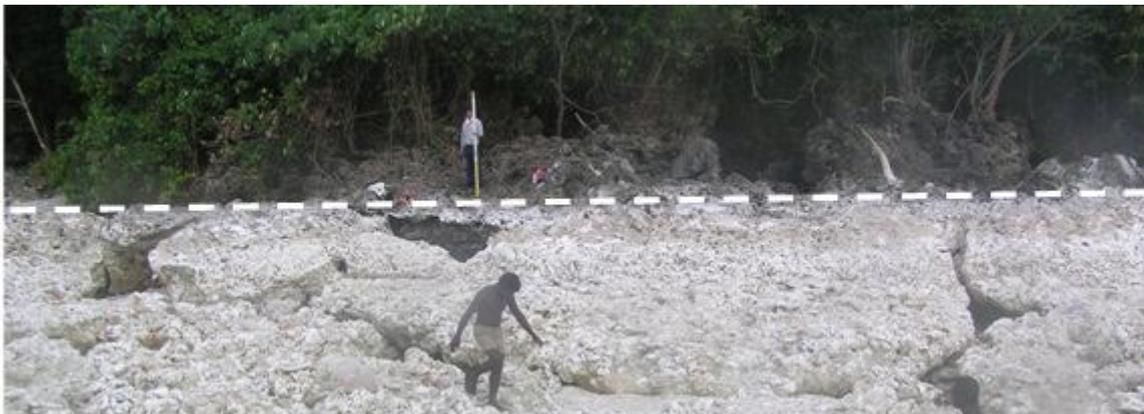
Photo 3.3.1.1 Bleaching coral reef uplifted more than 3 m at Lale village. The white broken line shows the possible low tide level before the earthquake.

Lale village is located on the west coast in the southern tip of the island. The height of ground upheaval was estimated to be more than 3 m. A bleaching coral reef uplifted by the earthquake is shown in Photo 3.3.1.1. Cracks in the ground were recognized in the residential area, as shown in Photo 3.3.2.1.

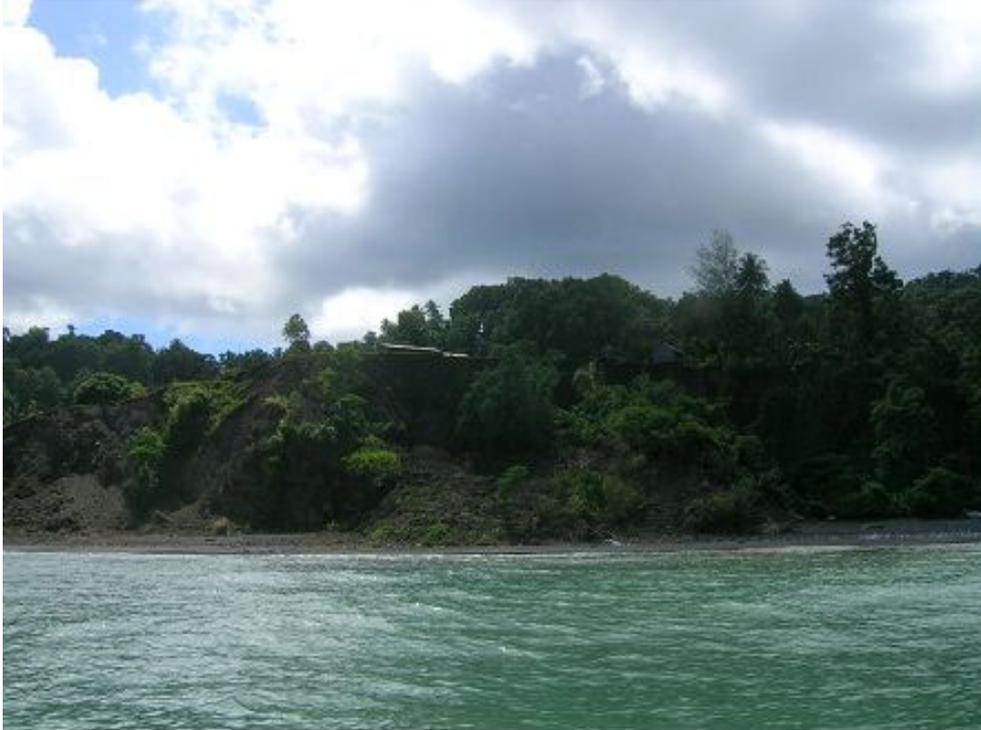
Photo 3.3.1.2 Small scale landslide at Mondo village on the west coast in the middle of Ranongga Island

Because the ground of the island was uplifted, the damage from the tsunami was light, considering the runup height of the tsunami. On the island, two persons were killed not by the tsunami, but rather by a landslide, which occurred almost everywhere on the west coast of the island. Photo 3.3.1.2 shows an example of the landslides at Mondo village where the two were killed. In the photo, a few houses can be seen at the edge of cliff.

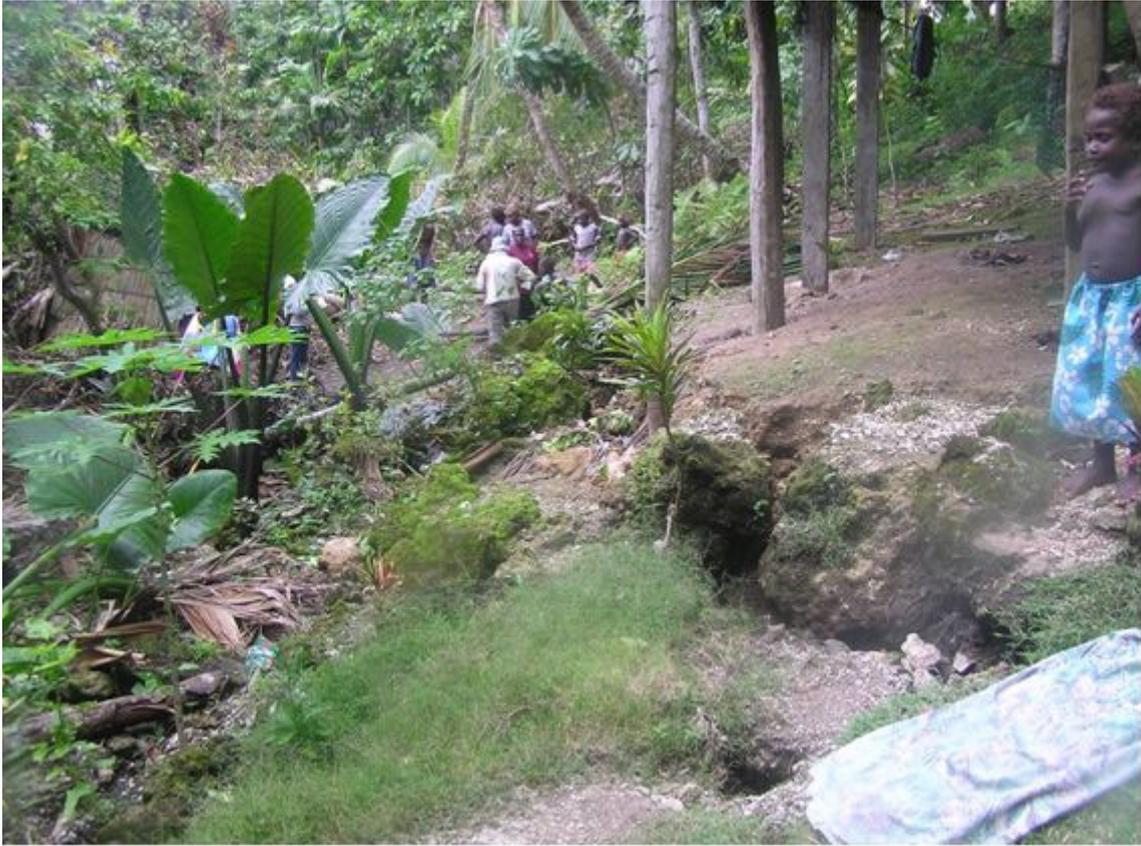
Photo 3.3.2.1 Cracks in the ground due to the earthquake in the residential area

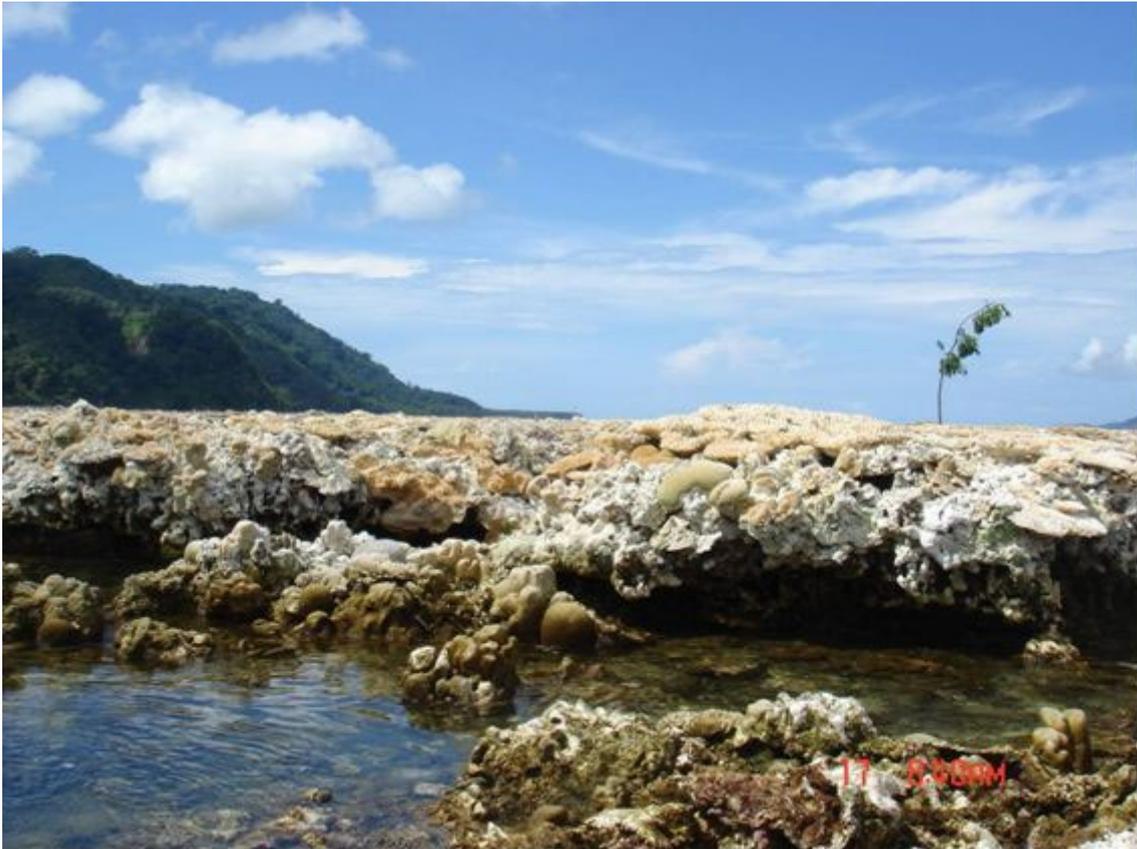
Photo 3.3.3.1 Bleaching coral reef uplifted by the earthquake in Keara

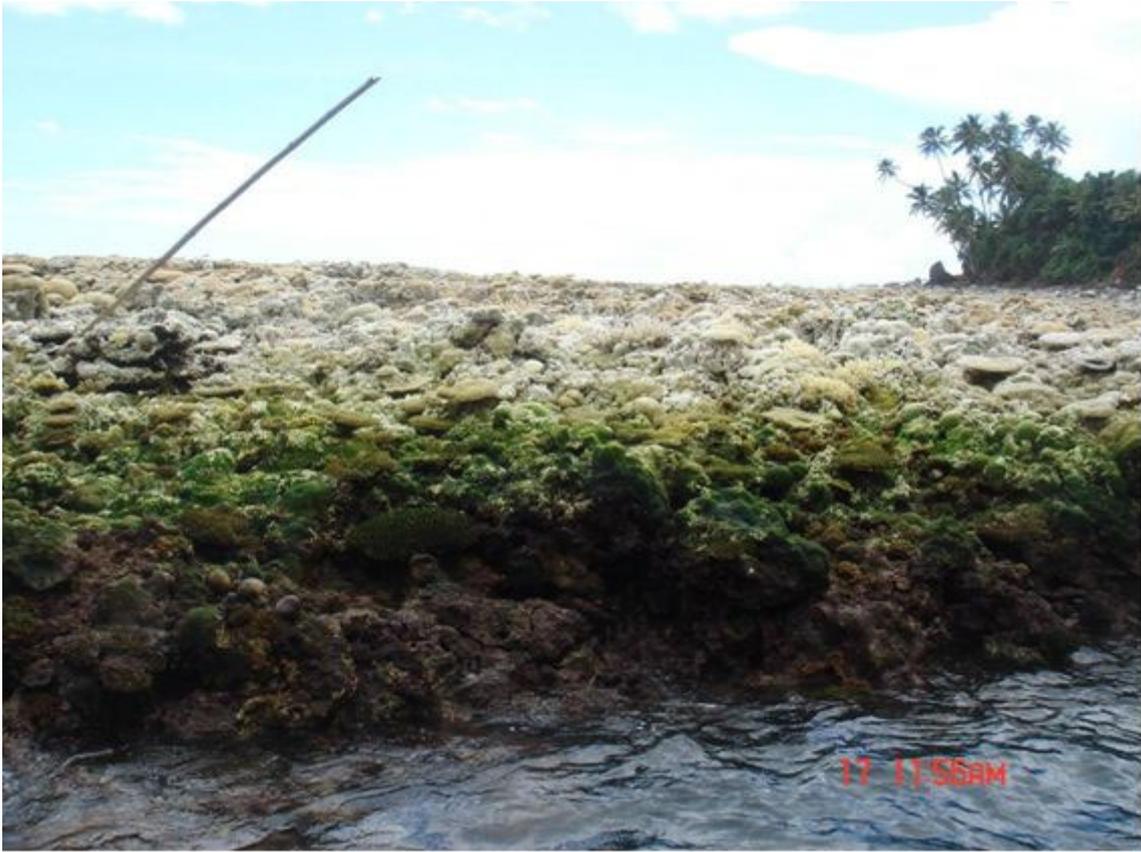
Photo 3.3.4.1 Bleaching coral reef uplifted by the earthquake in Keara

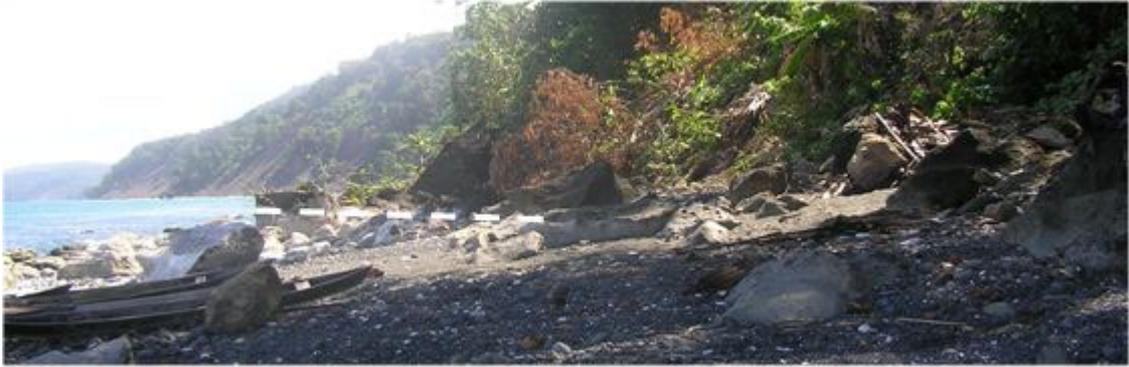
Photo 3.3.5.1 Clear upper limit line of coral bleaching after the earthquake at Kundu village

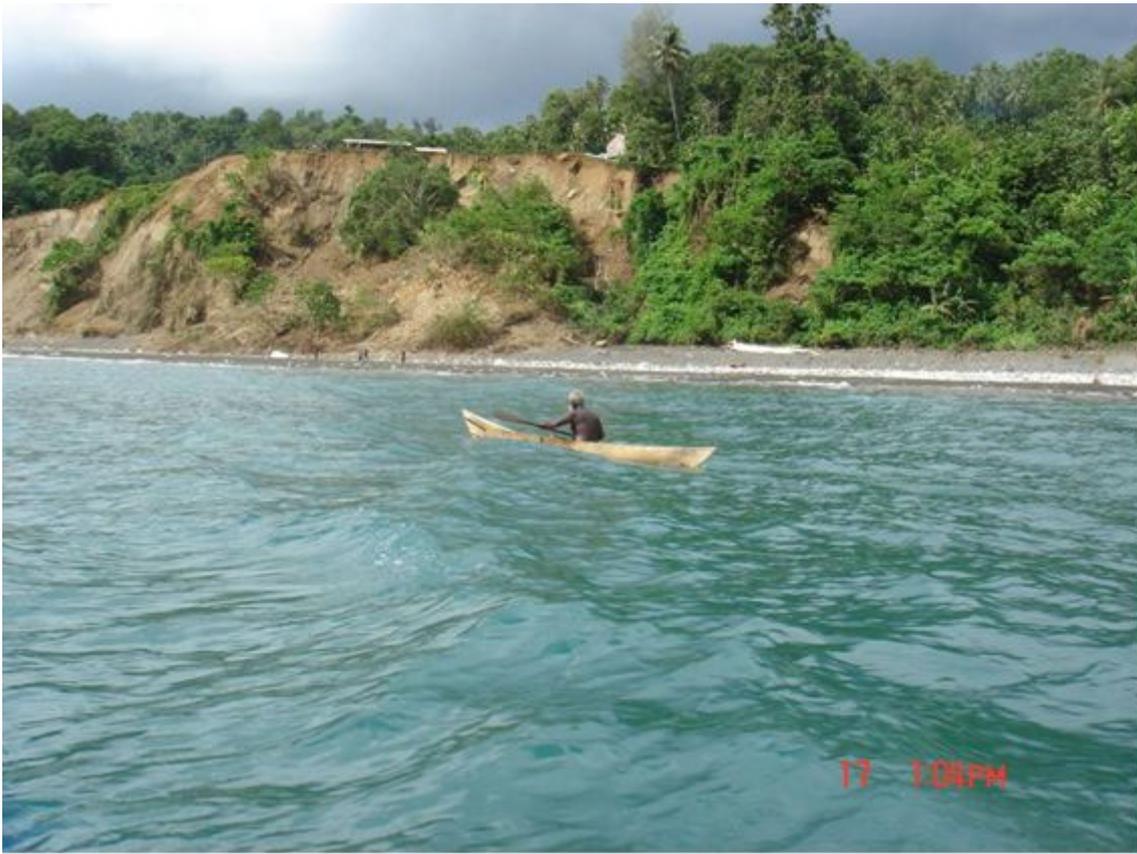
There was no damage from the tsunami, but a landslide, shown in Photo 3.3.6.1, killed two people.

3.3.6.1 Landslide in Mondo village

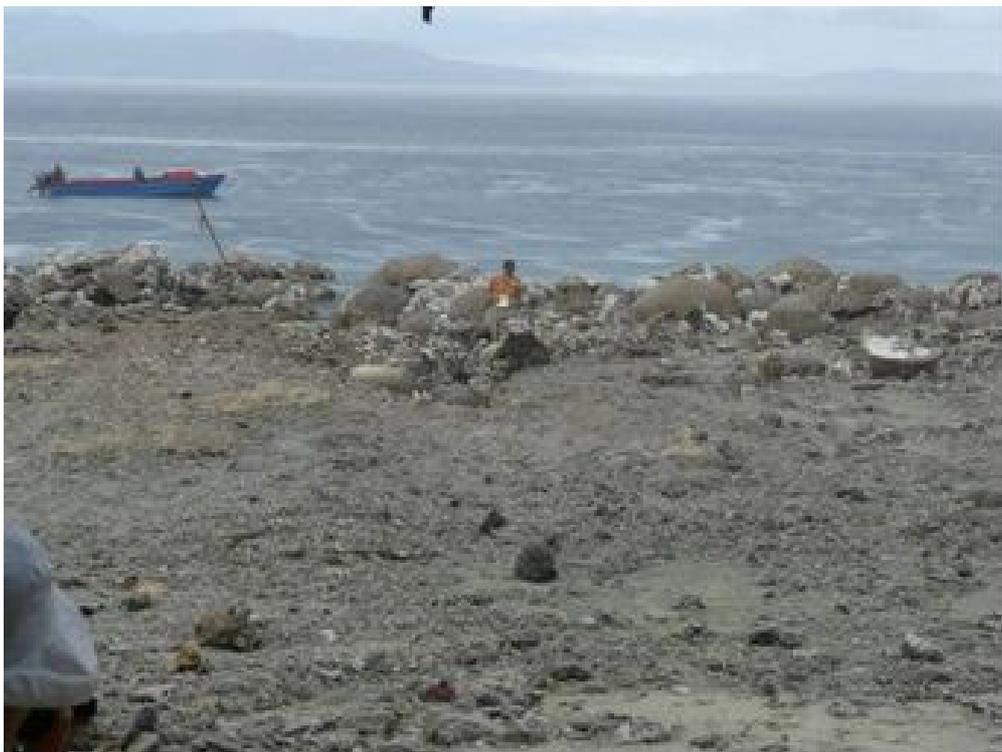
Pienuna village is located on the east coast in the middle of the island. No inundation and runup marks were found in the field survey, and residents noticed no tsunamis. Coral reefs were exposed above the sea surface, and now sit 2.22 m above present sea level.

Photo 3.3.9.1 Coral reef uplifted 2.2 m at Pienuna village

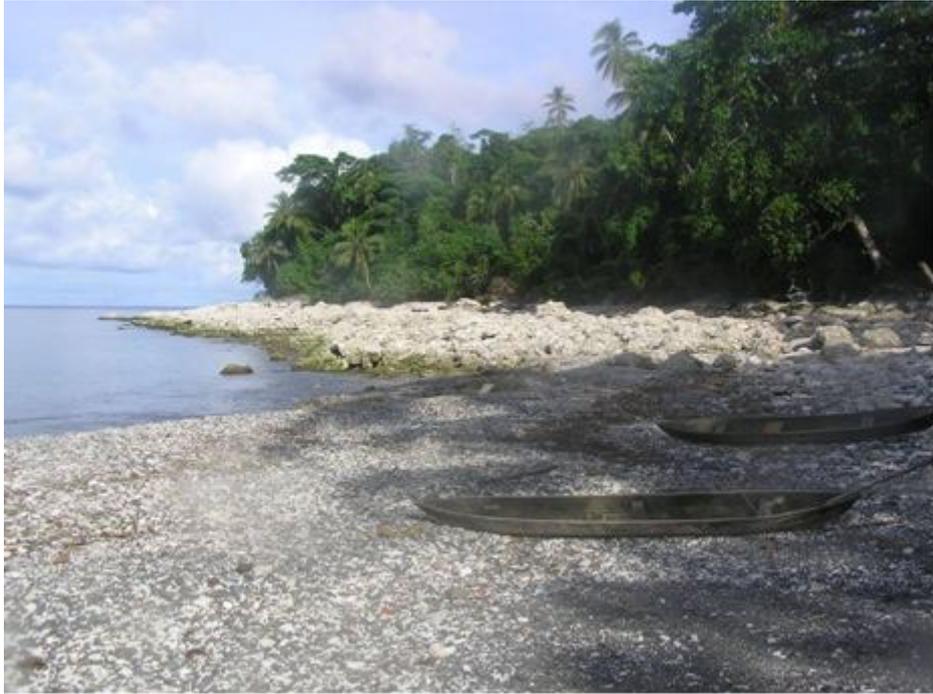
Photo 3.3.10.1 Bleaching coral reef uplifted more than 2.2 m at Suava village

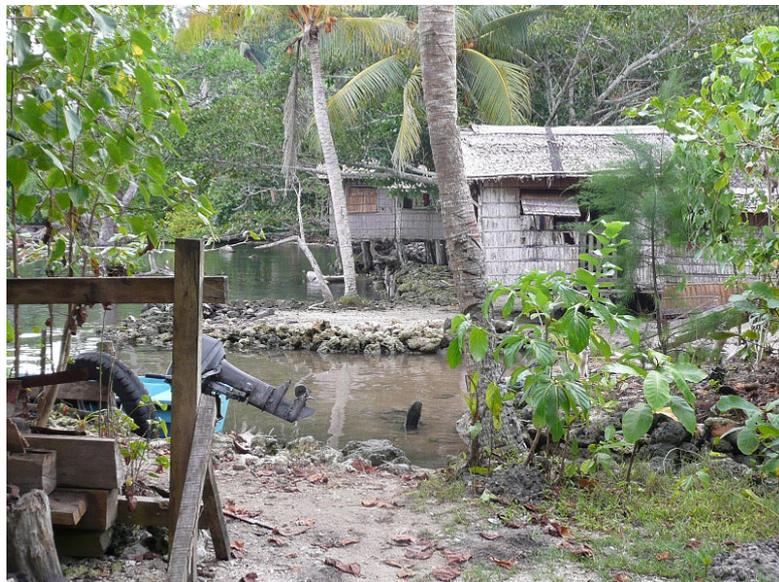
Photo 3.4.3.2 Light tsunami damage in Vonunu

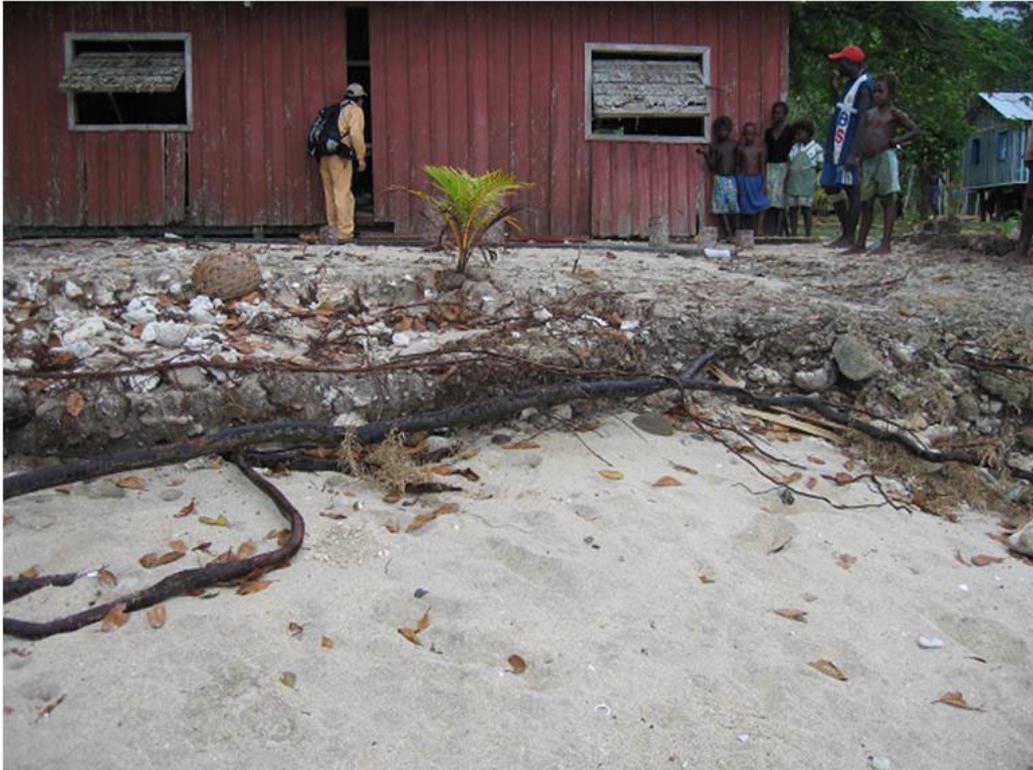
Photo 3.4.12.2 Beach erosion and roots of vegetation to prevent the erosion developing

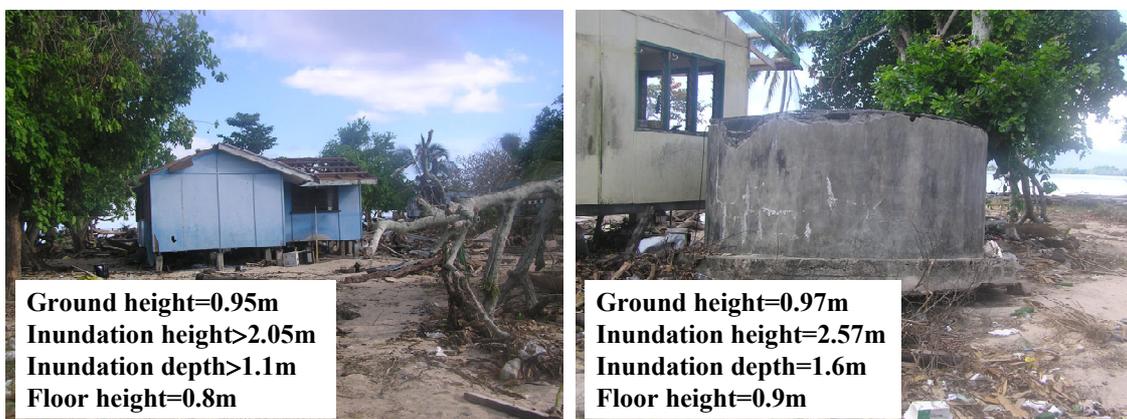
Photo 4.1.1.1 Examples of damage to the houses due to the tsunami in Medical area

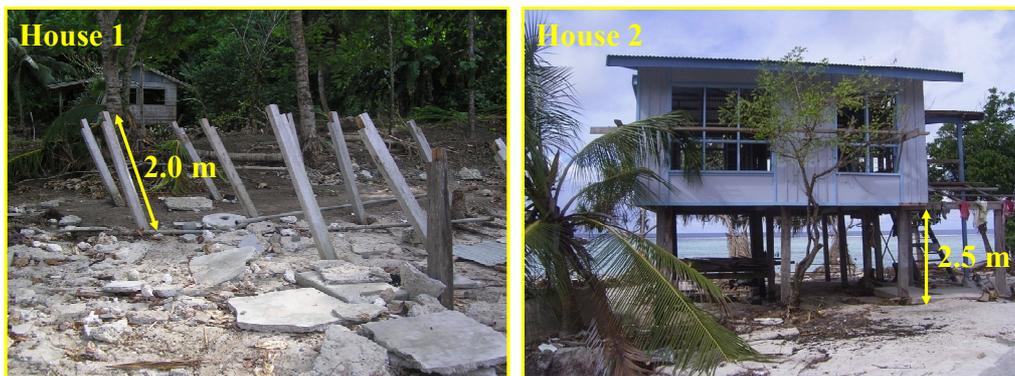
Photo 4.1.1.7 Difference in the degree of damage to wooden houses due to the difference in the floor height in Titiana village (left: swept away, right: withstood)

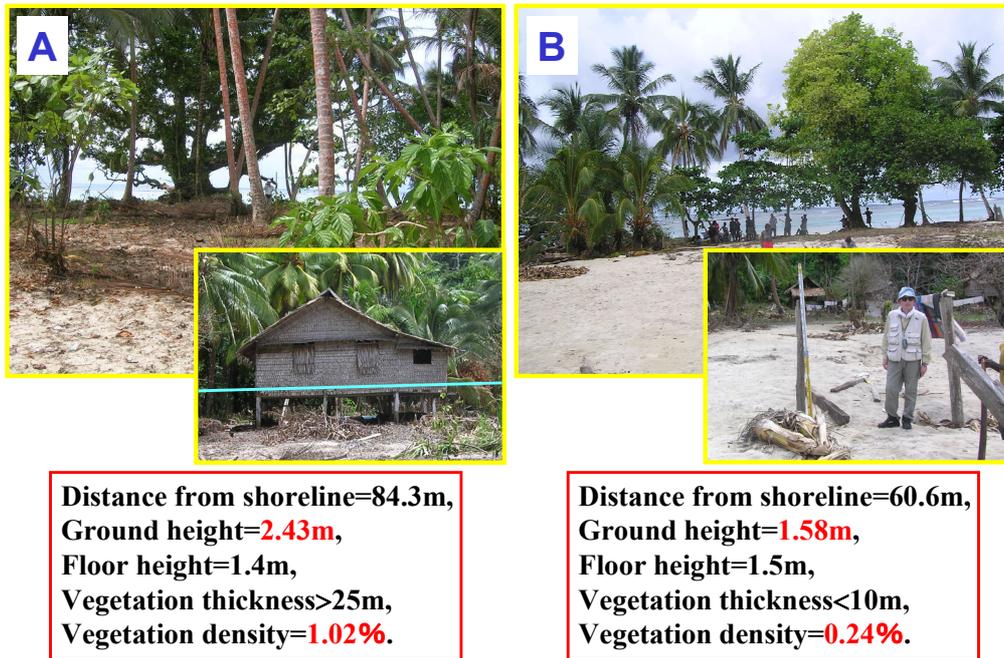
Photo 4.2.1 Example of the effect of coastal forest on reducing tsunami energy and force on the coast of Suve village in Ghizo Island
