3. SURVEY RESULTS ON TSUNAMI DAMAGE AND TRACE HEIGHT

3.1 Male'

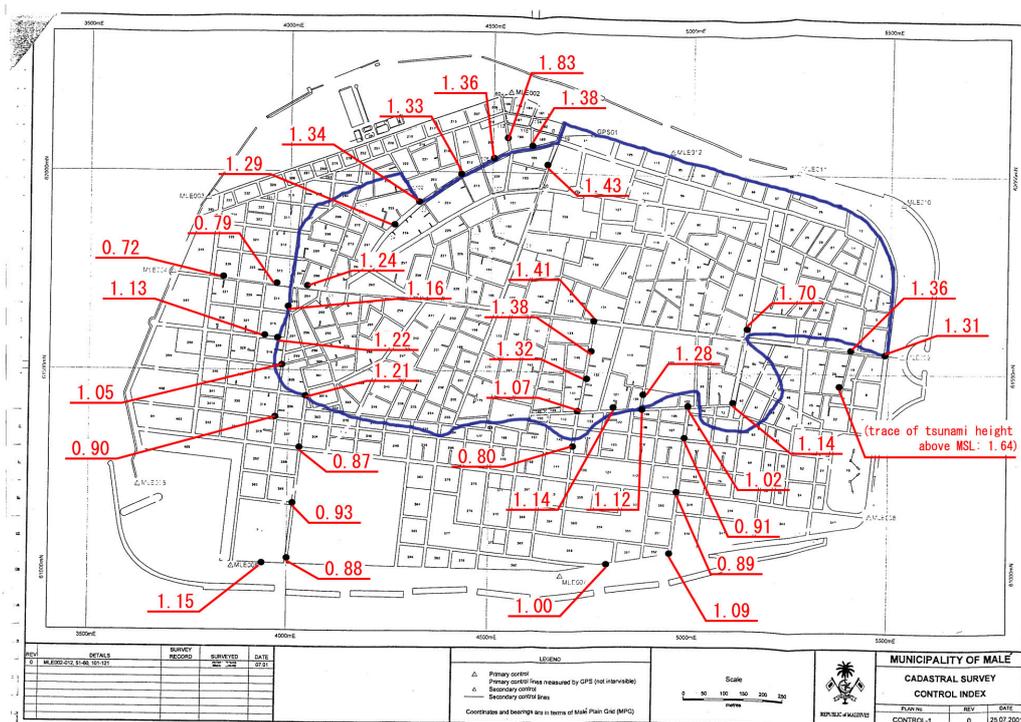
by the eyewitness evidences of the residents. Figure 3.1.2 shows the measured result of the inundation area in Male' Island. The inside of the blue line in the figure was not inundated, and the inundation area is approximately 60% of the island. The ground elevation of the boundary of inundation is approximately 1.1m almost over the island. This fact may indicate that the total volume of the overflowed seawater reached the 1.1m-line when the seawater was stored in the seawalls like a reservoir. On the other hand, the ground elevation of inundation-boundary in a part of north coast and a part of east coast is higher than 1.1m. In this region, the overflowed water might have some inertia force, and reached the high ground temporally.

Because the tsunami height was higher than the crown height of quaywall, it is thought that the inundated seawater mainly entered over the quaywall in the north and south wharf. However, Figure 3.1.2 shows that the overtopping over the seawall at the east coast was not negligible. The tsunami height, perhaps, was amplified in the east coast because the tsunami was dammed by the island there; and it made the overtopping of the swell and wind wave over the seawall easy.

Figure 3.1.2 Inundation area in Male' and the ground elevation near the boundary of inundation

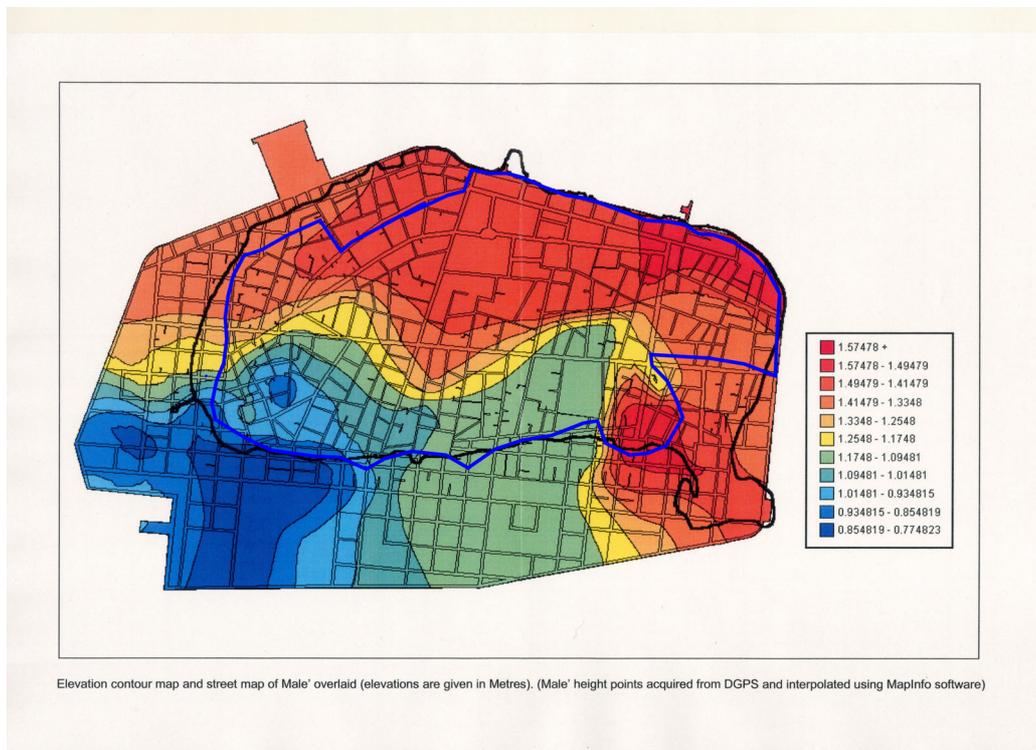
Figure 3.1.3 shows the comparison of the inundation area and the reclamation area in Male' Island. The blue line denotes the inundation boundary, and the black line the shape of the original Male' Island. This figure indicates that the reclamation land was fully inundated by the tsunami, and the inundation area was very similar to the reclamation area. Note that the reclamation land is relatively danger in comparison to the original land if the protection level (e.g. crown height of seawall) is the same.

Figure 3.1.3 Comparison of the inundation area (blue line) and the shape of the original island (black line)

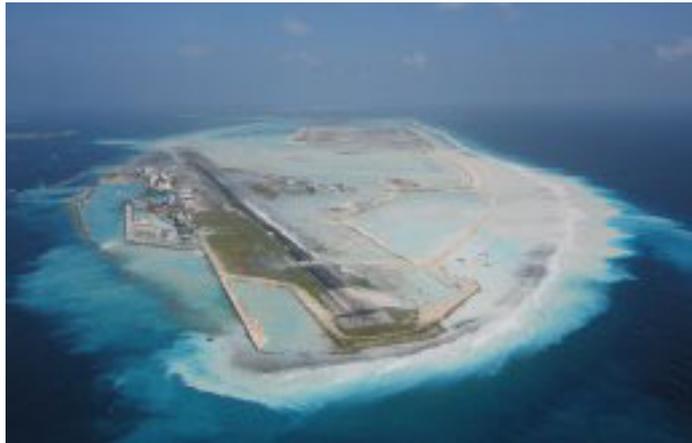
According to the investigation of the Maldives Airports Co. Ltd., two-thirds of the airport island was flooded, and the runway was out of operation for approximately 10 hours, resulting from debris and detritus due to the tsunami flooding. The runway lights were repaired after 18 hours. Photo 3.2.1 shows the inundated airport by the tsunami. The runway was flooded and coral sand flowed out of the island.

Photo 3.2.1 Male' International Airport inundated by the tsunami. ©Mr. Todd Rempel

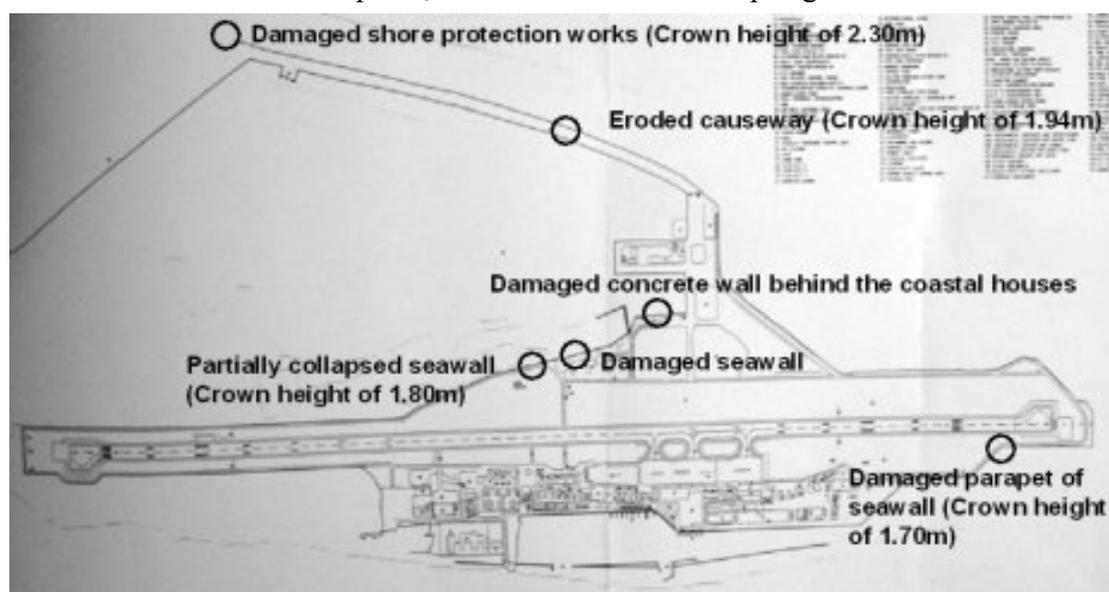
Figure 3.2.3 shows some structural damages due to the tsunami. The most severe damages are along the inner sea between the causeway and airport.

Figure 3.2.3 Tsunami damages

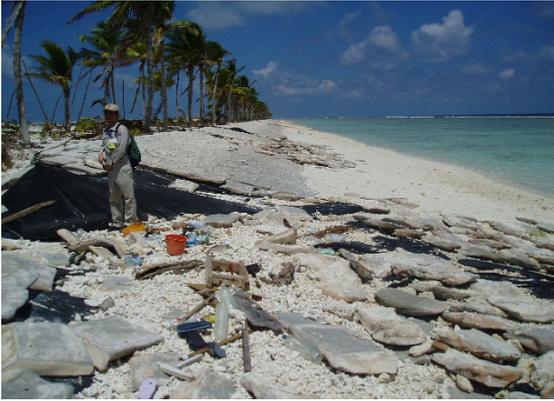
In Hulhumalé, the shore protection works which consisted of cement bags were partially damaged as shown in Photo 3.2.2. Although the tsunami flow washed some cement bags on the land about 15m apart from the coast, it seems that they were mainly destroyed by the backwash of the tsunami, judging from the feature of the scattered bags on the beach.

Photo 3.2.2 Damaged shore protection works

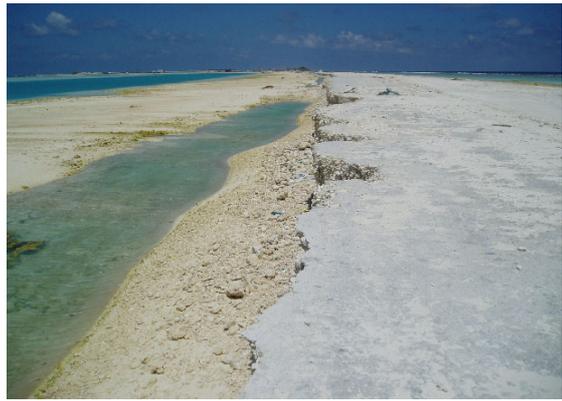
The east and west sides of the causeway were eroded by the tsunami action as shown in Photo 3.2.3. Tsunami pressure also broke an on-land wall even behind coastal

Photo 3.2.3 Eroded causeway

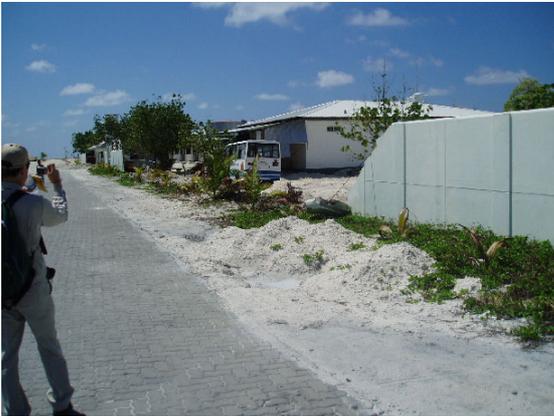
houses as shown in Photo 3.2.4. Seawalls were damaged in some areas as shown in Photo 3.2.5, and especially in the east side of the airport along the inner sea area the seawall were collapsed as shown in Photo 3.2.6 by the high tsunami. The seawall which was made from coral stones covered by concrete suffered severe damage from the tsunami action. In the southwest side of the airport, parapets of the seawall were fallen down as shown in Photo 3.2.7. Since the south and southwest sides of the airport faces the open sea, high tsunami attacks there.

Photo 3.2.4 Damaged inland wall

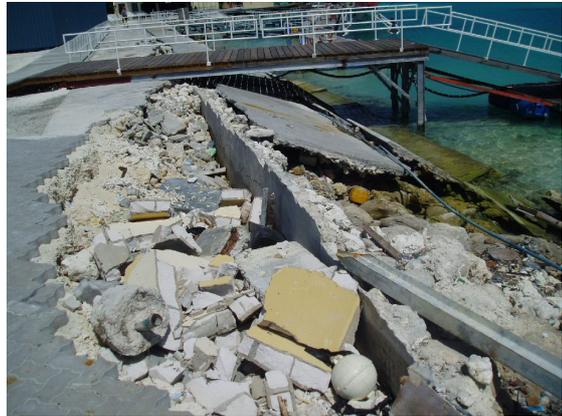
Photo 3.2.5 Damaged seawall

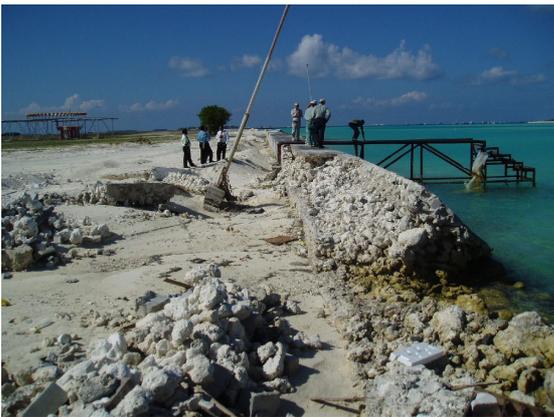
Photo 3.2.6 Collapsed seawall

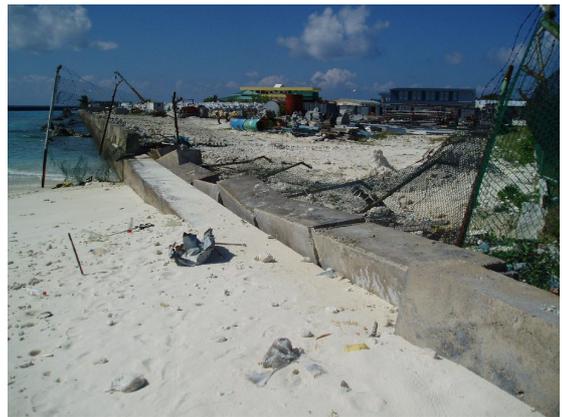
Photo 3.2.7 Damaged parapet of seawall

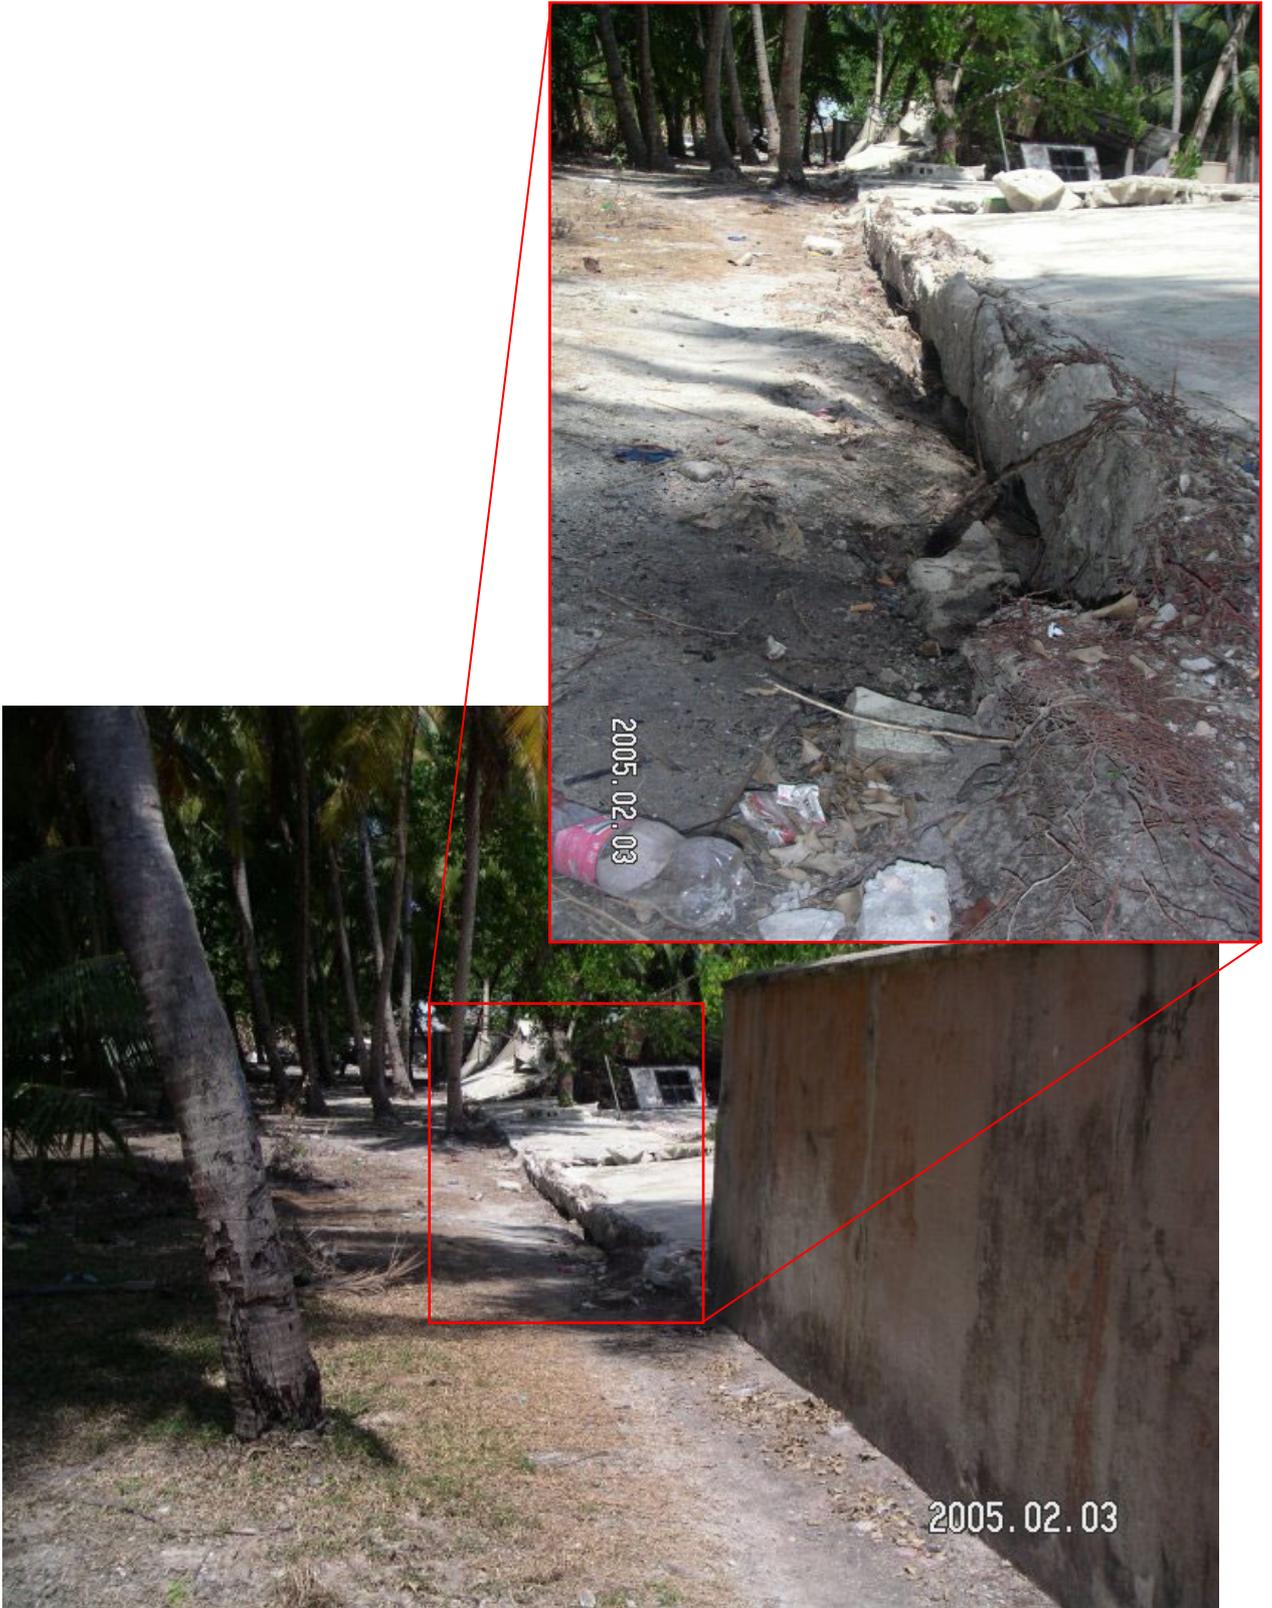
In the northern part of the west coast, collapsed houses and walls are observed (Photo 3.3.3). Several boats are thrown on the beach at the central part of the west coast.

It was found that the wall of Ministry of Public Works was collapsed. There were the clear marks at the wall of the yard(Photo 3.3.3 site# **【6】**).

Photo 3.3.3 Collapsed Wall at North West Part of the Is. Kulhudhuffushi

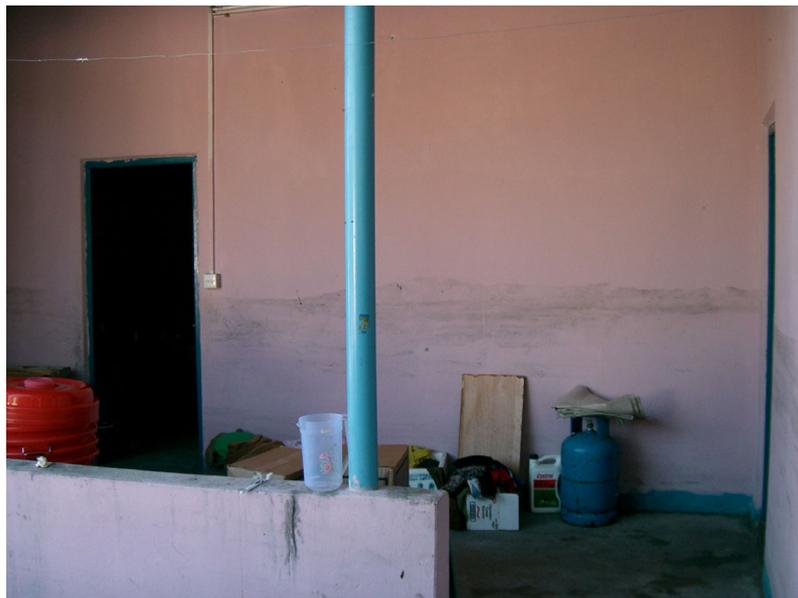
Photo 3.5.2 Trace of the tsunami on wall in a house (1.08m of water level from the ground)

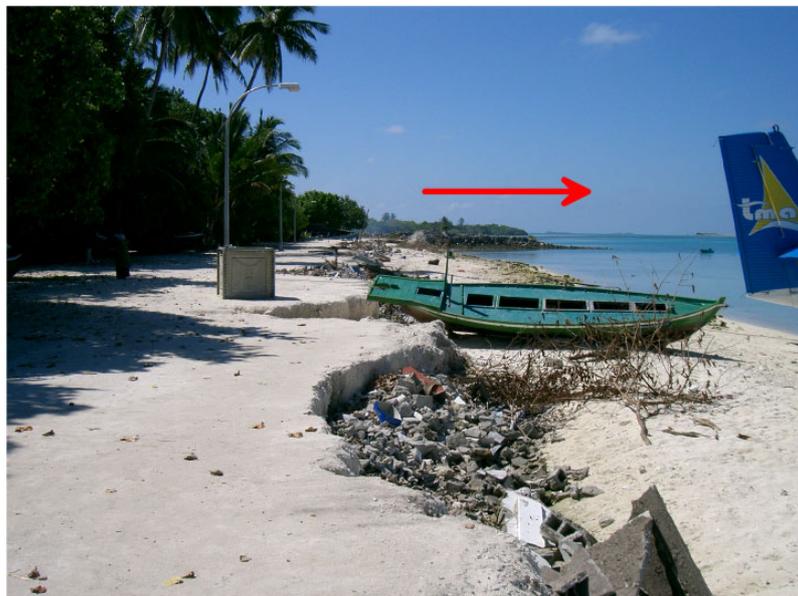
Photo 3.6.2 Coastal erosion by tsunami in west coast. Red arrow indicates the direction of tsunami.

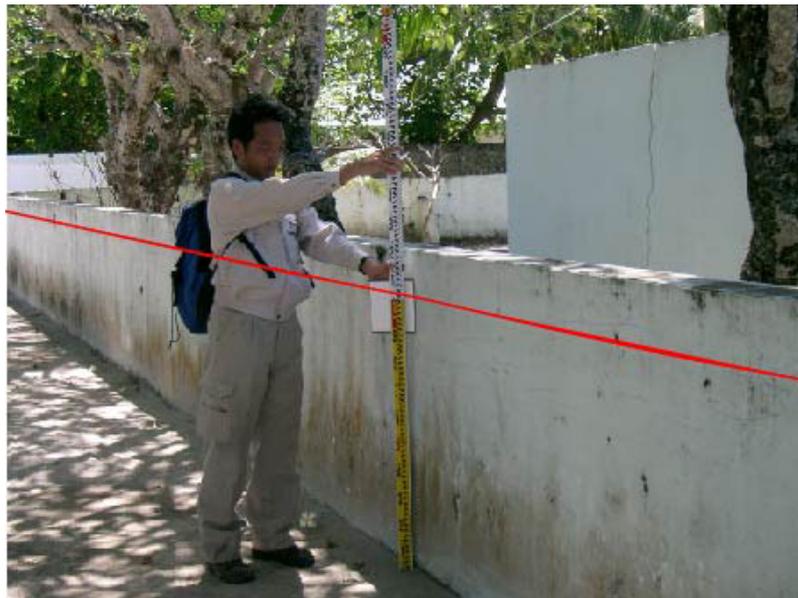
Photo 3.7.2 Tsunami trace on wall at central of the island

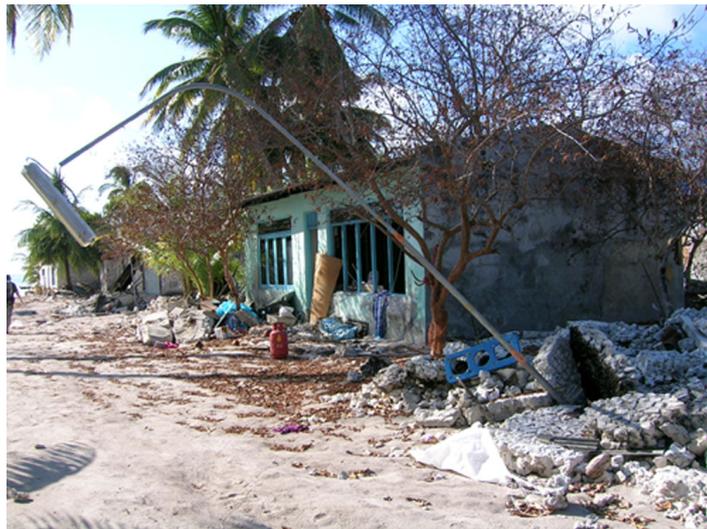
Photo 3.7.4 Electric light bent by tsunamis

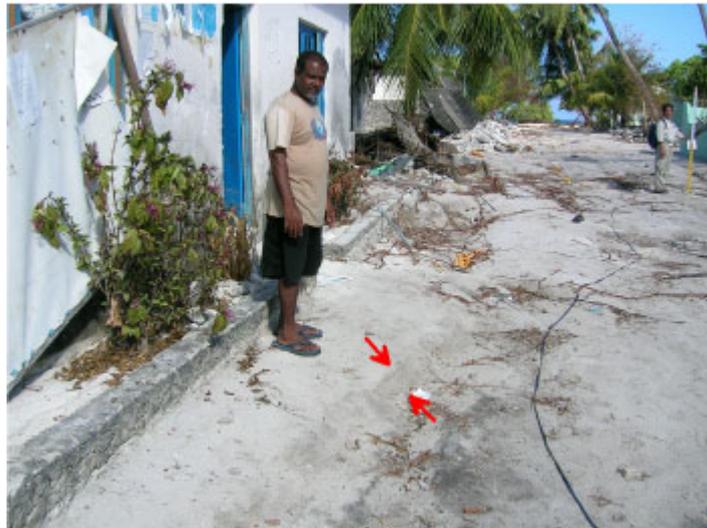
Photo 3.7.5 Sand erosion by tsunamis. Spacing red arrow indicates thickness of sands eroded by tsunamis.

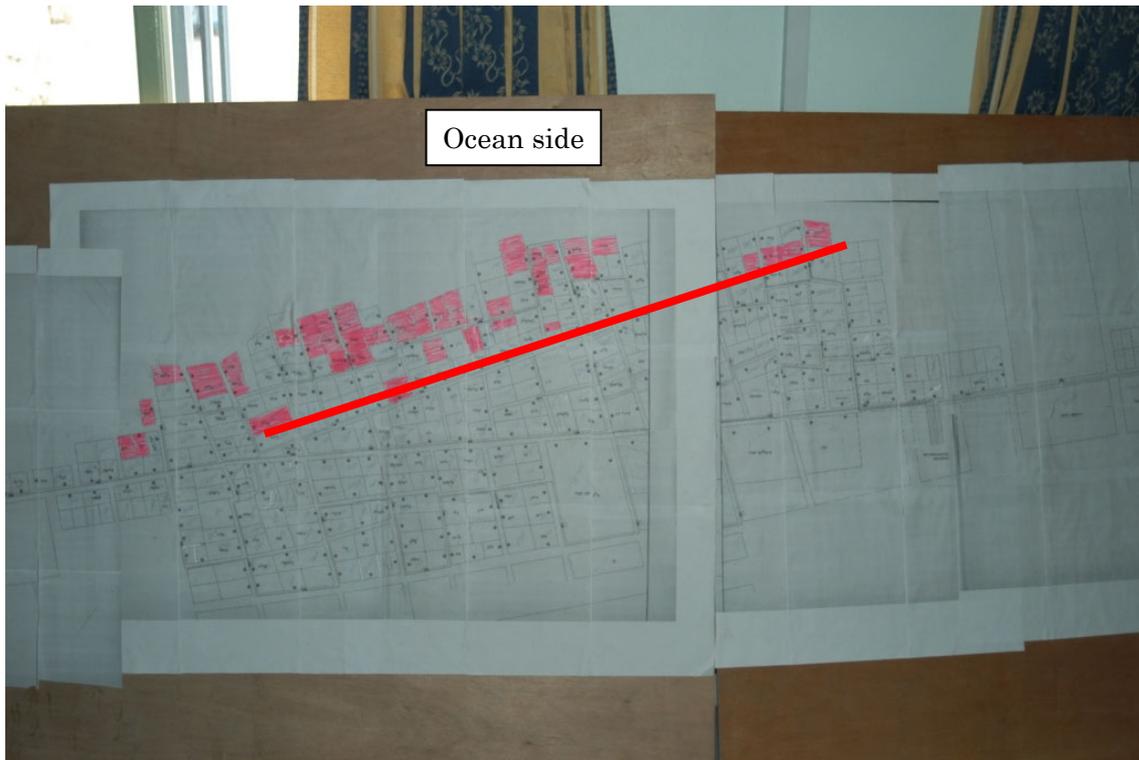
Photo 3.8.3 Map of completely damaged houses (red marks)

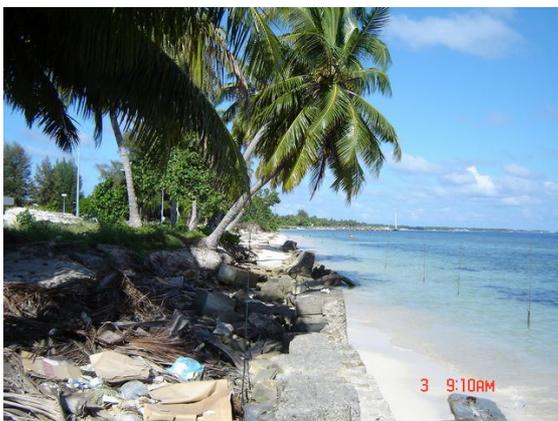
The first location of survey in Gan Island was around the construction site of new international airport terminal building. Two-way road is running between the building and seashore. The tsunami at this place considered to have reached about center of the road. This run-up height is estimated at 1.79m as shown in Figure 3.9.6 as Point No.49. The seashore in front of the terminal building facing inside the atoll was damaged by the tsunami as shown in Photo 3.9.2.

Photo 3.9.2 Seashore in front of Terminal Bldg.

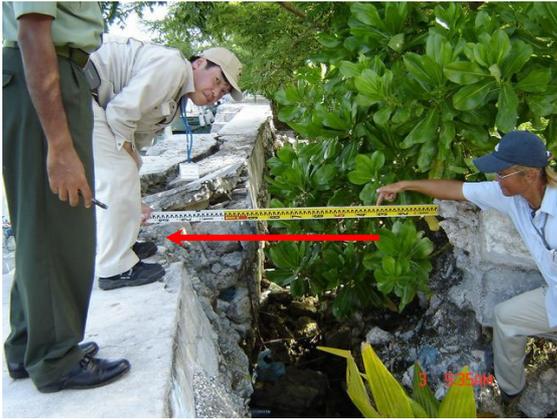
Photo 3.9.4 Damage of Seawall

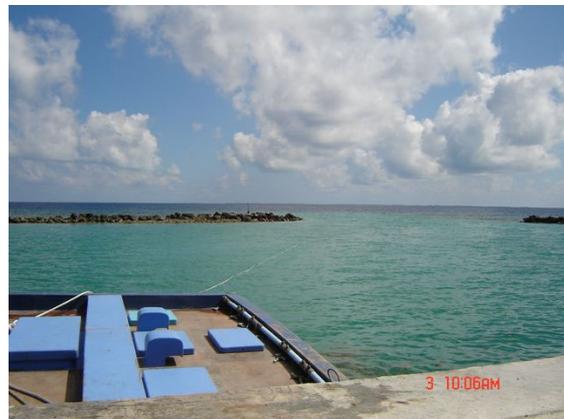
The survey was carried out around the fishing harbour in Feydhoo. The witnesses said that water level in this area moved up and down for 30 to 40 times within the period of 45 minutes from 9:00am. The water level rose up suddenly and kept high level for about 20 to 30 seconds, then suddenly went down. The highest water level reached just above crown of quay wall shown in Photo 3.9.6. The run-up height was estimated at 1.62m as shown in Figure 3.9.6 as Point No.52. At the time of the minimum water level, the sea bottom of 5m below HWL 1.0m above LWL could be seen, resulting turning over of fishing boat which was under repair in ship yard in Hithadhoo. The detached breakwater made of coral stones was partially damaged by the tsunami as shown in Photo 3.9.7.

Photo 3.9.7 Detached Breakwater

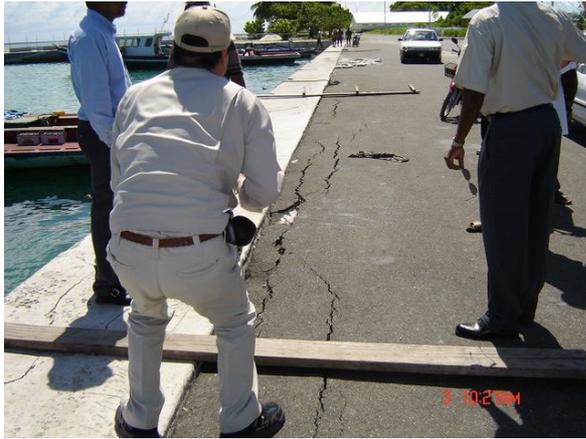
Two locations were surveyed in Maradhoo. The first one was fishing harbour. The witnesses said that three waves of the tsunami came to this area and the first one was observed at 9:15am followed by the second and third ones with interval of 5 to 10 minutes. They said that the second one was biggest and the tsunami height was about 1.5m. The inundation height was estimated at 1.65m as shown in Figure 3.9.6 as Point No.54. The sea bottom could be seen at the time of minimum sea level and 5 seconds after the minimum sea level was reached then next tsunami came. The seawall in this harbour was cracked and moved to seaward by the tsunami as shown in Photo 3.9.9. The seawall is considered to move to seaward still now.

Photo 3.9.9 Seawall Damage in Fishing Harbour

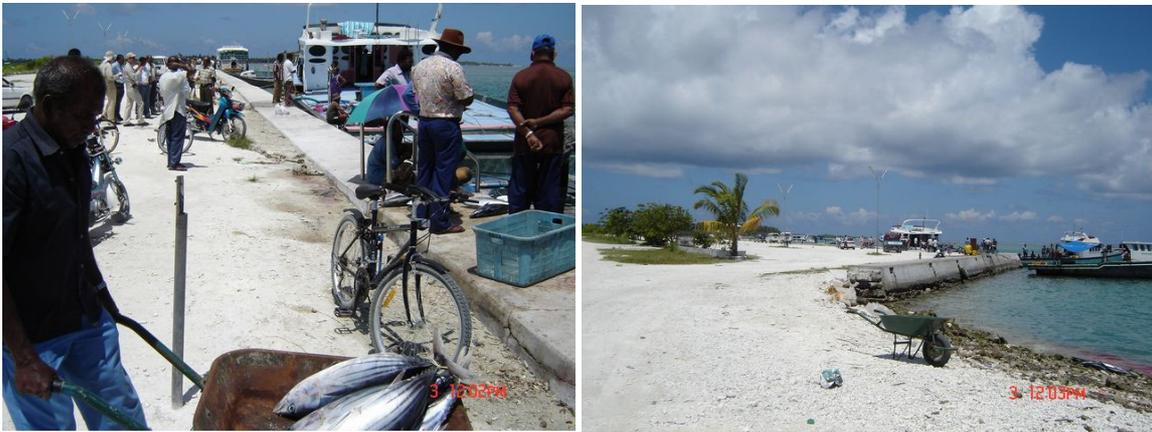
3.9.13. The seawall has two crown levels. The tsunami ran over the lower part and reached 15cm below the high crown level. The inundation height was estimated at 1.31m as shown in Figure 3.9.6 as Point No.59

Photos 3.9.12 (Left) and 3.9.13 (Right) Seawall in Hithadhoo Harbour
