# Report on Post Tsunami Survey along the Myanmar Coast for the December 2004 Sumatra-Andaman Earthquake

**Abstract:** The tsunami heights from the 2004 Sumatra-Andaman earthquake were between 0.4 and 2.9 m along the Myanmar coast, according to our post tsunami survey at 22 sites in Ayeyarwaddy Delta and the Taninthayi coast. Interviews to coastal residents indicate that the tsunami arrived between 2 to 5.5 hours after the earthquake, although nobody felt ground shaking. Much smaller tsunami than the neighboring Thai coast, where the tsunami heights were 5 to 20 m, explains relatively slighter tsunami damage in Myanmar; the casualties were reported as 71, compared to about 8300 in Thailand. The smaller tsunami was probably due to the fact that the tsunami source did not extend to Andaman Islands. The tsunami travel times and maximum heights computed from a 700 km long source are basically consistent with the observation. For a nearby tsunami source, the tsunami hazard would be more significant in Myanmar, because coastal houses are unprotected for tsunamis and no infrastructure exists to disseminate tsunami warning information.

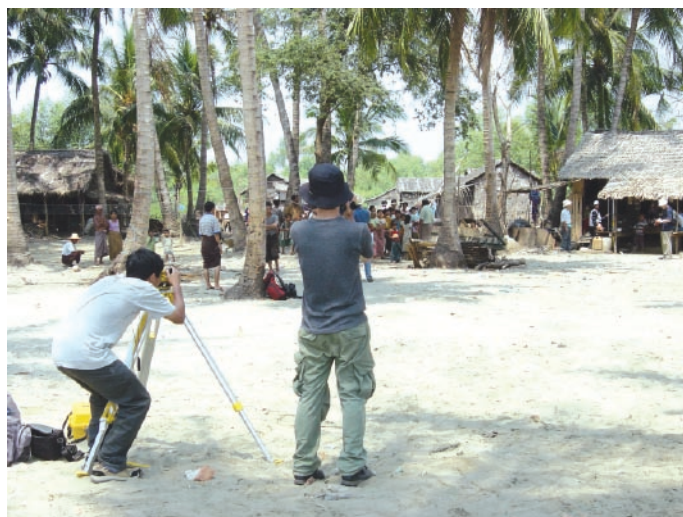
Photo 1. Two kinds of measurements, using auto-level (left) and laser (right) instruments.

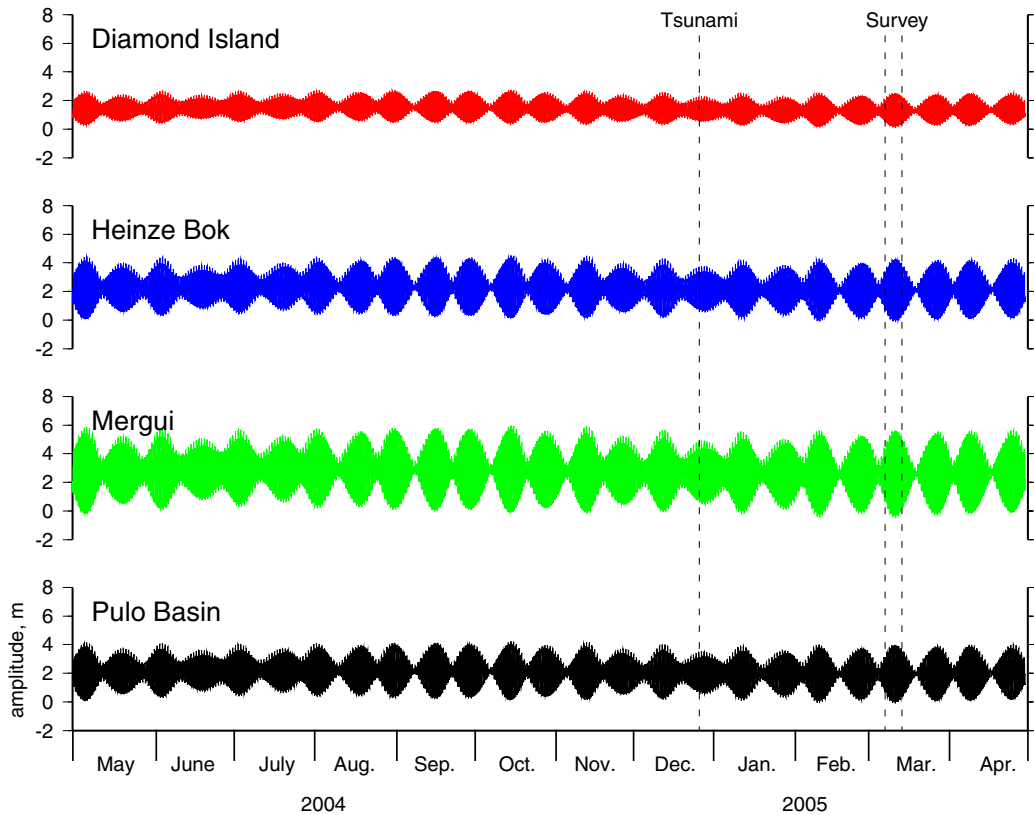
Fig. 5. Computed astronomical tidal changes at Diamond Island, Heinze Bok, Mergui and Pulo Basin for one year, starting May 2004. Note that tidal range is similar throughout the year, both dry and rainy seasons.

Figure 5 indicates the tidal levels for one year, from May 2004 through April 2005, including both dry and rainy seasons. In Myanmar, a year is divided into three seasons: summer from February through May, rainy season from June through September, and winter from October through January. As reported in more detail in each locality, many coastal residents compared the tsunami heights with the “rainy season high tide level”. From the interviews, we had an impression that high tide levels are different from dry and rainy seasons. However, the seasonal change is very small, if any, compared to the amplitude of daily tidal change (Fig. 5).

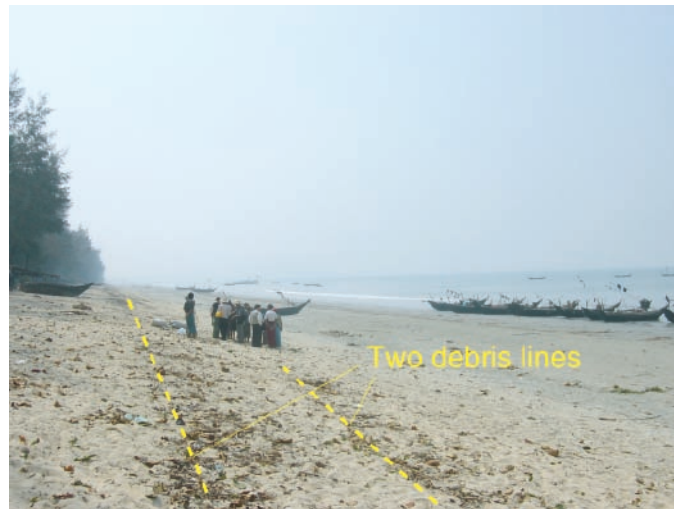
On this beach, two parallel lines of debris were observed (Photo 2). A local fisherman (36 years old male) told us that the lower debris line was formed by the December tsunami. He did not feel the earthquake but observed that the tsunami arrived at around 2 pm, in a total of four successive waves with 3 to 4 m height. The tsunami arrived at low tide and did not exceed the high tide level of the rainy season (the higher debris line). Another eyewitness indicated the tsunami arrival times were between 10 am and 12 noon.

Our measurement at 10:27 on March 7, 2005 indicates that the lower and higher debris lines are 2.4 m and 2.9 m above the sea level at the time of measurement (Photo 2). The dune, to which the tsunami did not reach, was 4.0 m high. The corrected tsunami height, assuming that the tsunami arrived at 11:00, becomes 1.8 m.

Photo 2. Group interviewing local people who had observed tsunamis at Maungmagan Beach, MM-01 (looking south).

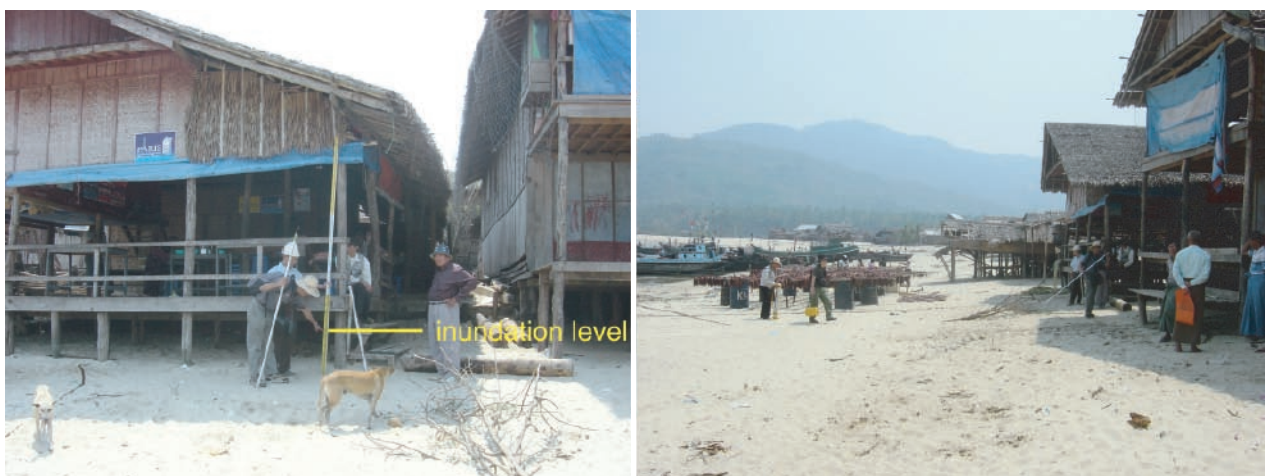
Thabawseik-Kyauksent Village is a coastal village of about 200 houses which builds up very close to the shore line. The peoples' stable earning is mainly fishery. The interview with a local person (51 year old male) confirmed that the tsunami reached up to 55 cm above the ground (Photo 3 left) and arrived between noon and 1 pm in three successive waves of 20 minute intervals but caused no severe damage. The tsunami height was lower than the rainy season high-tide level. The measurement at 11:25 on March 7 indicates that the tsunami height was 2.4 m above the sea level, while rainy season high tide level was 3.0 m. The corrected tsunami height becomes 1.6 m.

Photo 3. Survey measurement at Thabawseik-Kyauksent Village. Arrow indicates the height of tsunami (pointed by interviewee).

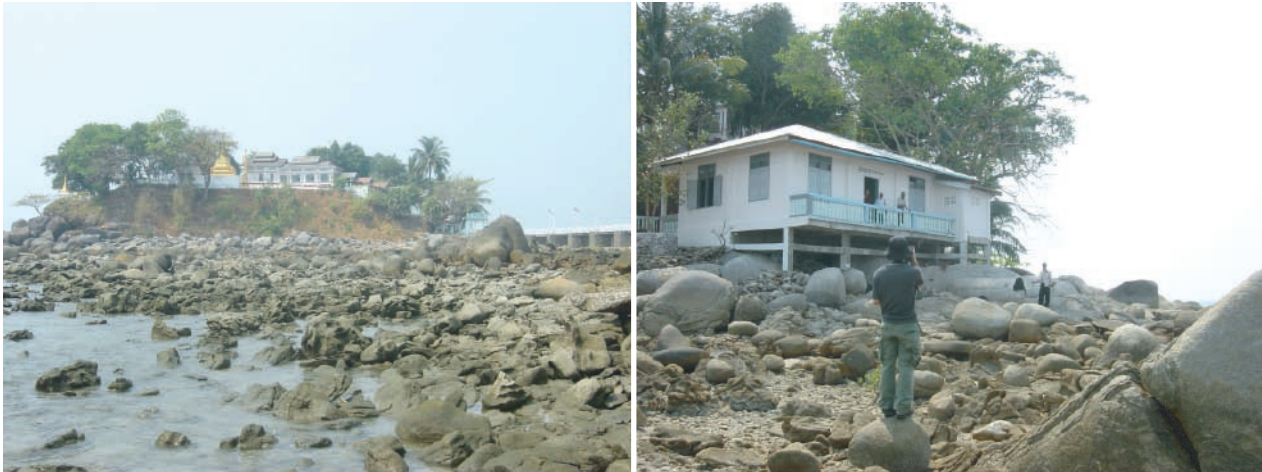
Myaw Yit Gyi Pagoda is situated on a small granite island and connected to the opposite bank by a concrete bridge (Photo 4). A Buddhist monk from the Pagoda told us that he did not feel the earthquake shaking. Between 9:30 and 11:30 am, he observed that three waves coming from different directions reached at the base of the bridge. The height of tsunami was larger than the high tide of the rainy season. When receded, the seafloor was exposed about 200 m from the shore line.

The measurement at 13:56 on March 7, 2005 indicates that the tsunami height was 3.3 m above the sea level. The corrected tsunami height becomes 1.4 m.

Photo 4. Interview with a Buddhist monk at Myaw Yit Gyi Pagoda (left) and view of Myaw Yit Gyi pagoda in seaward (westward) direction (right).

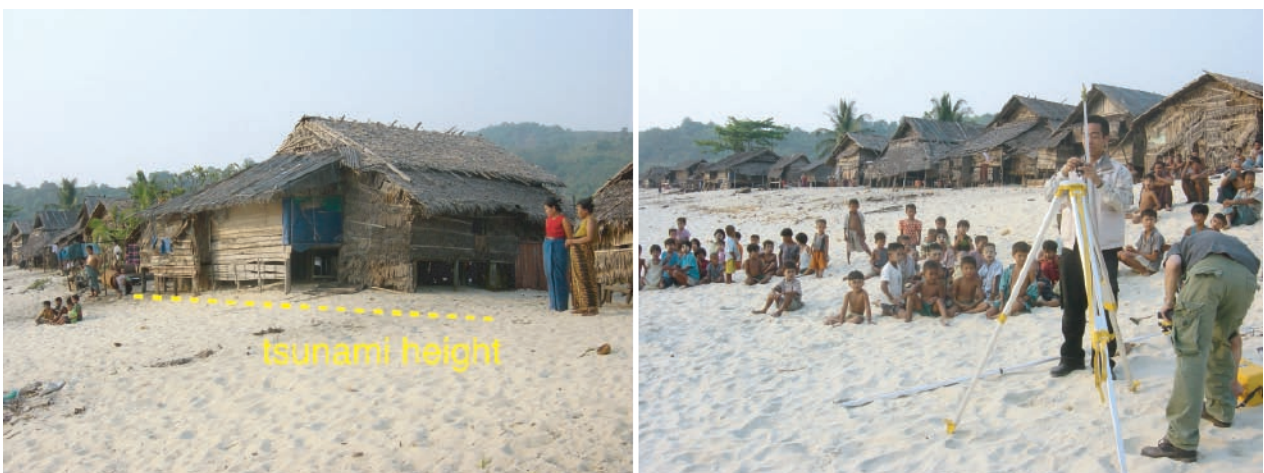
Sann Lan Village is also situated on the same shore line, and constituted of almost wooden houses. The major earning is fishery. A fisherman told that the tsunami arrived at 11 am in four times with 15 minute intervals and it was coincidence with low tide (Photo 5).

Measurement at 16:40 on March 7, 2005 indicates that the tsunami height was 4.9 m above the sea level, while the high tide of the day was between 1.9 and 2.3 m. The corrected tsunami height becomes 2.9 m.

Photo 5. Survey at Sann Lan Village. Yellow dotted line is tsunami height (left). Measurement at Sann Lan Village (right).

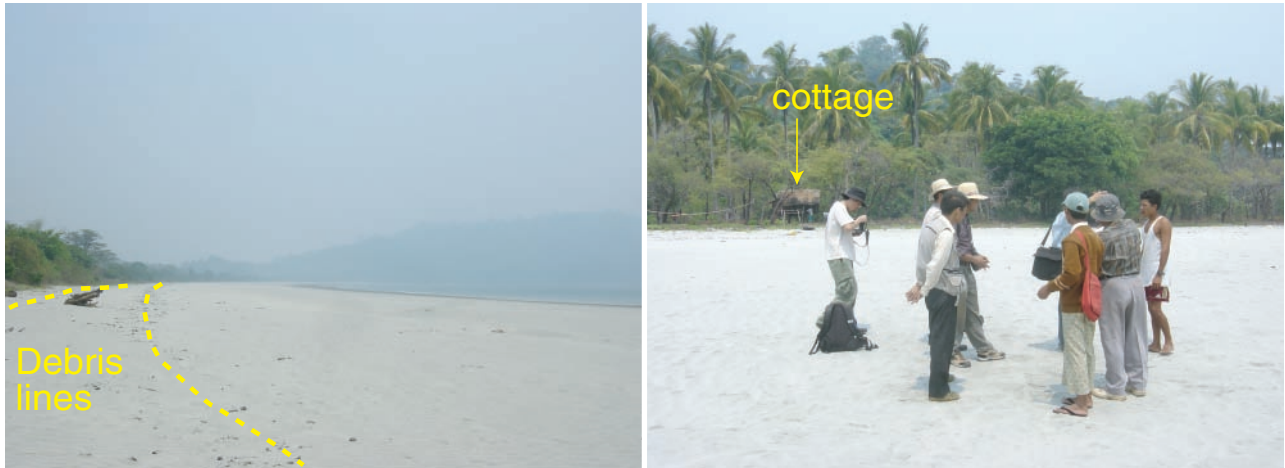
Kyet Lut beach is situated on the southern tip of the peninsula, 60 km from the Dawei. Two parallel debris lines were observed on the beach (Photo 6 left). A 19-years old male who live in a cottage where a group of farmers living seasonally reported that the tsunami entered after lunch (normally, local people take lunch about 10 am), and observed three times with 3 to 5 minute intervals. In addition, the lower debris was brought by the tsunami, while the upper one was by rainy season high tide.

Measurement at 12:30 on March 8, 2005 indicates that the lower debris line was 2.7 m above the sea level, while the upper line was 3.2 m. The corrected tsunami height becomes 1.9 m.

Photo 6. Survey at Kyet Lut Beach. Debris line indicates the maximum reach of tsunami (left) and a small seasonal hut where the interviewee lives (right).

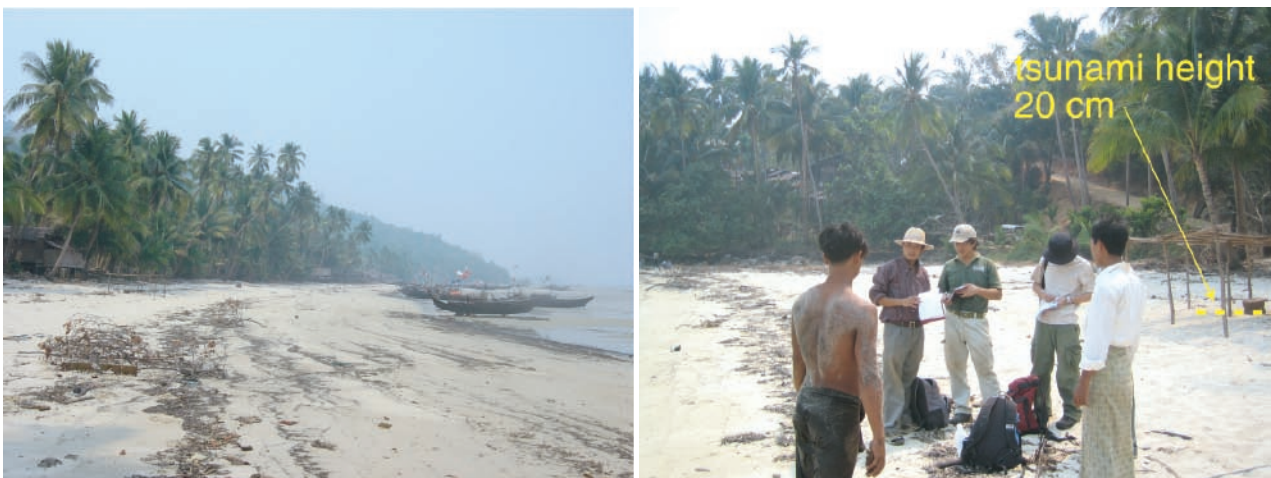
Measurement at 14:00 on March 8, 2005 indicates that the tsunami height was 2.6 m above the sea level. The indicated high tide levels of the day and rainy season were 2.3 m and 3.8 m, respectively. The corrected tsunami height becomes 0.9 m.

Photo 7. Survey at Kyaukmattat Village on the west bank of the Dawei River.

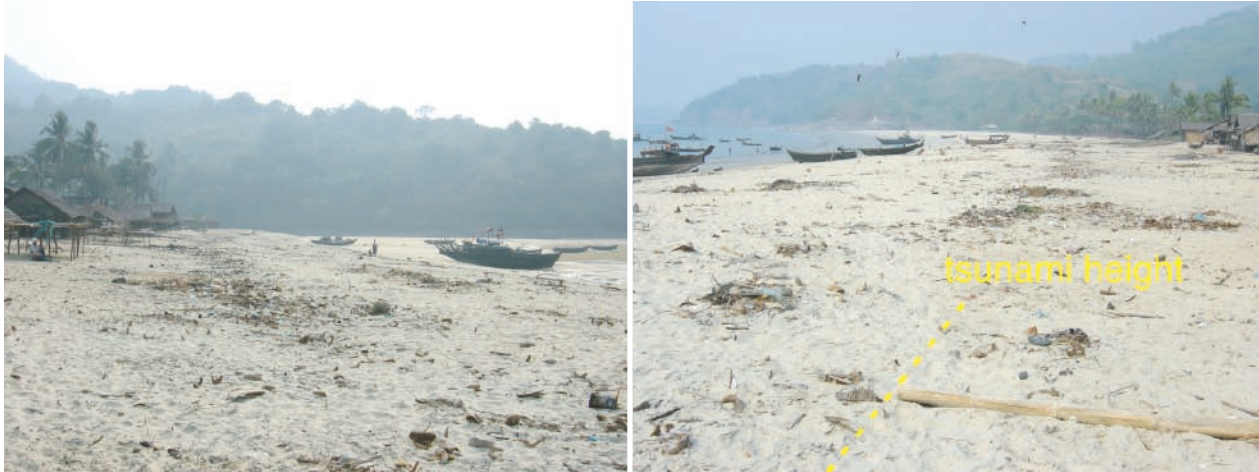
The measurement at 15:07 on March 8 indicates that the tsunami height was 4.3 m above the sea level. The indicated high tide levels of the day and rainy season were 3.2 m and 4.8 m, respectively. The corrected tsunami height becomes 2.0 m.

Photo 8. Survey at Nyawbyin Village in Longlon Township.

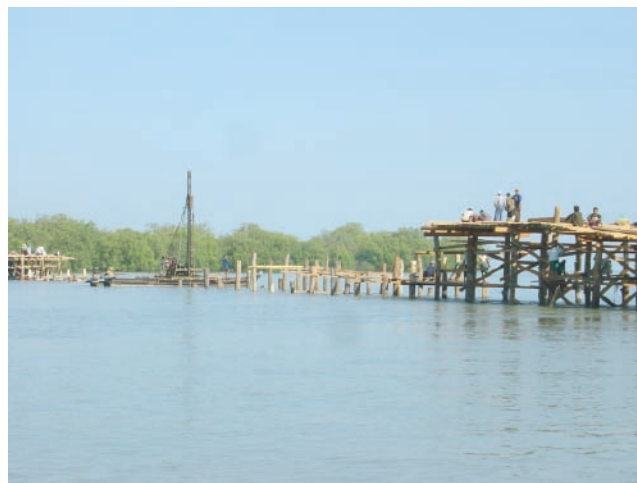
Plautonton Island is a small island close to the west coast of Kawthaung City, connected by a 600 meter long wooden bridge. The central part of the bridge was destroyed by the tsunami (Photo 9). Field survey was taken at Plautonton Village on the island. Most houses of the village are built on a mudflat, raising floor level up to one or two meters above the sea surface (Photo 10 left). Watermarke was observed at the interviewee's house (Photo 10 right). A 37 year old housewife told that the tsunami arrived at 10: 30 am in three waves with 15 minute intervals. A 62 year old male, owner of a grocery store, said that two waves with 10-15 minute intervals arrived. Because the tsunami arrived during low tide, there was no severe damage to buildings, but some household wares (rice bags, cloths and TV sets, etc) were flooded. One person died in this village.

Measurement at 9:30 on March 10, 2005 indicates that the tsunami height was 1.8 m above sea level, while that of the rainy season high tide was 0.7 m. By assuming that the time arrived at 11:00, the corrected height becomes 2.5 m.

Photo 9. Destruction of wooden bridge to Plautonton by the tsunami.

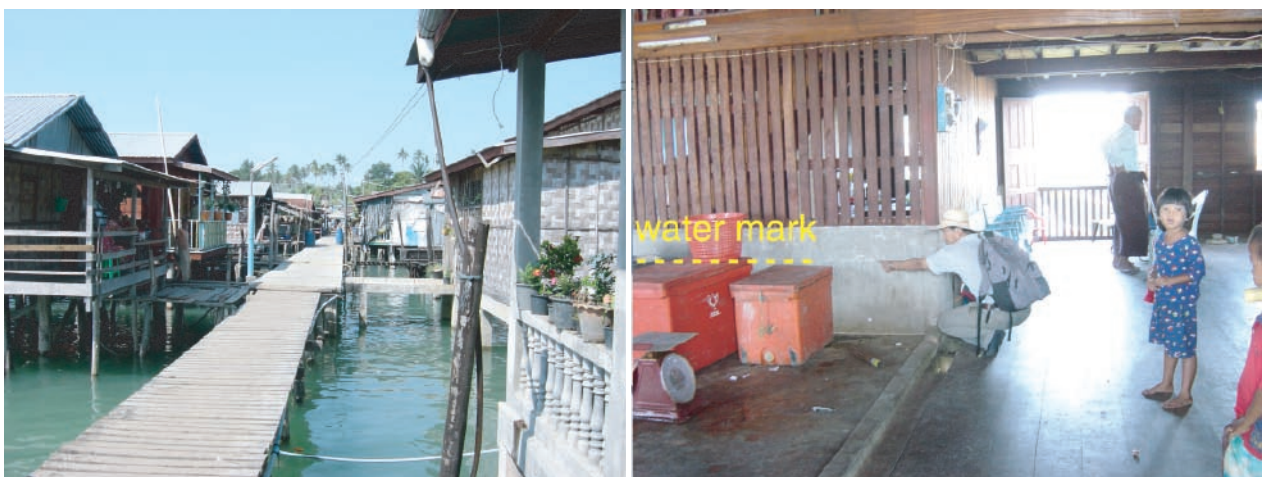
Photo 10. Houses above water (left) and the watermark on the wall of a house (right).

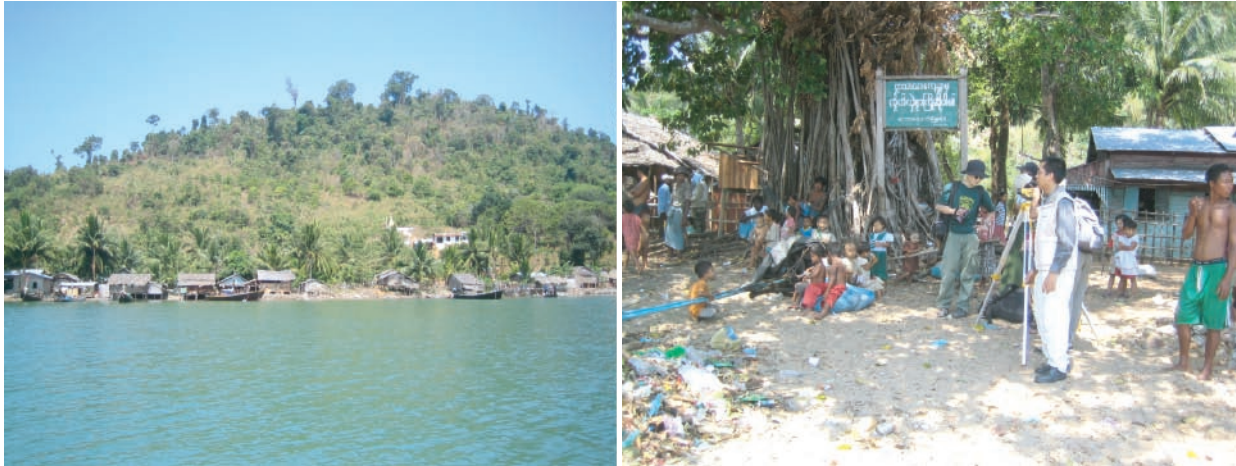
At the Ywarthaya Village of Salonlay Island, situated to the west of the Plautonton Island, there was no damage at all by the tsunami (Photo 11). A 23 year old male told us that the tsunami arrived at 11:15 am. Three to four waves arrived with 5 minute intervals. Measurement (at 10:50 March 10) indicates that the tsunami height was 1.0 m above the sea level, while the rainy season high tide level was 0.6 m. The corrected height is 1.8 m.

Photo 11. Field survey at Ywarthaya Village, Salonlay Island.

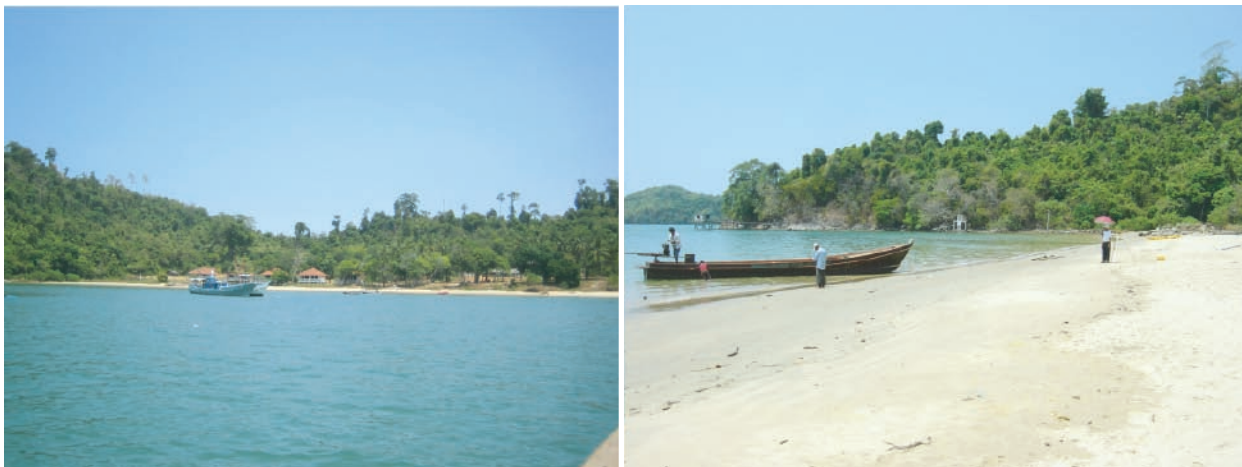
The Dolphin Club of Salon Island, a few kilometers south of Salonlay Island, has a flat shore line. An interview was made to an eyewitness from the Dolphin Club. A 27 year old male told us that tsunami arrived at 11:45 am, in four waves with 5 minute intervals, and the height was the same as the sea level at the time of our visit at 11:40 on March 10. The high tide level in rainy season is 1.1 m above the sea level. The corrected height is 0.4 m (Photo 12).

Photo 12. Survey at the Dolphin Club, Salon Island.

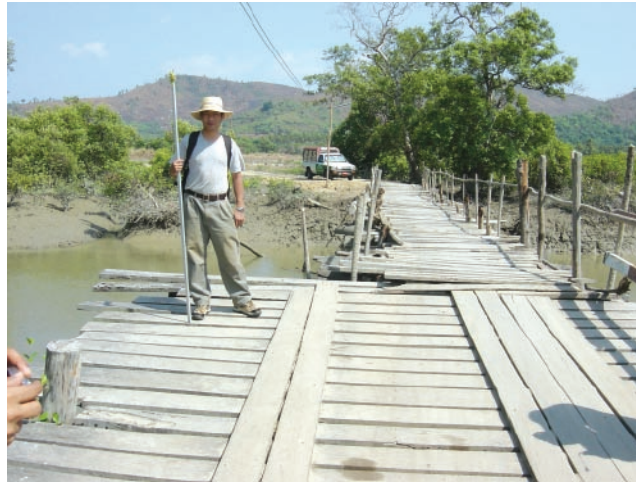
Konnamaing Chaungwa is a small village located on the western coast, northwest of Kawthaung City. A bridge over a stream connected to the village was partly damaged during the incoming tsunami (Photo 13).

Photo 13. Destruction of bridge to Konnamaing Chaungwa Village by tsunami (narrow flat portion in the right far site of photo).

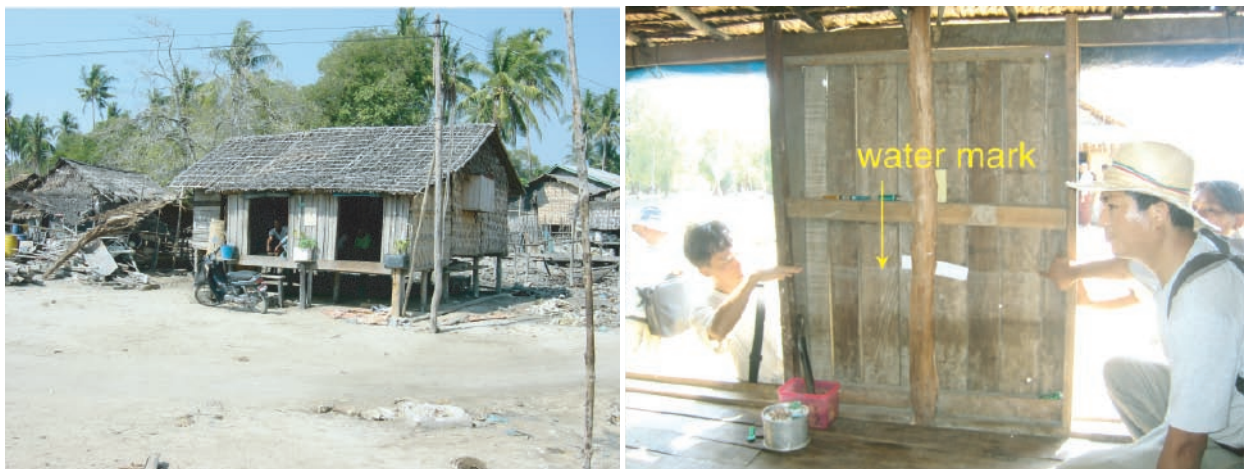
There were some damages by the tsunami: one death and destruction of eight houses. There is a clear watermark on a wall of a house indicating the tsunami height (Photo 14 right). Furthermore, the tsunami brought up some fishing boats along the stream course and then onto the paddy field (Photo 15 left). Some traces of marine mud on telephone post indicated the height of splash from the tsunami (Photo 15 right). According to eyewitness account, the tsunami arrived at 10:45 am.

Systematic measurement at 14:40 on March 10, 2005 indicates that the two watermarks were 1.4 and 1.2 m above the ground level, and 3.9 m and 4.0 m above the sea level. The corrected tsunami height is 1.9 m.

Photo 14. Watermark (right) at the wall of the interviewee's house (left).

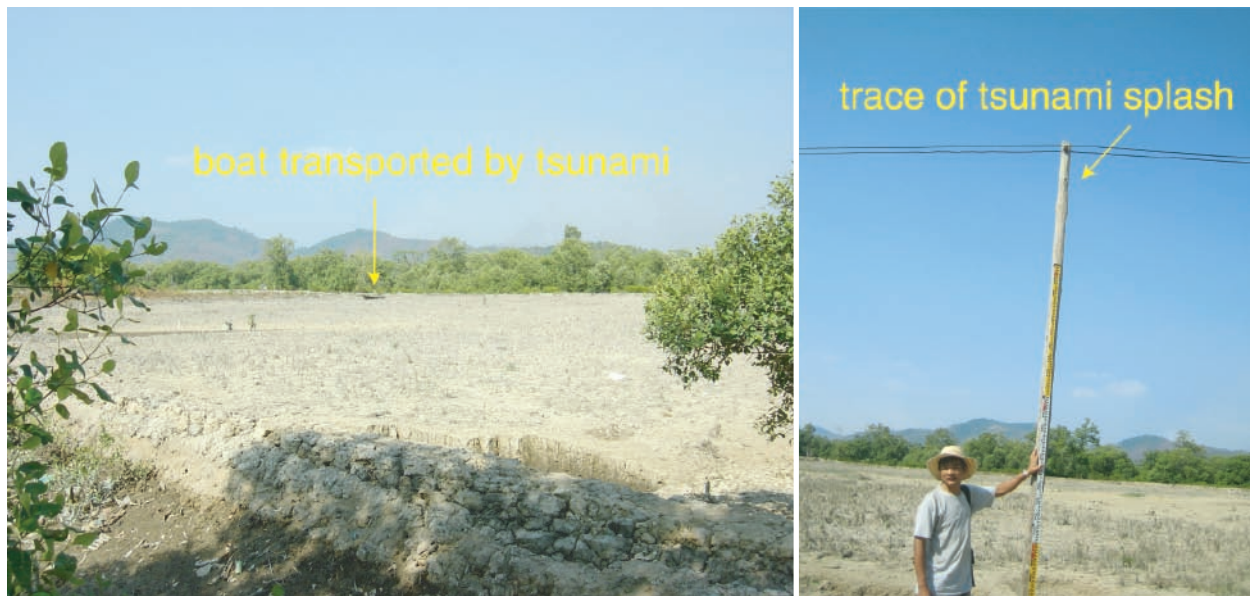
Photo 15. Traces of mud brought by tsunami at the top of the telephone post (right) and a boat and tsunami deposit in a paddy field (left).

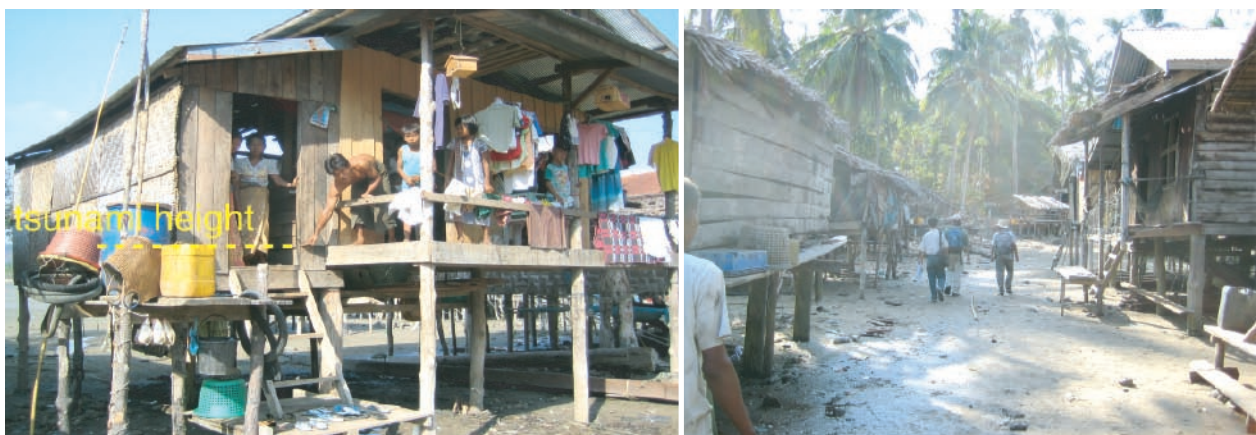
The measurement at 15:50 on March 10 indicates that the tsunami height was 4.4 m above the sea level. The sea level was very low at the time of measurement and the current water front was more than 200 m offshore, hence the height measurement was less reliable. The corrected tsunami height becomes 1.7 m.

Photo 16. Field survey at Tannyopada.

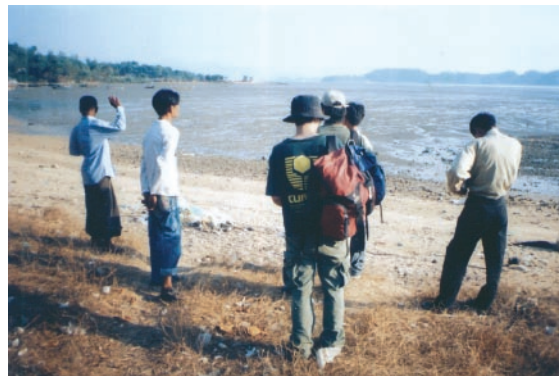
Measurement at 16:54 on March 10 indicates that the tsunami height was 3.3 m above the sea level. The calculated tide levels at the time of measurement and 11:00 of December 26 are 0.2 m and 2.9 m, respectively, hence the corrected height would be 0.6 m. However, the sea level at the time of measurements was very low, and the measured heights are not reliable. Alternatively, we estimate the tsunami heights using the differential levels at this location. We also measured, on the basis of eyewitness accounts, the high tide levels of the rainy season, evening and morning of the day as 2.0 m, 1.8 m and 1.5 m, respectively, above the sea level. The tsunami height was 1.8 m higher than the high tide level of the morning of March 10. The calculated high tide is 3.7 m, or 0.8 m higher than 11:00 of December 26. From these, the tsunami height is estimated as 2.6 m. We consider that this estimate is more reliable.

Photo 17. Field measurement was carried out in Thirimyaing Quarter of Kawthaung City. A large coverage of mud flat in connection with low tide and a barrier of Island in the seafront lead to less tsunami effect on the shore.

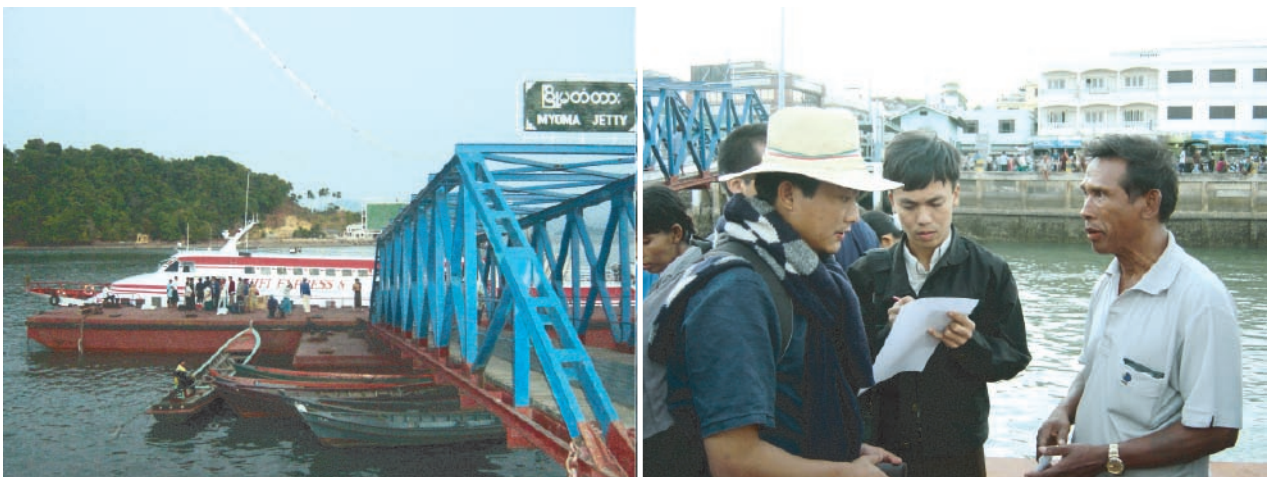
Measurement at 17:30 March 10 indicates that the tsunami height was 4.1 m above the sea level. The estimated tsunami height becomes 1.6 m.

Photo 18. Survey at Kawthaung Myoma Jetty.

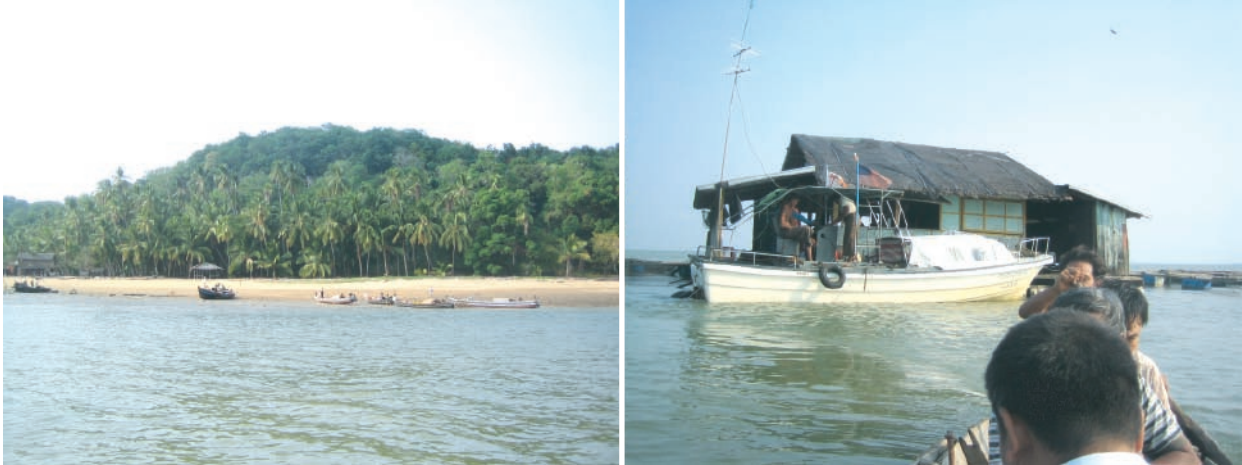
Our measurement (at 16:10 March 11) of the tsunami levels of two accounts are 2.2 m and 4.4 m, and the high tide level of the rainy season is 5.1 m. Assuming that the higher level (4.4 m) represents the maximum tsunami height and the tsunami arrival time as 11:00 am, the corrected height becomes 0.7 m.

Photo 19. Field survey at Thandar Kyun Village.

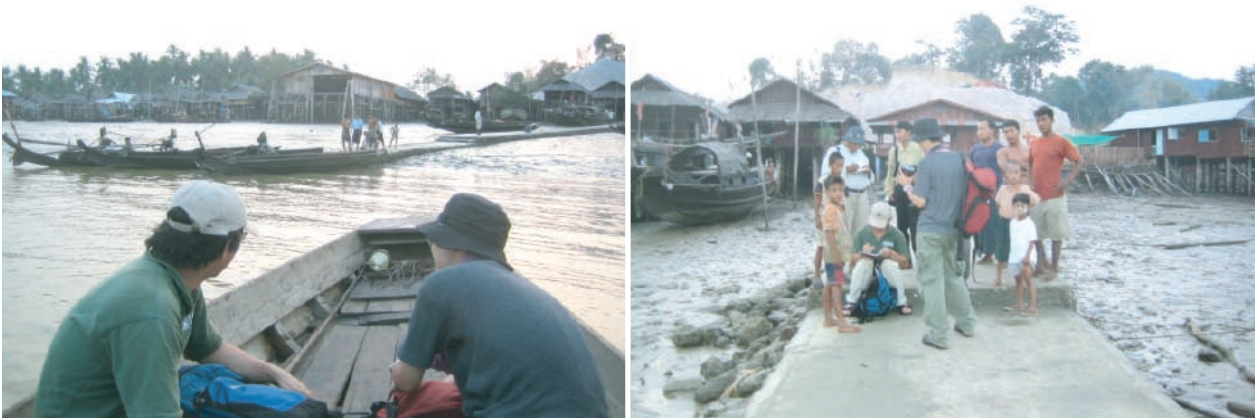
Measurement (at 18:00 March 11) indicates that the tsunami height was 6.7 m above the sea level, while the high tide in the rainy season was 6.3 m. Assuming that the tsunami arrival time was 11:00, the corrected tsunami height becomes 2.2 m. An eyewitness indicated that the tide level just before the tsunami arrival was 4.6 m, making the tsunami height 2.1 m, very similar to the corrected height.

Photo 20. Field survey at Pahtaw Village.

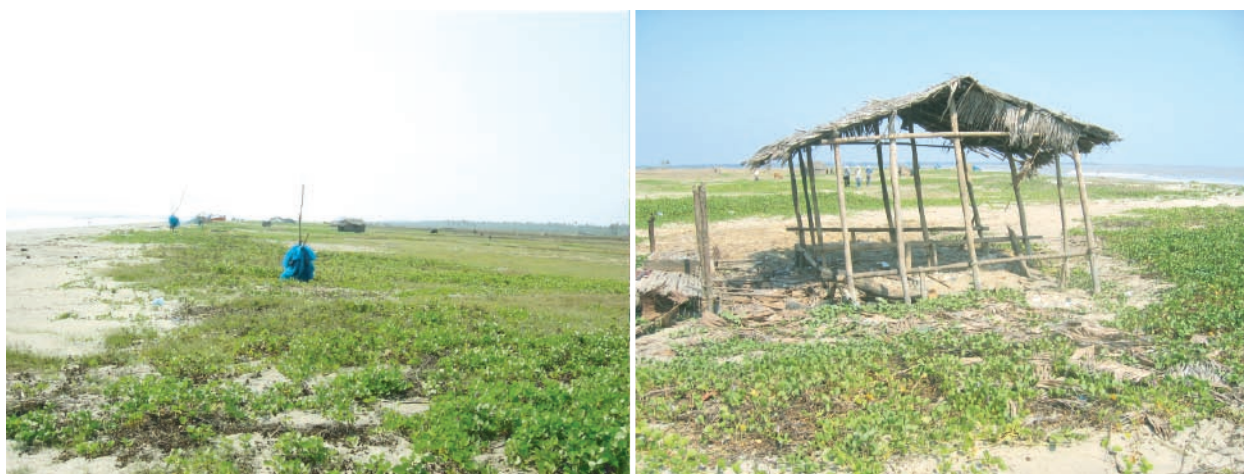
Measurement at 14:46 on March 13, 2005 indicates that the tsunami level was 0.7 m above the sea level. Assuming that the tsunami arrived at 11:30, the corrected tsunami height becomes 0.6 m.

Photo 21. Field survey at Layyin Kwin (Airfield) Village near Pyinsalu.

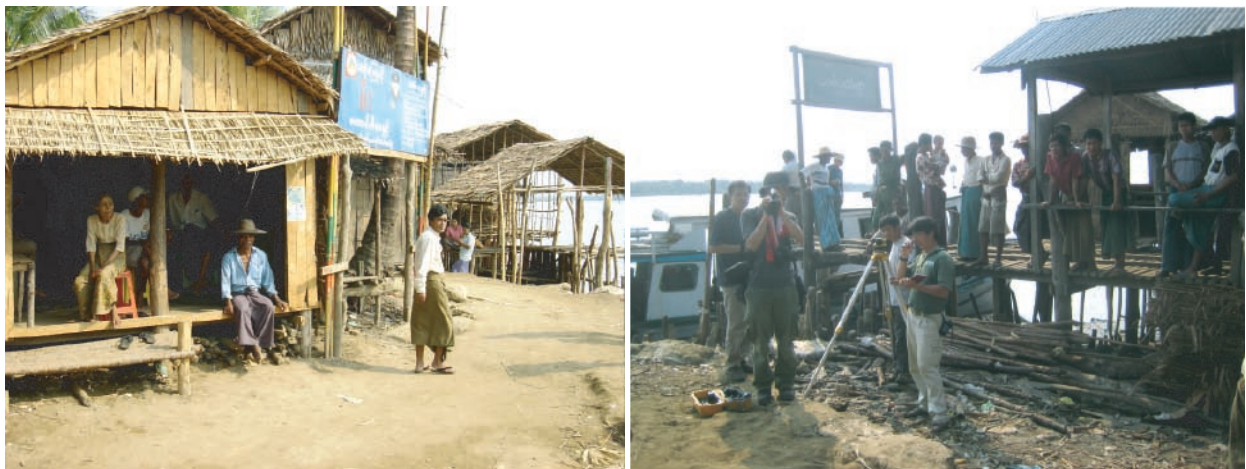
Thit Poke Village is a small one with 332 houses and located at about 20 km from Pyinsalu. Two houses were damaged, but the tsunami caused no injuries or casualties. Interview with local people indicated that the tsunami inundated about 50 cm above the ground at 11:40 am. Measurement at 8:57 on March 14 indicates that the tsunami height was 2.9 m above the sea level. Assuming that the tsunami arrived at 11:30, the corrected height becomes 1.7 m.

Photo 23. Field survey at Thit Poke Village.

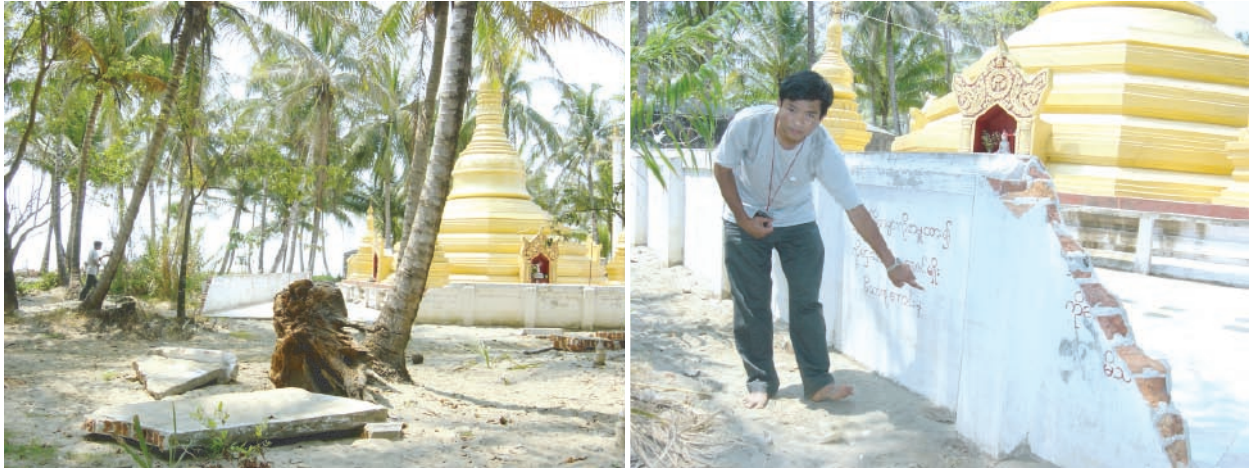
In Kaing Thaung Village, a pagoda built near the shore line was damaged by the tsunami. Part of the outer wall was knocked down (Photo 24 left) and watermark was clearly observed at 50 cm above the ground level (Photo 24 right). A Buddhist monk told us that the tsunami arrived at 11:30 am. Our measurement at 11:46 on March 14 indicates that the tsunami height was 1.8 m above the sea level. Assuming that the tsunami arrived at 11:30, the corrected height becomes 1.9 m.

Photo 24. Field survey at Kaing Thaung Island Pagoda. Walls of Pagoda are destructed by Tsunami (left) and Watermark at the wall (right).

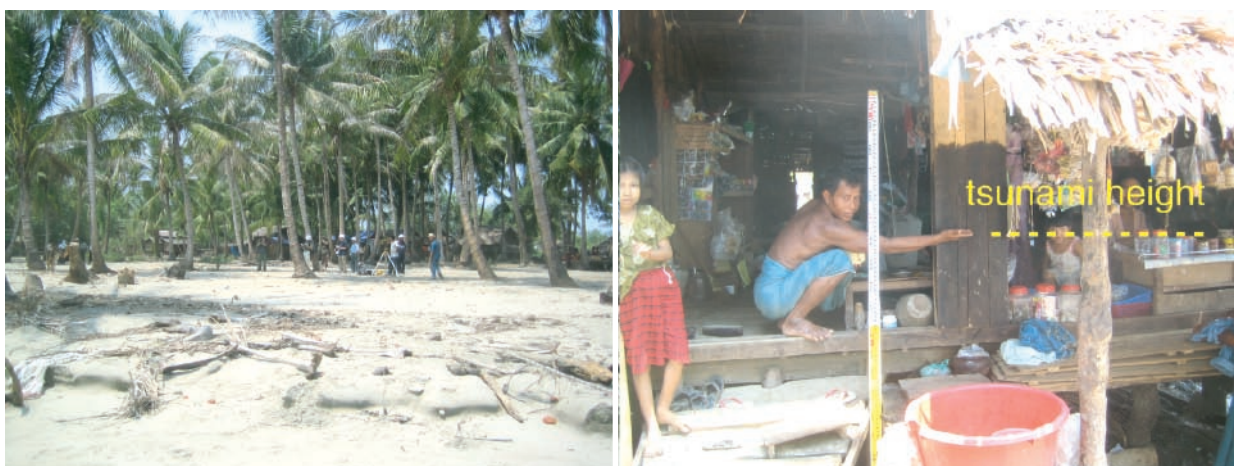
In the village, 8 casualties and 16 damaged houses are reported by Department of Meteorology and Hydrology. An eyewitness account indicated that the tsunami height was 1.35 m above the ground (Photo 25). Measurement at 12:05 on March 14 indicates that the tsunami height was 2.0 m above the sea level, and the corrected tsunami height is 2.3 m.

Photo 25. Field survey at Kaing Thaung Island Village. Local people showed the inundation height of tsunami wave (right).

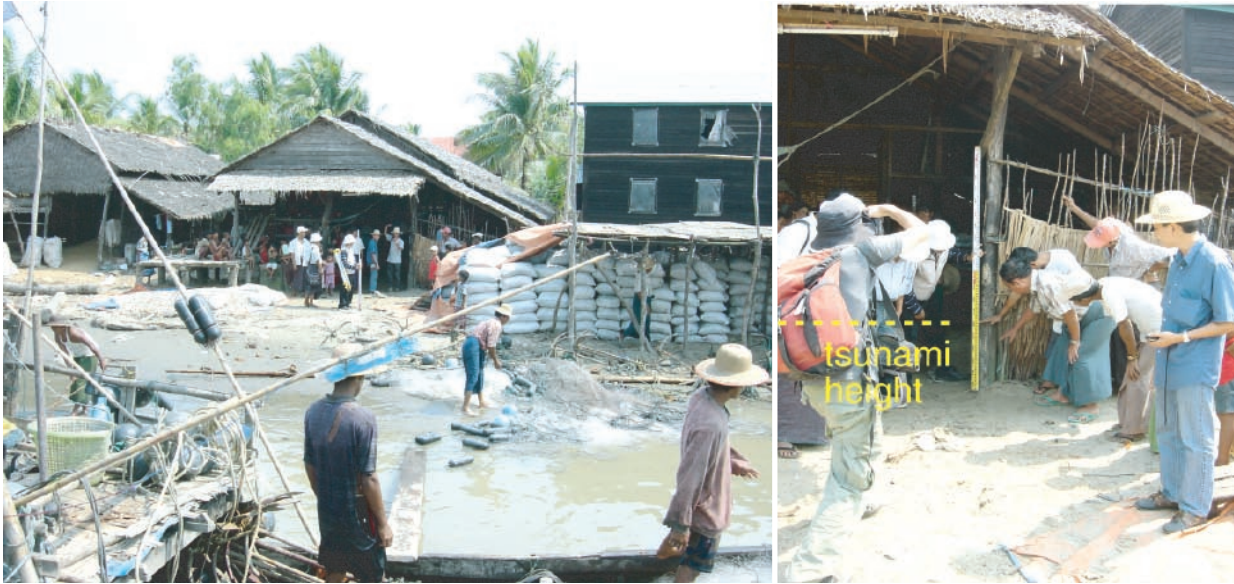
In Aung Hlaing Village, an eyewitness account indicated that the tsunami arrived at 11:45 am in two waves. The tsunami inundated about 60 cm above the ground (Photo 26 right). The second wave caused damage to 55 houses without any fatalities. Measurement at 14:06 on March 14 indicates that the tsunami height was 1.2 m above the sea level. Assuming that the tsunami arrived at 11:30, the corrected height becomes 1.5 m.

Photo 26. Survey at Aung Hlaing Village.
