3.3 Ranongga Island

3.3.1 Location and bathymetry

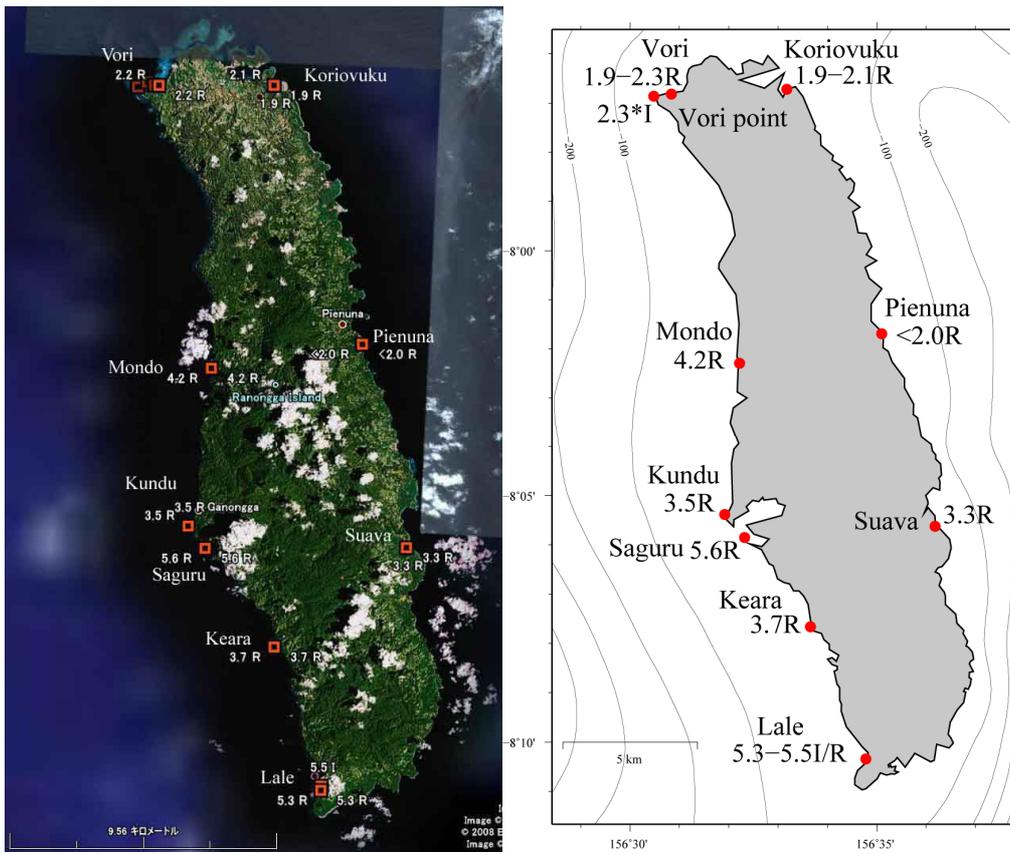
Figure 3.3.1.2 Surveyed sites in Ranongga Island and bathymetry around the Island

A field survey was carried out at nine villages and one point on the island; Lale, Keara, Saguru, Kundu, Mondo, Vori, Vori Point, Koriovuku, Pienuna and Suava (see Fig. 3.3.1.2).

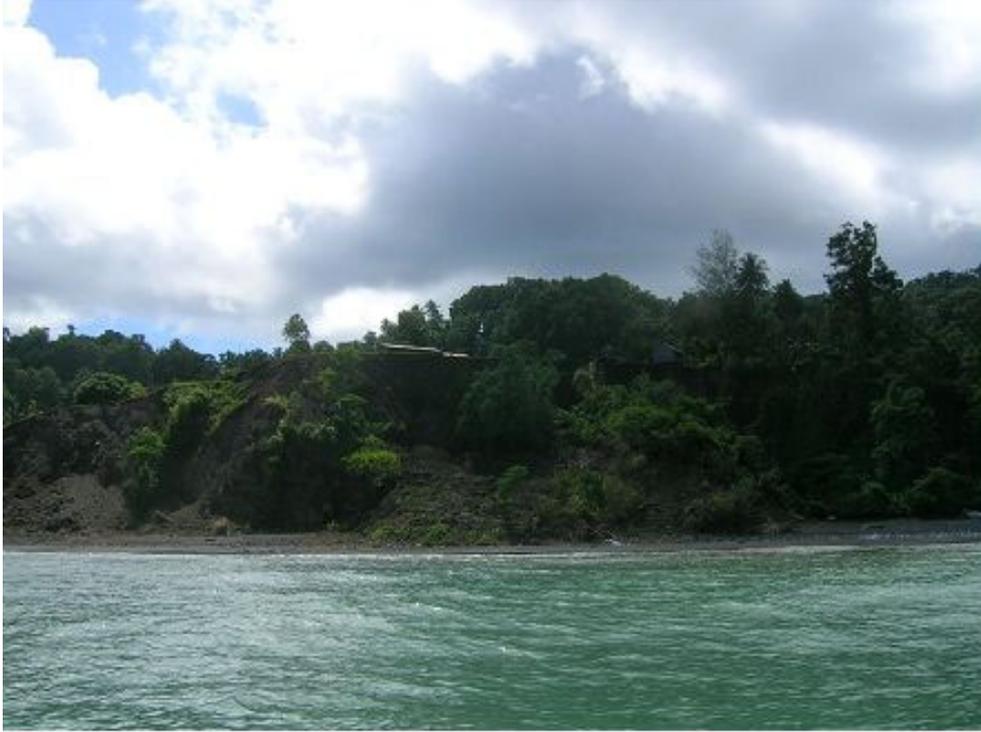
Photo 3.3.1.2 Small scale landslide at Mondo village on the west coast in the middle of Ranongga Island

Because the ground of the island was uplifted, the damage from the tsunami was light, considering the runup height of the tsunami. On the island, two persons were killed not by the tsunami, but rather by a landslide, which occurred almost everywhere on the west coast of the island. Photo 3.3.1.2 shows an example of the landslides at Mondo village where the two were killed. In the photo, a few houses can be seen at the edge of cliff.

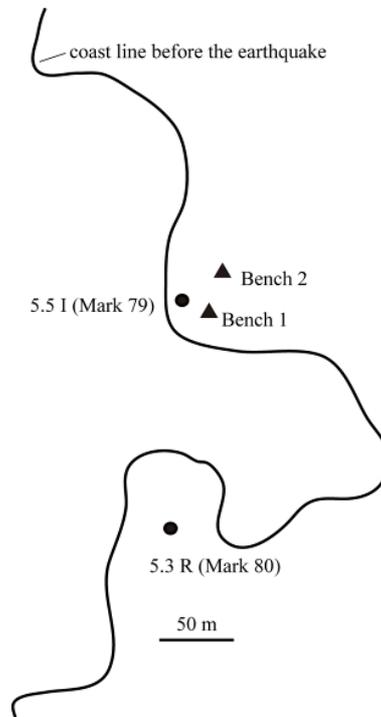
Figure 3.3.2.1 Location map of benchmarks at Lale

Because there was the large upheaval, the postseismic deformation is likely. According to eyewitness accounts of inhabitants, the ground was uplifted by about 7 m just after the earthquake, and the sea level started to rise up gradually after about 10 days of the earthquake (evidence of subsidence). In order to detect such postseismic deformation, two benchmarks (reference points) were set up. Their location and tsunami-measured points are shown in Fig. 3.3.2.1. Two benchmarks were near Mark 79. One is located at the top of the base in water supplies shown in Photo 3.3.2.2 (Bench 1). The height of the top is measured as 5.787 m above Mean Sea Level. Other is located at the top of the base in the different water supplies shown in Photo 3.3.2.3 (Bench 2). The height of the top is measured as 5.750 m above Mean Sea Level. We recommend future survey team to measure the heights of the benchmarks and compare them to the above values.

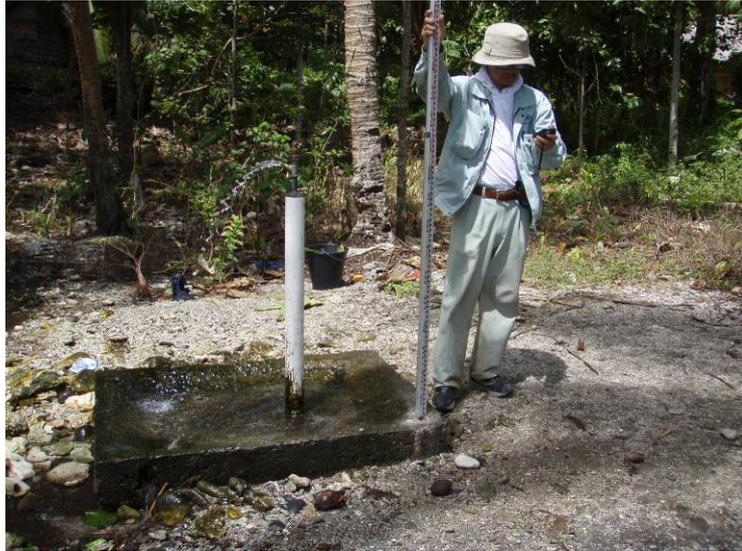
Photo 3.3.2.2 Bench mark of Bench 1 at Lale

The reference point is at the intersection point between the staff and concrete base.

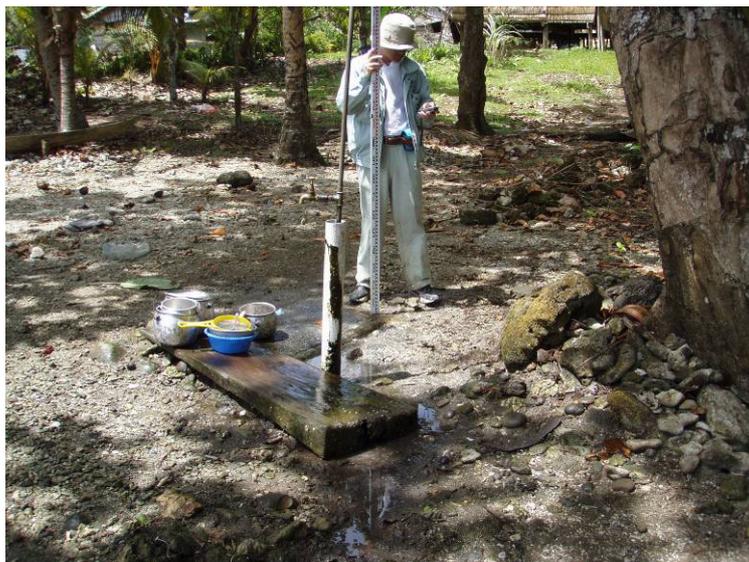
Photo 3.3.2.3 Bench mark of Bench 2 at Lale

The reference point is at the intersection point between the staff and concrete base.

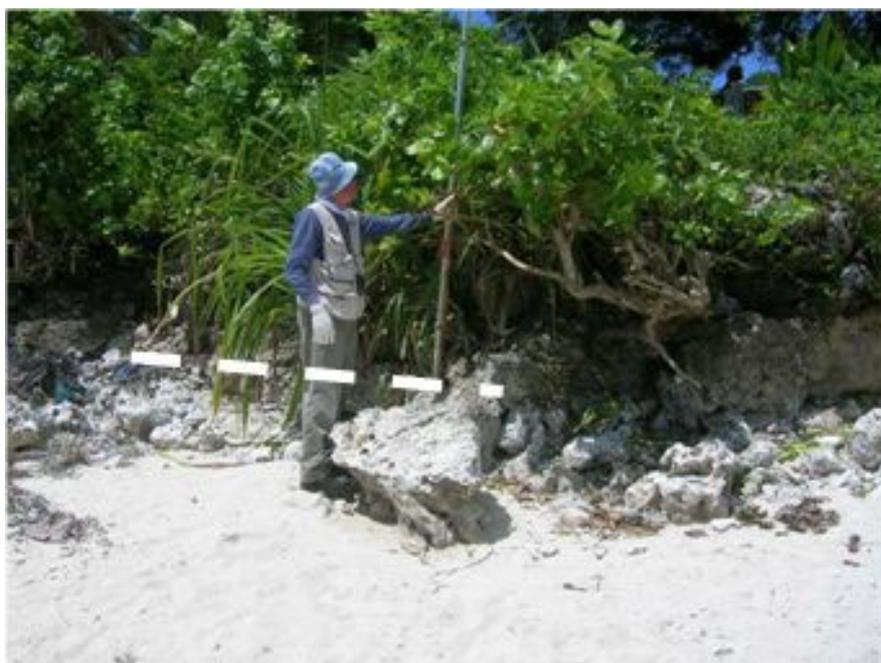
Koriovuku village is located on the east coast in the northern part of the island. The height of uplift was estimated around 1.9 m. Photo 3.3.8.1 shows a clear upper limit line of coral bleaching after the earthquake.

Photo 3.3.8.1 Clear upper limit line of coral bleaching after the earthquake at Koriovuku village

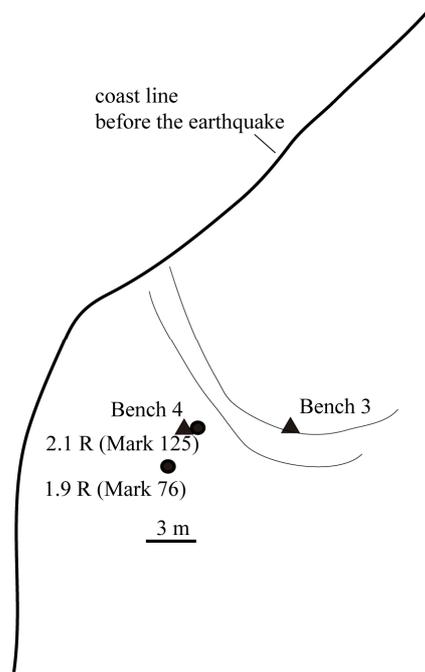
Fig. 3.3.8.1 Location map of benchmarks at Koriovuku

As at Lale, in order to detect expected postseismic deformation, two benchmarks (reference points) were set up in Koriovuku. Their location and tsunami-measured points are shown in Fig. 3.3.8.1 and Photo 3.3.8.3. Two benchmarks were near Mark 125. One is located at the top of the base in water supplies shown in Photo 3.3.8.4 (Bench 3). The height of the top is measured as 4.444 m above Mean Sea Level. The other is located at the base of a shed pillar shown in Photo 3.3.8.5 (Bench 4). The height of the top is measured as 2.713 m above Mean Sea Level.

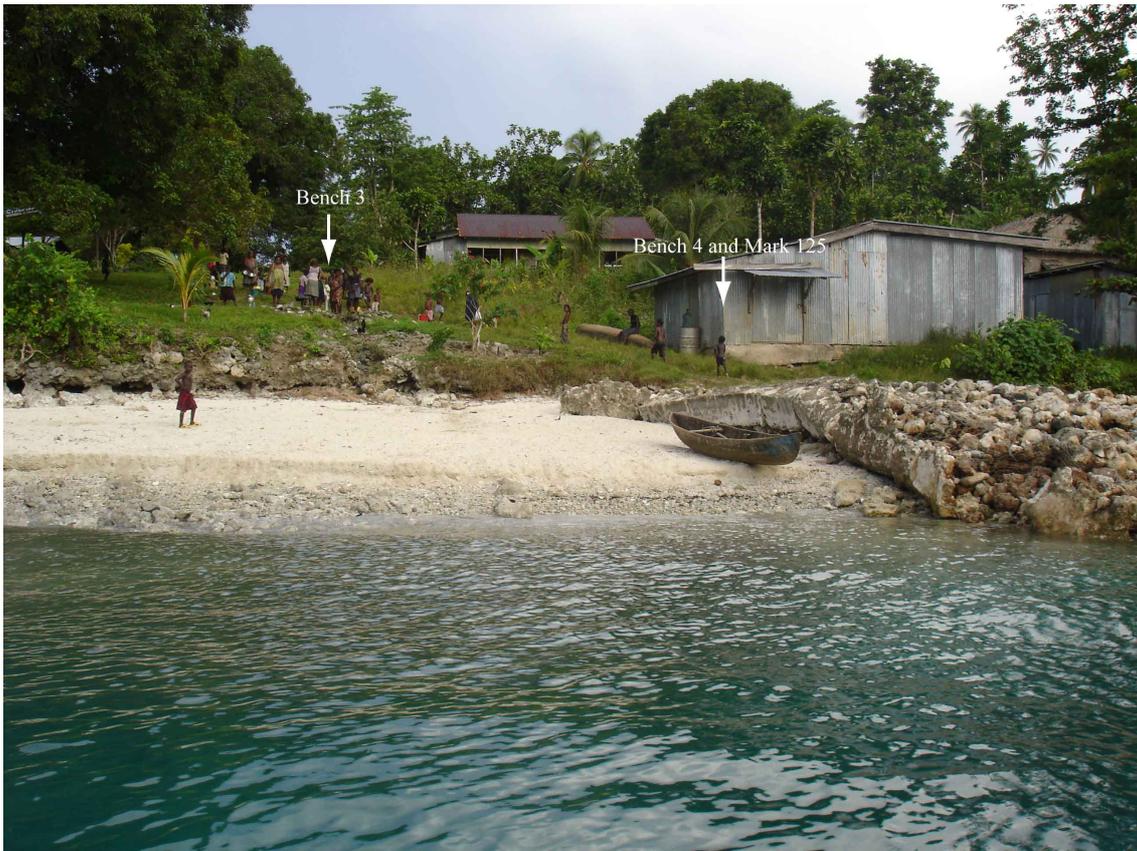
Photo 3.3.8.3 Location of benchmarks and tsunami survey point

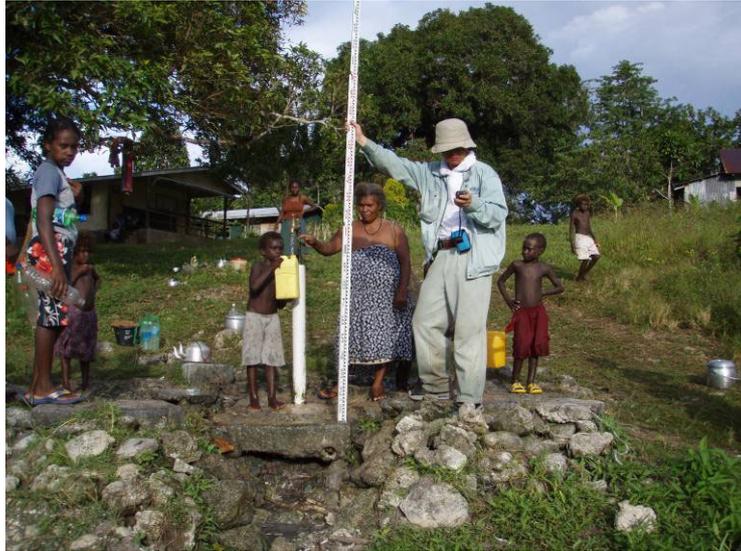
Photo 3.3.8.4 Bench mark of Bench 3 at Koriovuku

The reference point is at the intersection point between the staff and concrete base.

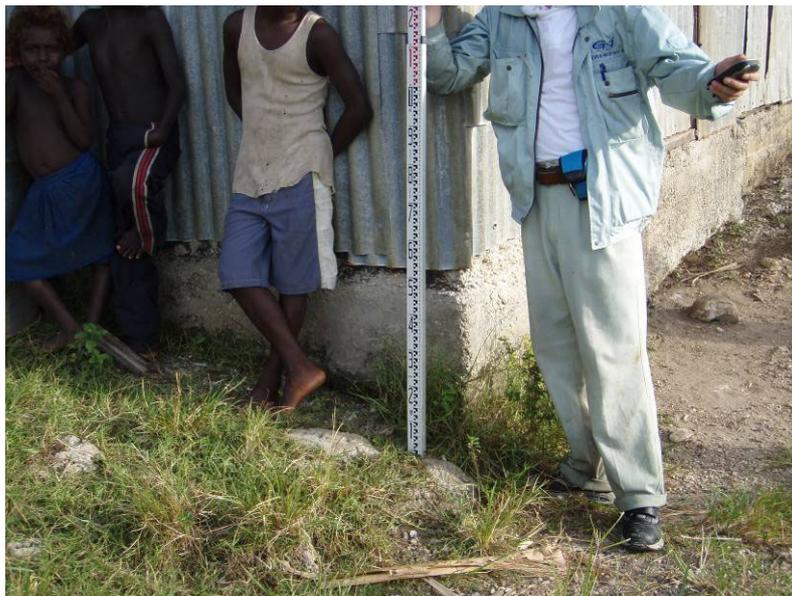
Photo 3.3.8.5 Bench mark of Bench 4 at Koriovuku

The reference point is at the intersection point between the staff and concrete base.

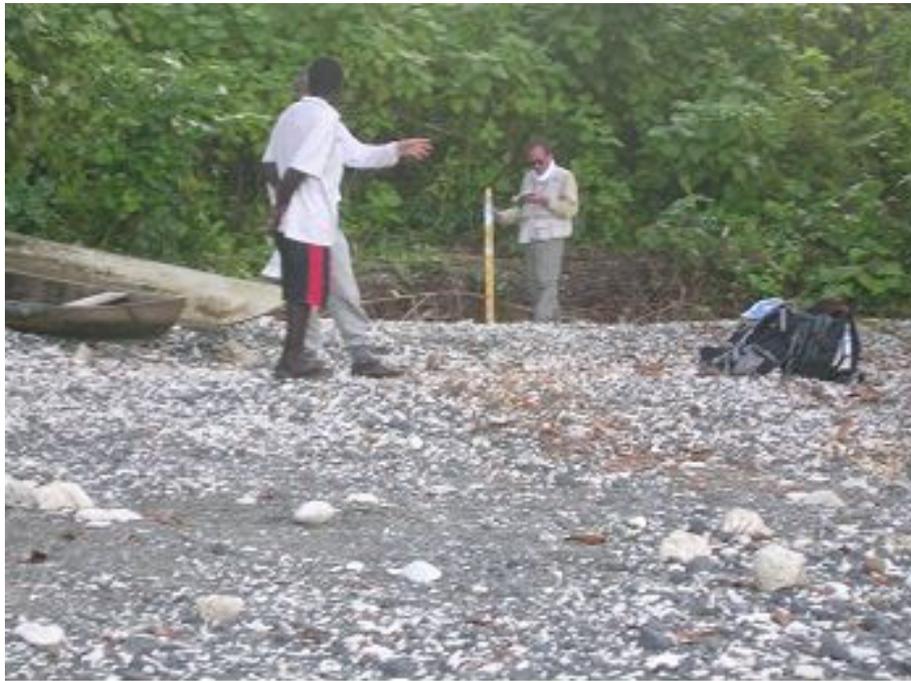
The tsunami run-up height reached nearly 3.3 m. The measured point was located on the beach and determined from eyewitness accounts of inhabitants (Photo 3.3.10.2). There was no damage except that caused by the earthquake. Although water tanks were destroyed by the earthquake, new ones had been already supplied by Solomon Islands' government.

Photo 3.3.10.1 Tsunami measured point at Suava village
