### 3.4 Vella Lavella Island

#### 3.4.1 Location and topography

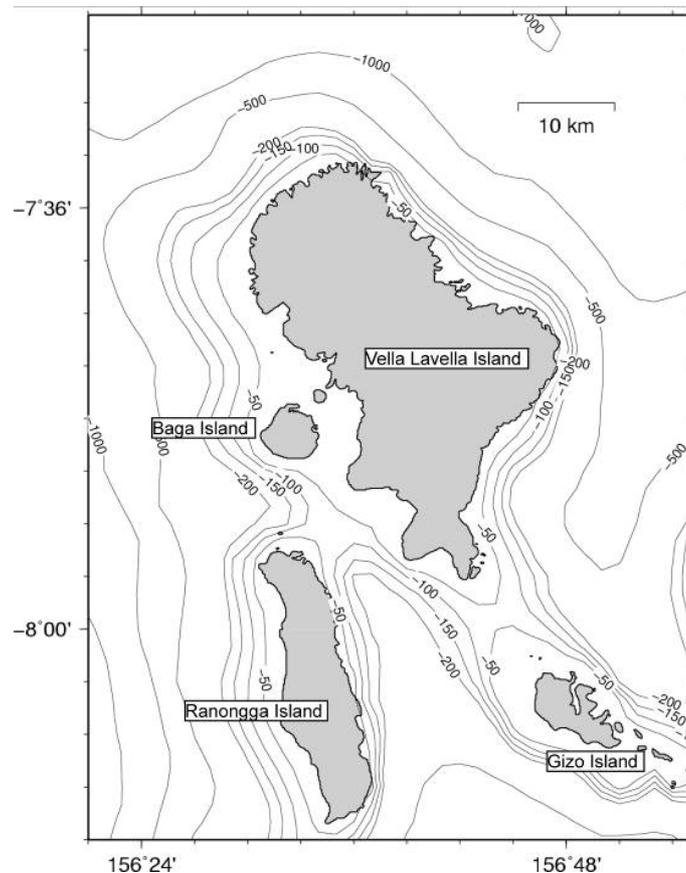
Figure 3.4.1.1 Topography around Vella Lavella Island.

Vella Lavella Island is located 15 km northwest of Ghizo Island and 15 km northeast of Ranongga Island (Fig.3.4.1.1). Fig. 3.4.1.1 shows the bathymetry around Vella Lavella Island. There is a steep slope on the north side of the island, while a gentle slope characterizes the side facing Ranongga and Ghizo islands (Fig.3.4.1.2). The tsunami source area is estimated to spread out to the offshore region of the south coast of this island. The total population of the island is about ten thousand, and three people were killed. One of them was nine-year-old child who was killed because of the shaking of the earthquake.

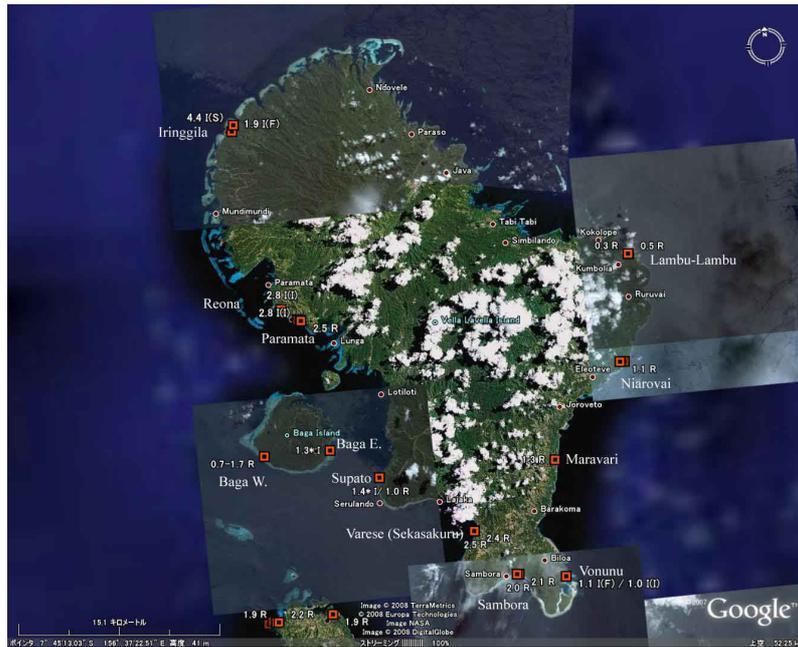
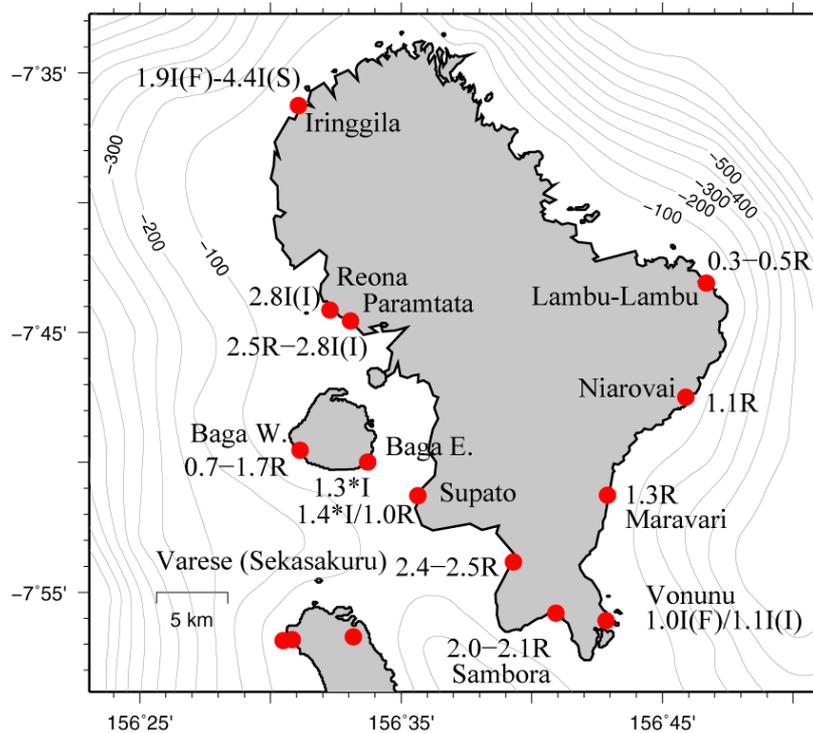
Figure 3.4.1.2 Surveyed sites in Vella Lavella Island (image by Google Earth)

We carried out the field survey at ten villages on this island and a small island adjacent to the island; Sambora, Vonunu, Varese, Maravari, Niarovai, Lambu-Lambu, Supato, Baga Island, Paramata, Reona, and Iringgila (Fig.3.4.1.2) on April 13<sup>th</sup>, 18<sup>th</sup> and 23<sup>rd</sup>, 2007.

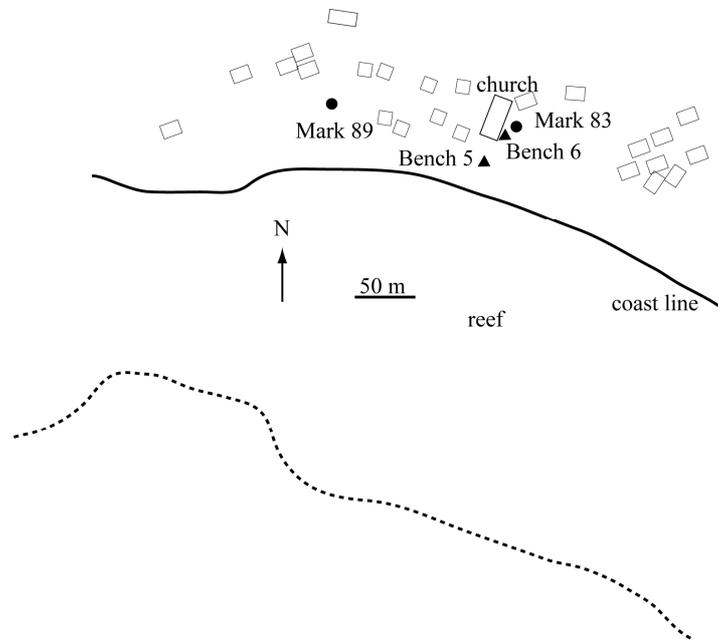
Figure 3.4.2.1 Location map of tsunami survey points and benchmarks at Sambora

We measured the tsunami heights at two points in Sambora (Fig. 3.4.2.1) judged by a debris line and eyewitnesses' accounts. At Mark 83, which is close to a church, the sea water inundation limit was recognized as the boundary between living and dead vegetation, and moreover we found that the surface of the inundated ground was wet and its color had become darker because of salt (Photo.3.4.2.2). An eyewitness corroborated that the boundary was really the limit of inundation. The height was determined to be 2.1 m above sea level at the tsunami arrival (after correction of the astronomical tide). At Mark 89, we measured the tsunami height to be 2.0 m in the same way.

Though significant upheaval did not occur here, in order to detect postseismic or interseismic deformation, two benchmarks (reference points) were set up as at Lale on Ranongga Island. Their location and tsunami-measured points are shown in Fig. 3.4.2.1. Two benchmarks were near Mark 83. One is located at the top of the base in water supplies shown in Photo 3.4.2.3 (Bench 5: 7°55'50"S, 156°40'56"). The height of the top is measured as 1.800 m above Mean Sea Level. Other is located at the corner of

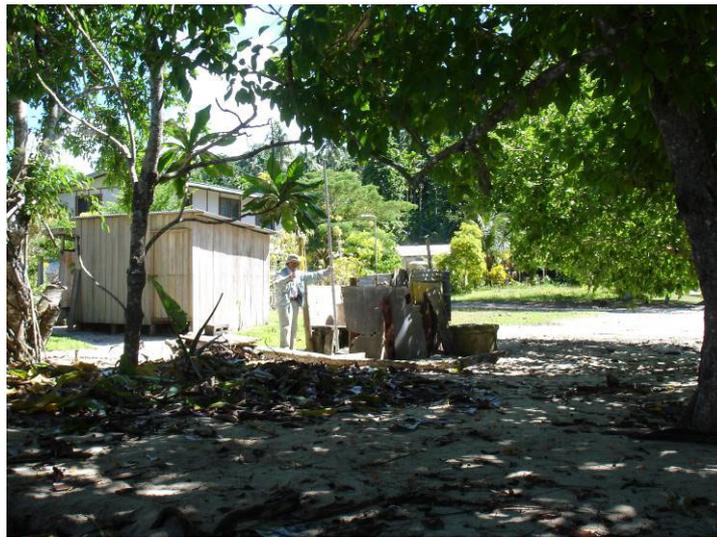
Photo 3.4.2.3 Bench mark of Bench 5 at Sambora

The reference point is at the intersection point between the staff and concrete base.

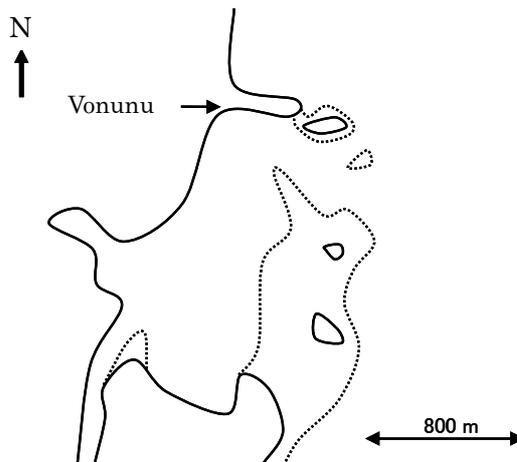
Figure 3.4.3.1 Coastline (solid line) and reef edges (dotted lines) around Vonunu

Vonunu is a village on the eastern coast of the south part of Vella Lavella Island. In front of the coast of Vonunu, reefs have developed offshore and small islands exist, as shown Fig. 3.4.3.1. The offshore reefs and small islands reduced the tsunami striking Vonunu and mitigated tsunami disasters in Vonunu, although the ground level in Vonunu was only about 0.3m above the sea surface.

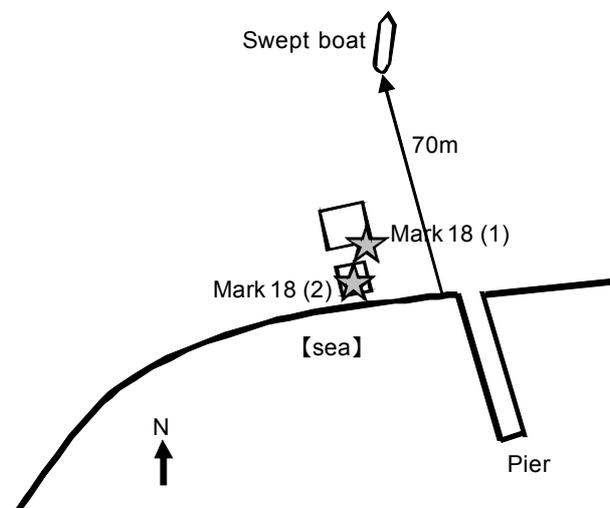
Figure 3.4.3.2 Locations of measured tsunami traces, Marks 18(1) and 18 (2), in Vonunu

Tsunami trace heights were measured at two points, Marks 18 (1) and 18 (2), as shown in Fig. 3.4.3.2. Their transects are shown in Figs. 3.4.3.3. Mark 18 (1) was an inundation mark on a seaward-facing wall of a high-floored house with stilts. The inundation height was 1.09 m. Mark 18 (2) was also an inundation mark on an outboard engine of boat in a storage house along the coast, as shown in Photo 3.4.3.1. The inundation height was 1.03 m. Although the storage house was a wooden structure without stilts, it suffered less damage from the tsunami. Less damage of the storage house results from shallow inundation depth of 0.74 m on the ground, which provides less destruction of house as shown in Photo 3.4.3.2. The low tsunami is caused by topographic characteristics in Vonunu.

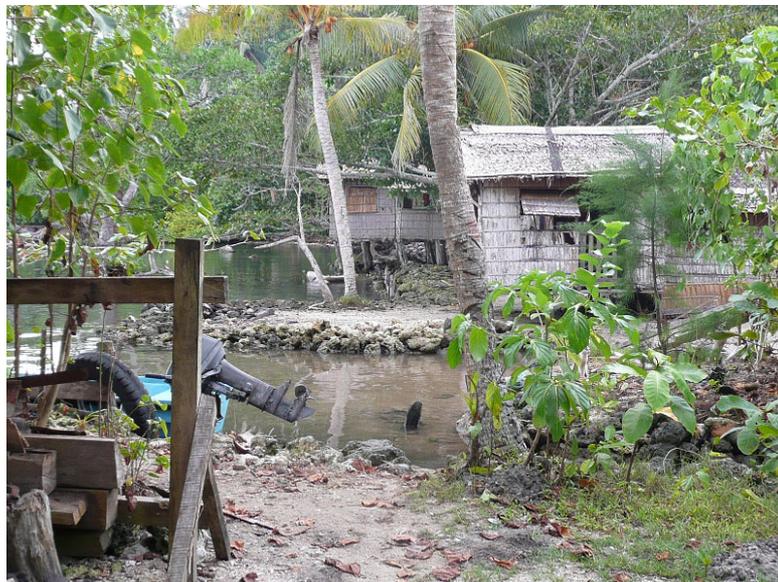
Photo 3.4.3.2 Light tsunami damage in Vonunu

Although the inundation depth was not so deep, small boats were swept inland 70 m from the coastline, as shown in Photo 3.4.3.2.

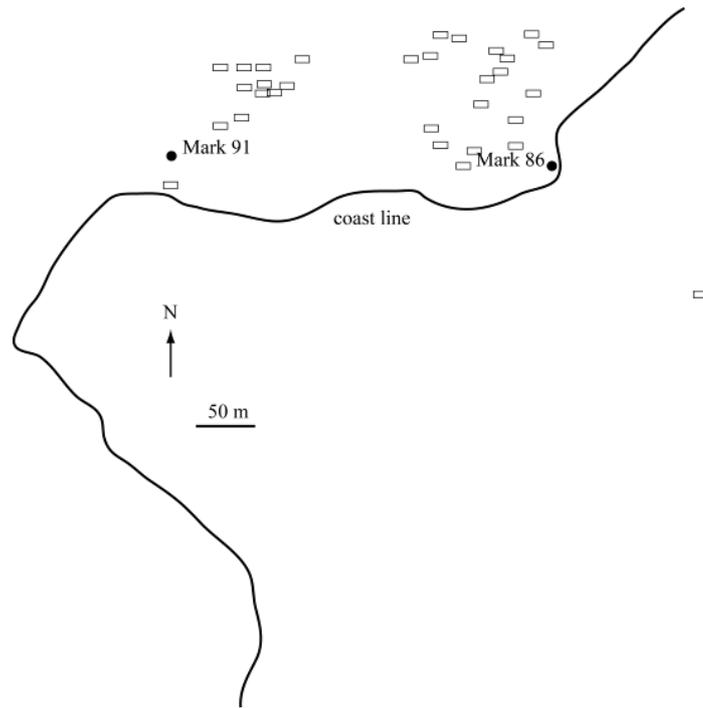
Figure 3.4.5.1 Tsunami survey points at Niarovai, Vella Lavella Island.

We measured tsunami heights at two points in Niarovai (Fig.3.4.5.1) judged by the debris. At Mark 86, tsunami ran up to the limit of dead leaves (Photo 3.4.5.1), which was corroborated by the inhabitants. The height of 1.1 m was measured. At Mark 91, we could measure the tsunami height in the same way, and the same height as 1.1 m was measured.

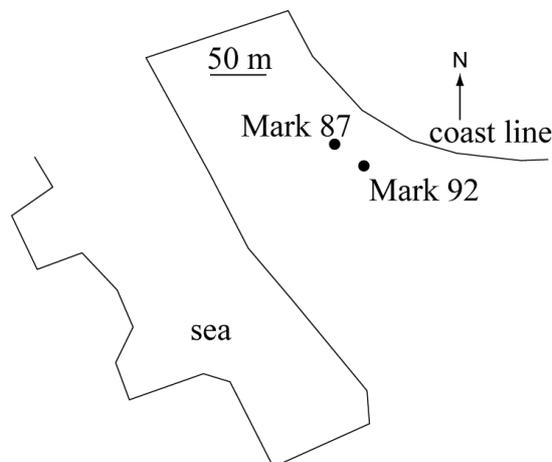
Figure 3.4.6.1 Same as Fig. 3.4.2.1 but in Lambu-Lambu

We measured the tsunami heights at two points in Lambu-Lambu (Fig.3.4.6.1) judged by the debris. At Mark 87, the tsunami ran up to the limit of dead leaves (Photo.3.4.6.1), which was also corroborated by the inhabitants. The height of 0.3 m (after correction of the astronomical tide) was measured. At Mark 92, we measured the tsunami height in the same way, and almost same the height was measured as 0.5 m.

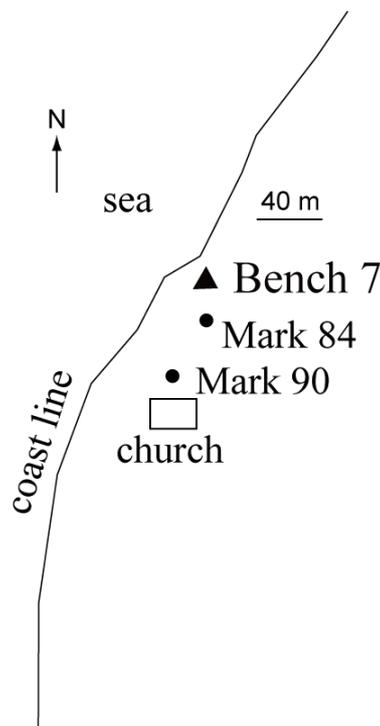
Fig. 3.4.7.1 Location map of tsunami survey points and benchmarks at Varese

We measured the tsunami heights at two points in Varese (Fig.3.4.7.1) judged by the trace of dead weeds on the ground. At Mark 84, sea water inundated up to the boundary of the area marked by dead weeds where the person stands in the Photo.3.4.7.1, which was also corroborated by the inhabitants. We measured the inundation height at 2.4 m (after compensation for the astronomical tide). At Mark 90, we measured the tsunami height in the same way, and almost same value (2.5 m) was obtained.

Although significant uplift did not occur here, in order to detect postseismic or interseismic deformation, one benchmark (reference point) was set up as at Lale in Ranongga Island. Its location and that of tsunami-measured points are shown in Fig. 3.4.7.1. It is located at the top of the base in water supplies shown in Photo 3.4.7.2 (Bench 7:  $7^{\circ}55'49''\text{S}$ ,  $156^{\circ}39'17''\text{E}$ ). The height of the top is measured as 2.156 m above Mean Sea Level.

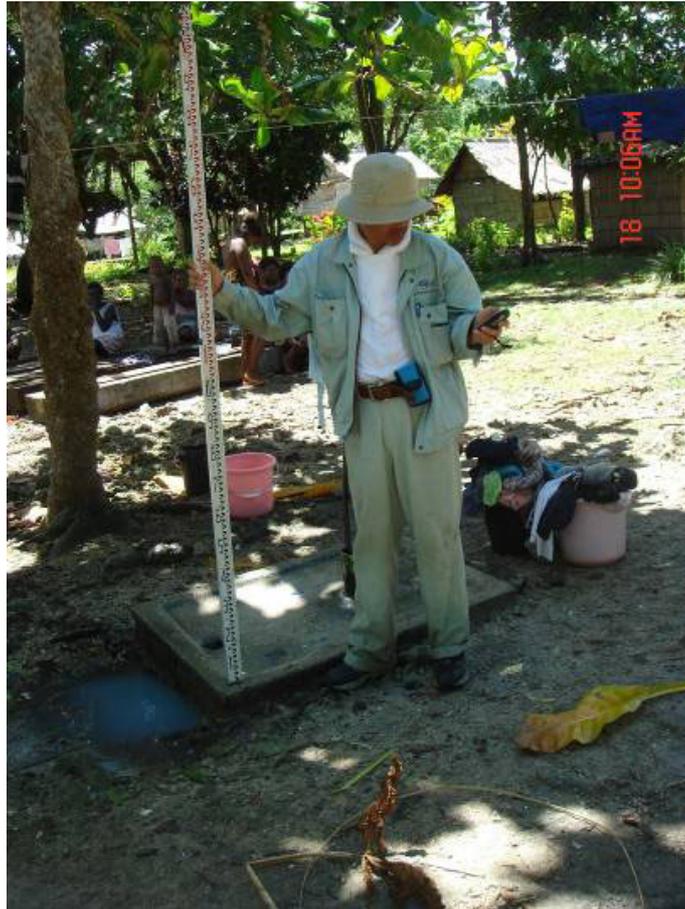
Photo 3.4.7.2 Bench mark of Bench 7 at Varese

The reference point is at the intersection point between the staff and concrete base.

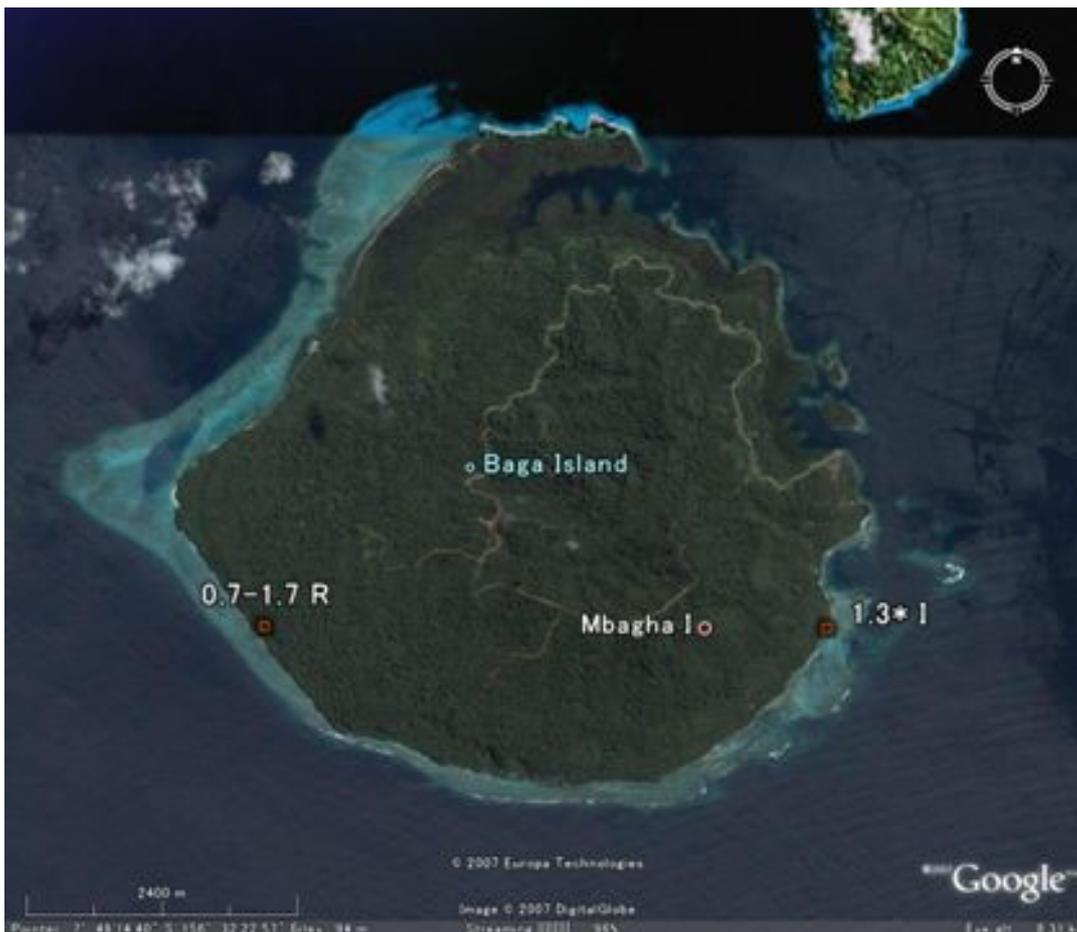
Figure 3.4.9.1 Trace heights in Baga Island

On the east coast of the island, we found some debris near the coastline. The tsunami might have inundated beyond this line, however; the limit of inundation was not clear. Thus, we measured the height of debris, 1.3 m. It is possible that the actual height was higher than 1.3 m.

On the west coast of Baga Island, we could not find clear tsunami-traces. The fallen big tree in Photo 3.4.9.2 was not a tsunami trace. However, it was thought that the tsunami could not have exceeded the location of the tree, considering the arrangement of debris and dead vegetation. The height of that place was 1.7 m, thus the runup height was lower than 1.7 m. The runup height of ordinary waves was estimated as 0.7 m, considering the debris on the beach. Thus, the runup height of the tsunami seemed to be higher than 0.7 m and lower than 1.7 m.

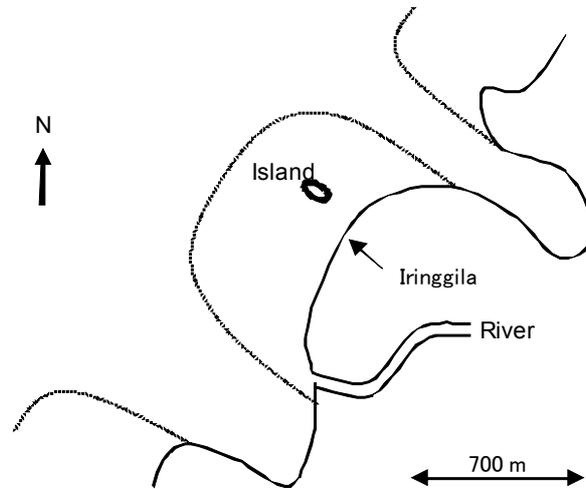
Figure 3.4.10.1 Coastal line (solid line) and reef edges (dotted lines) around Iringgila

Iringgila is located in the northwest part of Vella Lavella Island. As shown in Fig. 3.4.10.1, a coastal line and reef edges have formed complex bathymetry and geometry. Reefs have developed widely offshore in some areas whereas reefs have developed in the other areas. There is also a river flowing from behind the village to the sea.

The local change of tsunami height is probably attributed to the complicated bathymetry, geometry and topography around Iringgila. Especially, very-shallow water area in front of the village may converge energy of tsunami, resulting in high local tsunami height. The converged tsunami was also watched by residents as described later. Such characteristics can be calculated easily if bathymetric and geometric data are available.

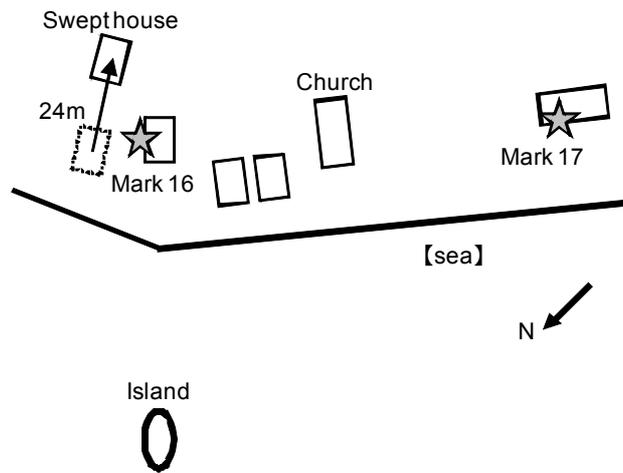
Figure 3.4.10.2 Locations of measured tsunami traces, Marks 16 and 17, in Iringgila

Two tsunami traces were measured in Iringgila: Marks 16 and 17, as shown in Fig. 3.4.10.2. Their transects are shown in Figs. 3.4.10.3 and 3.4.10.4. Mark 16 is an inundation mark on a side wall of a high-floored house located behind a small island, as shown in Photo 3.4.10.1. The inundation height was 4.37 m and inundation depth on the ground level was 2.90 m. Mark 17 is also an inundation mark on a facing-to-sea front door of a clinic located in the southwest edge of the village. The inundation height was 1.86 and inundation depth was 0.77 m.

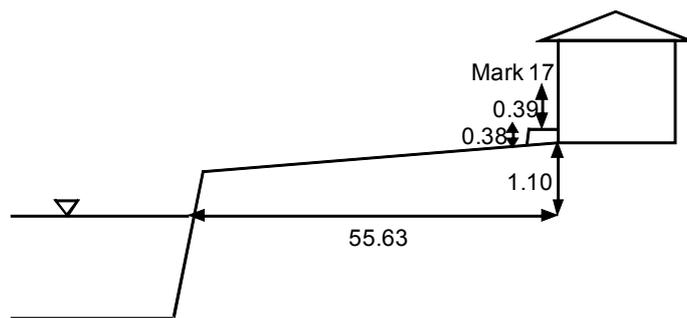
Figure 3.4.10.4 Section view around Mark 17

The inundation depth at Mark 17 was lower than that of Mark 16, even though the ground level at Mark 17 was lower by 0.38m than the level of Mark 16. If the tsunami heights were the same, the water flowed deeper over the lower area. Therefore, this difference was mainly caused by the tsunami height changing locally—the tsunami striking in the west side of the village was smaller than that of the east side. The change of tsunami height also provided the change in level of damage to houses, that is, houses in the east side of the village were swept and destroyed as shown in Photo 3.4.10.2, even though houses on the west side suffered less destruction.

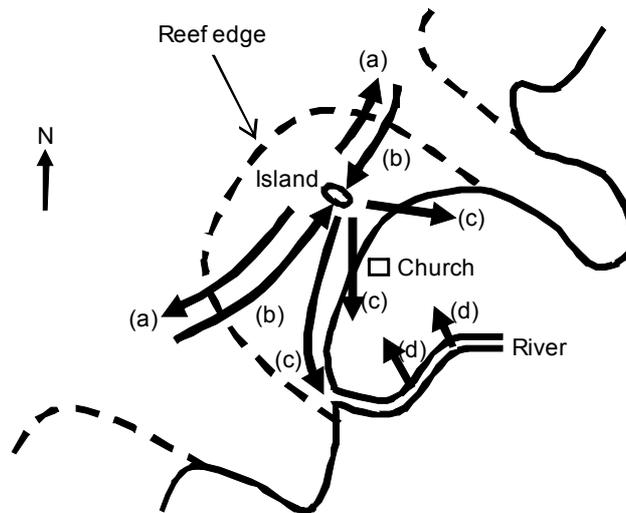
Figure 3.4.10.5 Tsunami striking process by resident's witness

- (1) Three tsunami waves struck the village.
- (2) The biggest tsunami was the first.
- (3) The first tsunami started as a retreating wave.
- (4) At the beginning, the sea receded from around the island in the directions of northeast and southwest, as shown by Arrow (a) in Fig. 3.4.10.5. Then, the fronts

of the first tsunami came from the directions of northeast and southwest and met together around the island, as shown by Arrow (b). After that, the combined tsunami front struck the village, as shown by Arrow (c).

- (5) Even though the tsunami striking around the church was smaller, it was broken like a rolling wave on land.
- (6) The tsunami climbed the river and overflowed behind the village, as shown by Arrow (d) in Fig. 3.4.10.5.

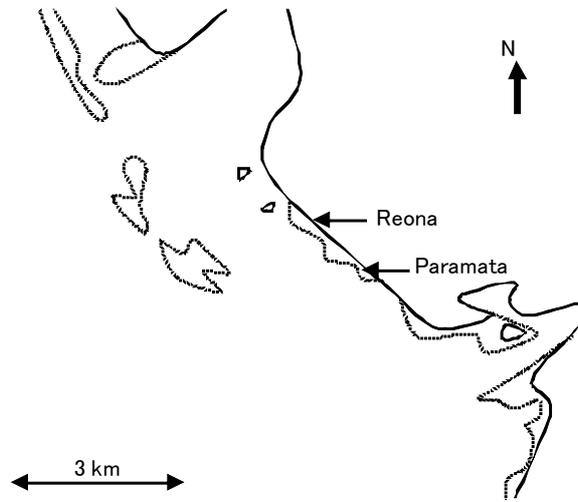
Figure 3.4.11.1 Coastline (solid line) and reef edges (dotted lines) around Reona and Paramata

Reona is located on the western coast in the middle of Vella Lavella Island. Reefs have developed in front of the Reona coast, and a line of reefs parallel to the coastal line have also developed offshore 2.3 km from the coast, as shown in Fig. 3.4.11.1.

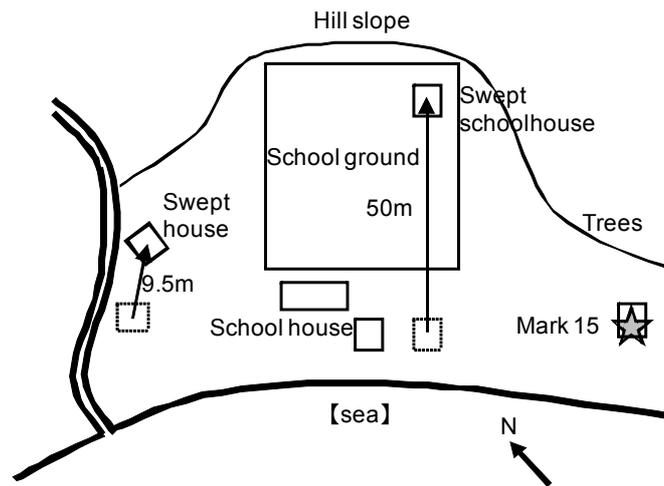
Figure 3.4.11.2 Location of measured tsunami trace, mark 15, in Reona

Fig. 3.4.11.2 indicates the measurement location in Reona: Mark 15. The transect near Mark 15 is shown in Fig. 3.4.11.3. Mark 15 was an inundation mark on an inside wall of a high-floored house. The inundation height was 2.82 m. The house was not moved by the tsunami but its walls were completely broken.

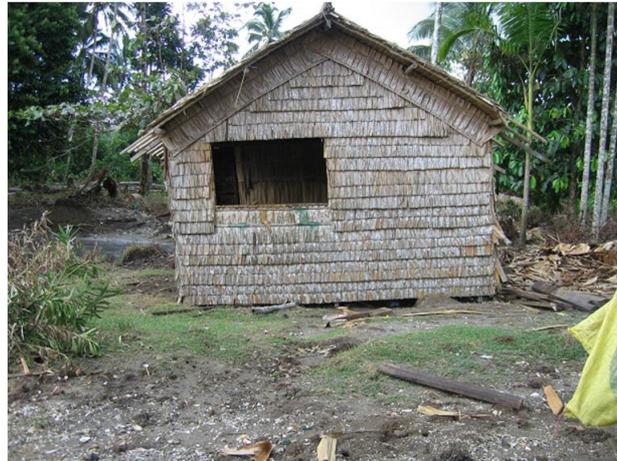
Photo 3.4.11.1 High-floored house in Fig. 3.4.11.2 moved by the tsunami

The tsunami moved several houses. One house in Fig. 3.4.11.2, as shown in Photo 3.4.11.1, was moved 9.5 m from the original position. The schoolhouse was also swept 50 m from its original position.

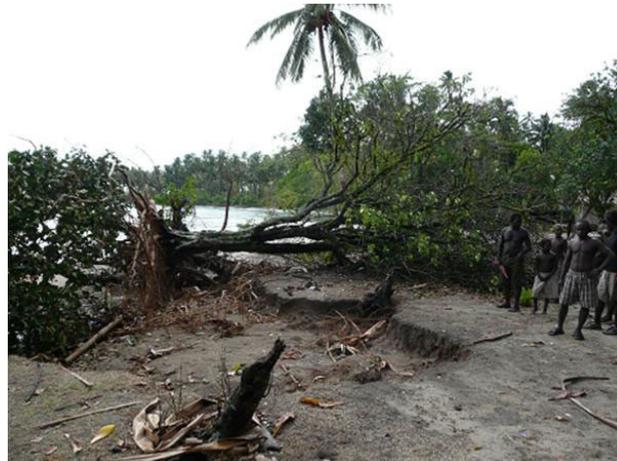
Photo 3.4.11.2 Eroded beach and fallen trees in Reona

The tsunami, moreover, eroded the beach as shown in Photo 3.4.11.2, and felled coastal trees. The depth of erosion was 0.5 m.

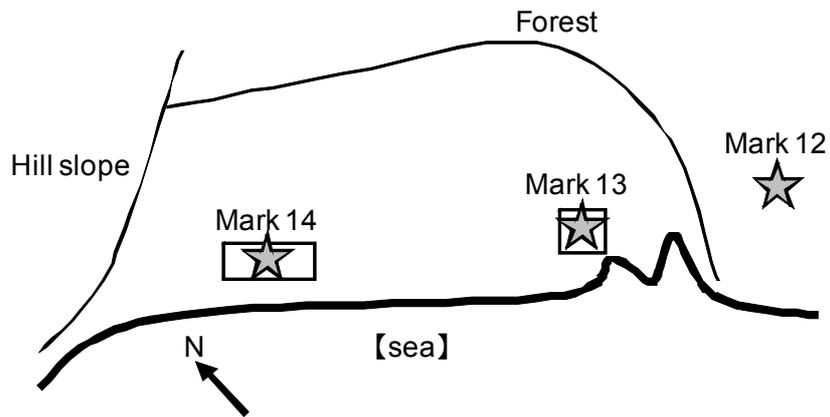
Figure 3.4.12.1 Locations of measured tsunami traces, Marks 12, 13 and 14, in Paramata

Three tsunami traces were measured in Paramata: Marks 12, 13 and 14. Their transects are shown in Figs. 3.4.12.1 to 3.4.12.3. Mark 12 indicated the inundation limit in a forest nearby the village, and was determined by a resident's witness. The ground level at Mark 12 was 2.71 m. Mark 13 was an inundation mark on an inside wall of the warehouse which had less damage. The inundation height was 2.79 m. Mark 14 was also an inundation mark on an inside wall of a kindergarten. The inundation height was 2.74 m. The walls of the kindertgarten had little damage and the floorboards were uplifted, as shown in Photo 3.4.12.1
