3.5 Islands in the east side

3.5.1 Location and topography

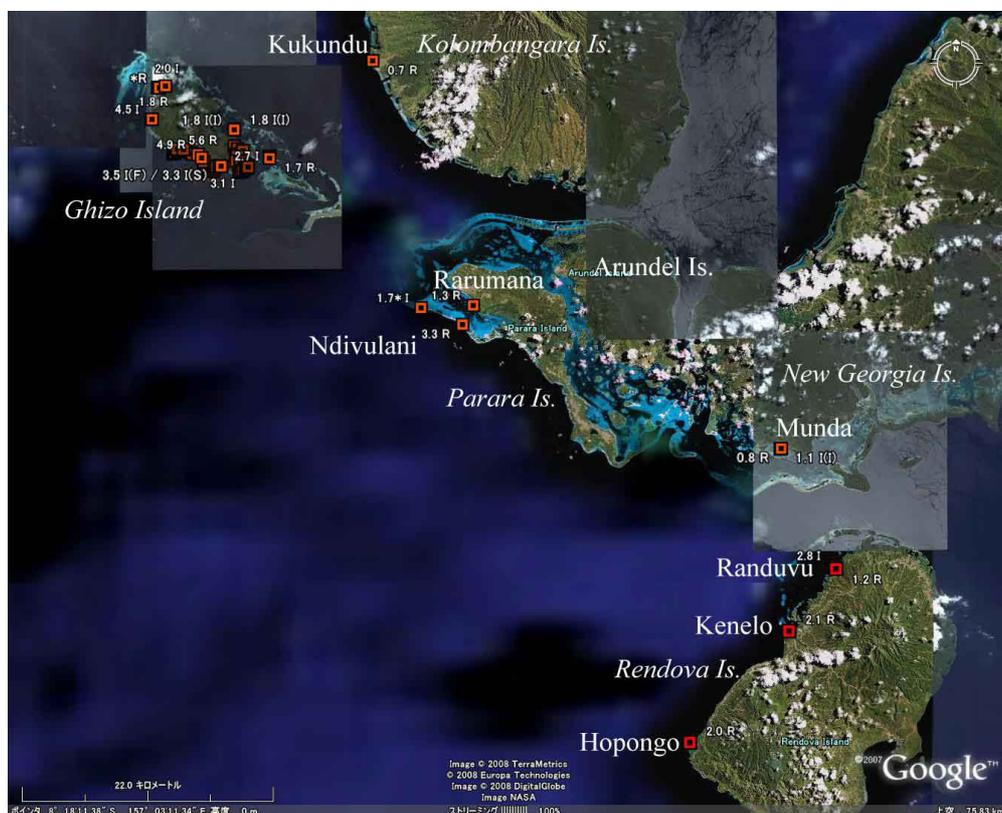
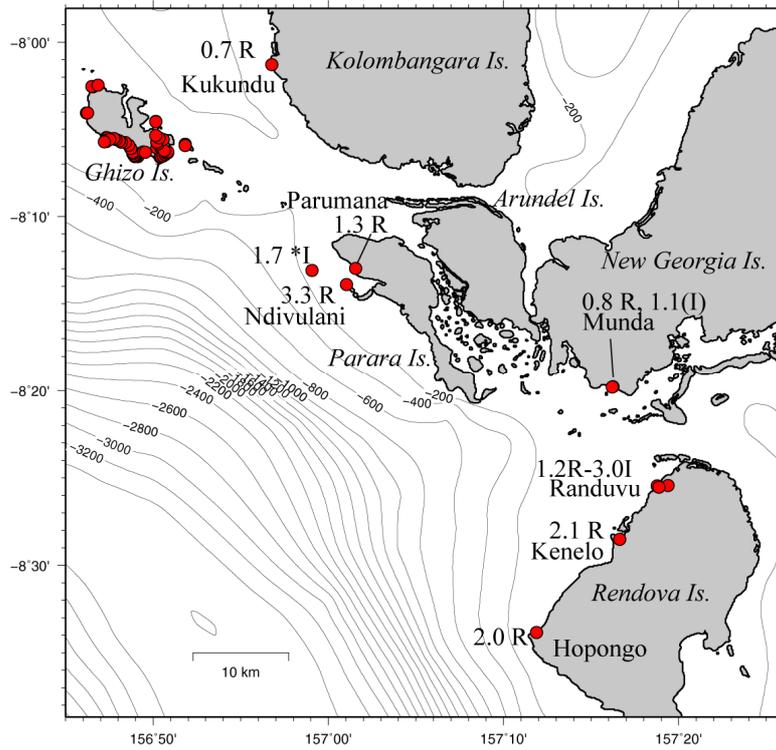
Figure 3.5.1.1 Surveyed sites in Parara, New Georgia and Kolombangara islands

The findings in the islands in the east of Ghizo Island are stated in this section. The surveyed islands are Parara (~S8° 13', E157° 0'), New Georgia (Munda, ~S8° 20', E157° 16'), Kolombangara (~S8° 1', E156° 57') and Rendova (~S8° 25', E157° 15'). The surveyed sites are shown in Figure 3.5.1.1.

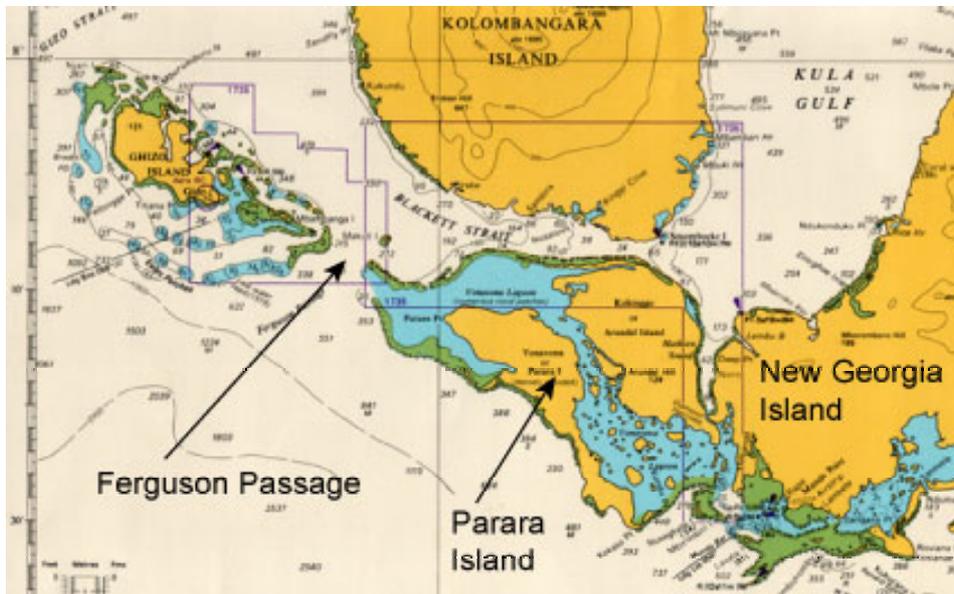
Figure 3.5.1.2 Bathymetry around Parara, New Georgia and Kolombangara islands

The bathymetry of this region is shown in Figure 3.5.1.2. Parara Island lies 20km southeast of Ghizo Island. The island in the northeast of Parara is Arundel Island. New Georgia Island is the big island lying east of Arundel Island. A very narrow channel separates New Georgia and Arundel Island. There is a well-developed coral reef between Parara and New Georgia islands; the coral reefs extend from both Parara and Arundel islands to Ferguson Passage like spits. Parara, New Georgia and Arundel islands form the calm inner sea like an atoll. Kolombangara Island is the circular big island lying northeast of Ghizo.

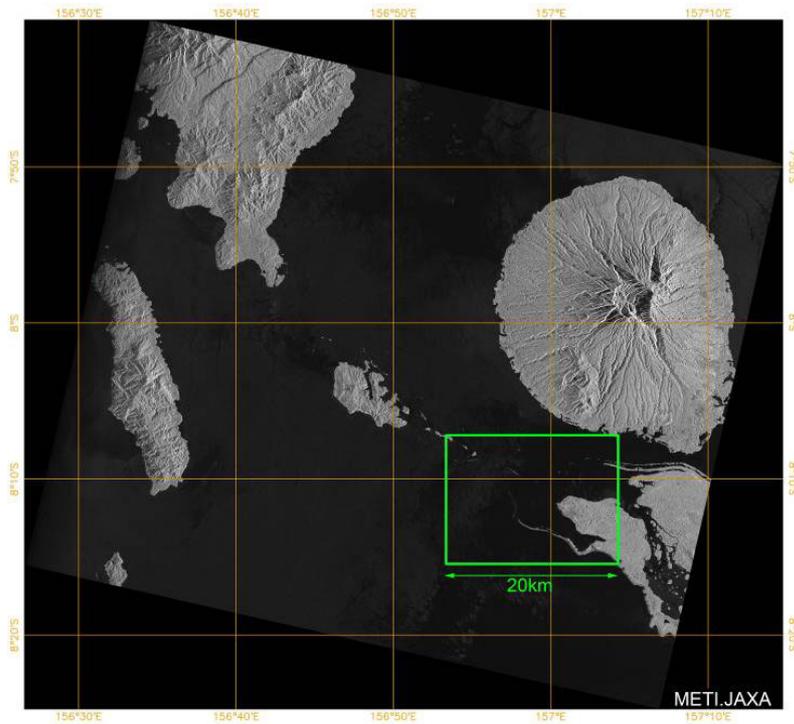
Figure 3.5.2.1 Satellite image taken at 10:38 AM (local time) on 8 April 2007 (@JAXA)

2007 as shown in Figures 3.5.2.1 and 3.5.2.2. By comparing the image taken before the earthquake, Figure 3.5.2.3, the uplift of the ground is clear in ‘Area A’ in Figure 3.5.2.2 (JAXA, 2007. See http://www.jaxa.jp/press/2007/04/20070409_daichi_e.html). This observation was supported by our field survey as shown in sections 2 and 3.

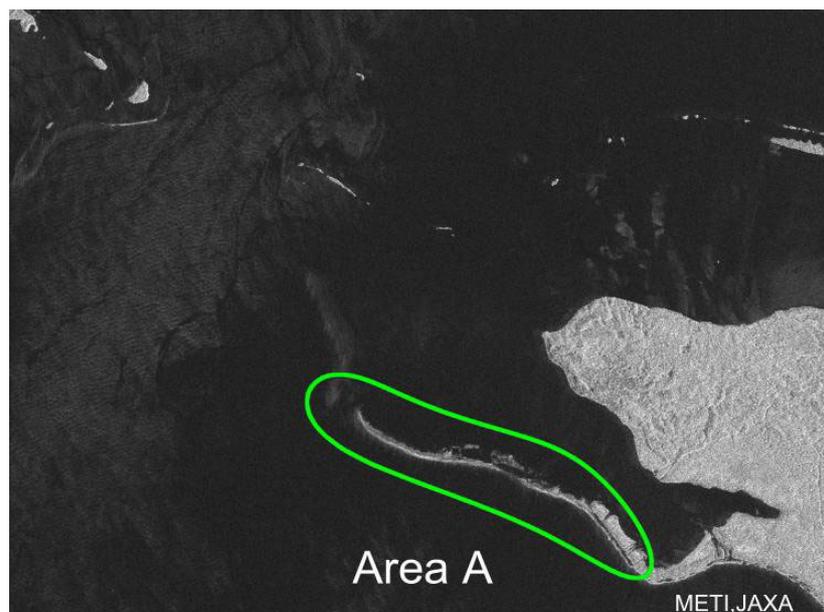
Figure 3.5.2.2 Enlarged image of the square in Figure 3.5.2.1 (@JAXA)

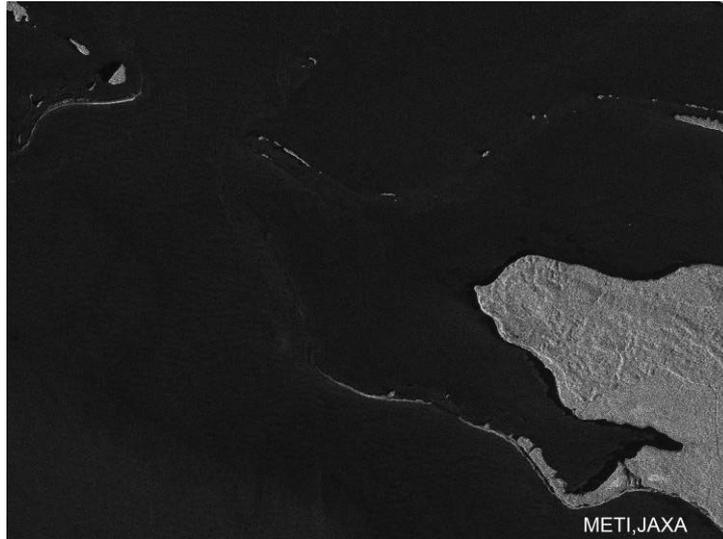
Figure 3.5.2.3 Image taken at the time of low-tide on 31 January 2007 (@JAXA)

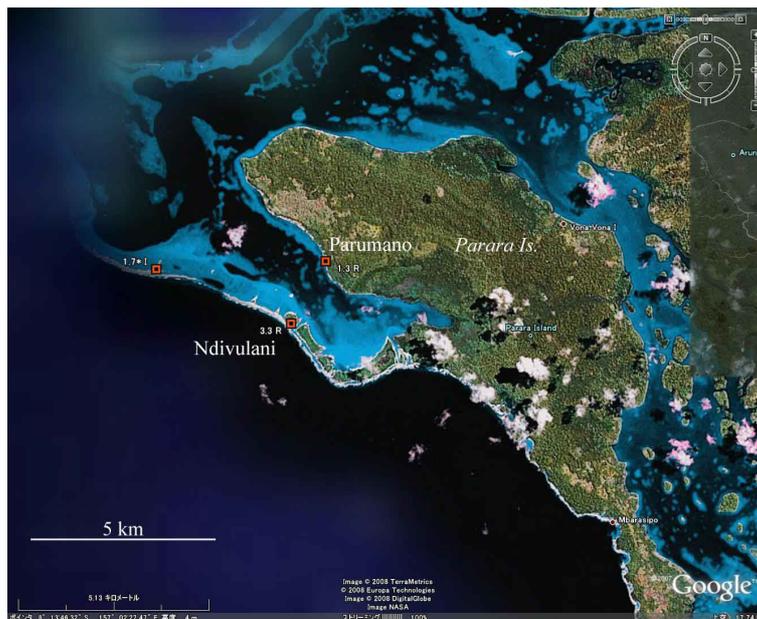
Figure 3.5.2.4 Trace heights surveyed in Parara (image by Google Earth)

The surveyed tsunami-trace heights in Parara Island are shown in Figure 3.5.2.4.

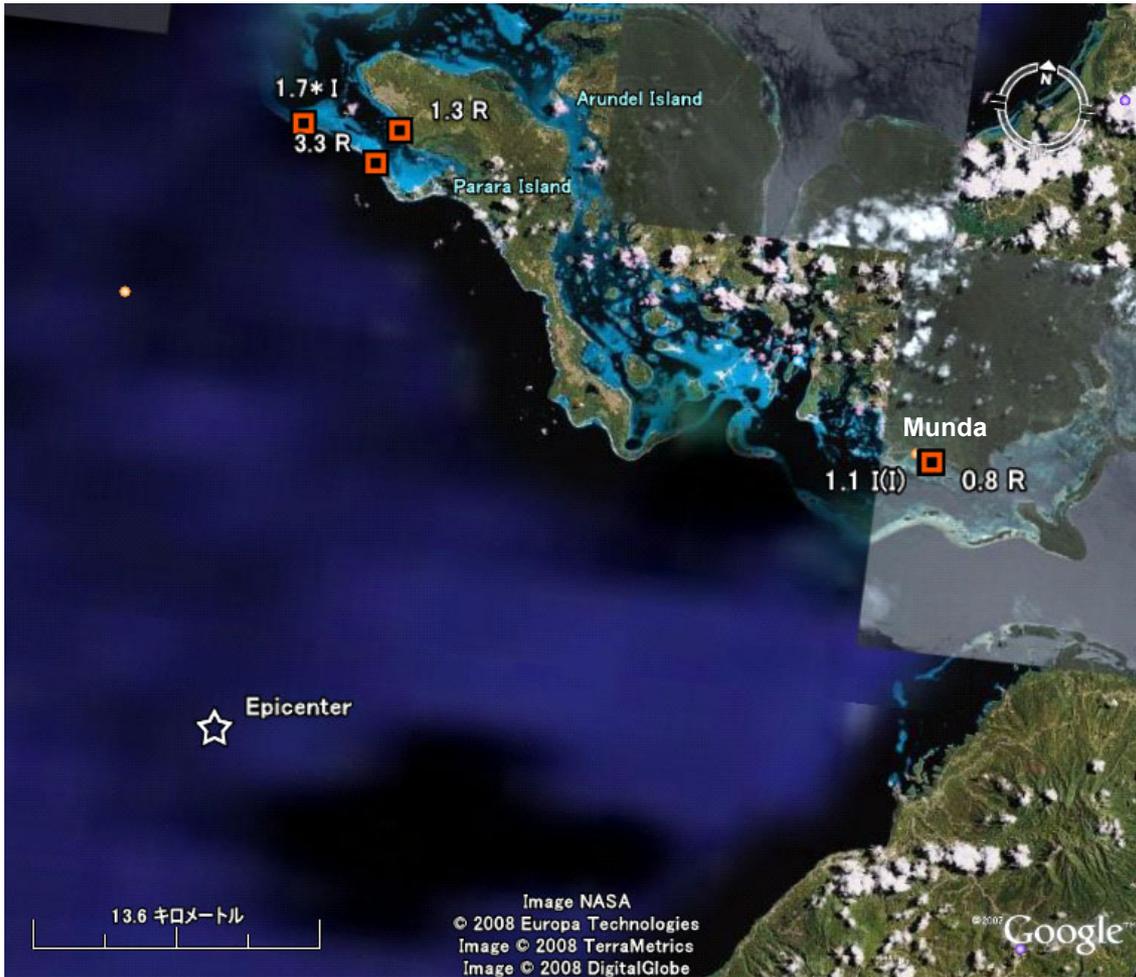
In Munda of New Georgia Island, the tsunami field survey was conducted. The measurement points in Munda were approximately 40 km apart from the epicenter, as shown in Fig. 3.5.3.1.

Figure 3.5.3.1 Measurement points in Munda and epicenter

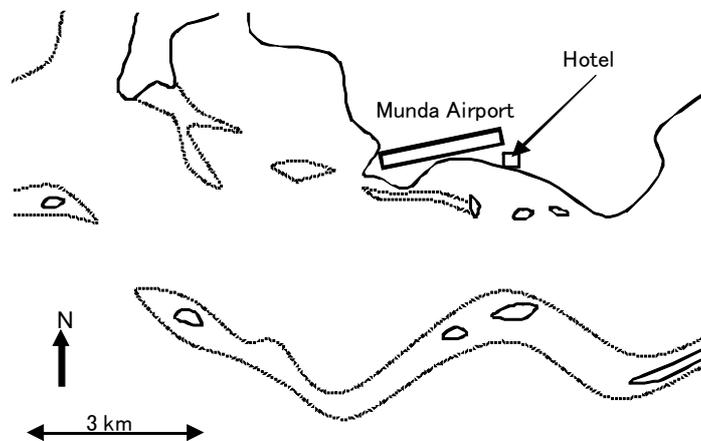
Fig. 3.5.3.2 shows the coastline and reef edges around Munda. Reefs have developed 800 m and 3000 m offshore along the south Munda coast; these reefs act as natural breakwaters. The survey points were in low-lying areas close to the sea surface as shown Photo 3.5.3.1. However, no severe damages were caused there, because the striking tsunami was approximately 1 m high as described later. The reason why the tsunami was not so high could be caused by tsunami reduction by reefs.

Figure 3.5.3.2 Coastal line (solid line) and reef edges (dotted lines) in Munda

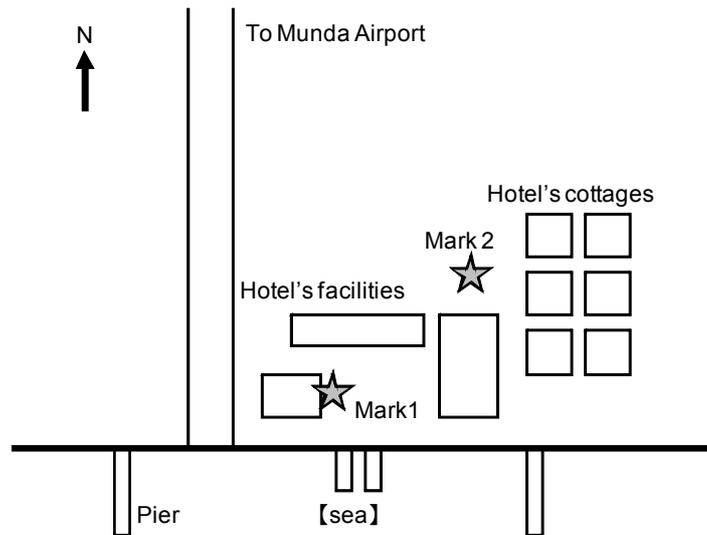
Two tsunami traces, Marks 1 and 2, were measured in Munda, as shown in Fig. 3.5.3.3. Their transects are shown in Figs. 3.5.3.4 and 3.5.3.5. Mark 1 was an inundation mark on the front wall of a refrigerator in a house. The inundation height was 1.05 m. There was also another water mark with the same height on a side wall of the house. Mark 2 was at the border of discolored grass in a lawn. A resident said that the tsunami reached this location. The tsunami inundation height was 0.80 m.

Figure 3.5.3.3 Locations of measured tsunami traces, Marks 1 and 2, in Munda

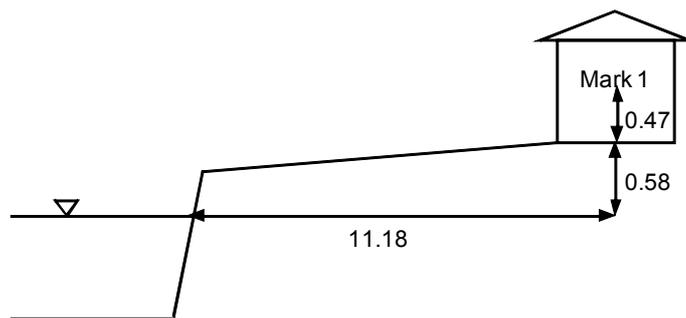
Figure 3.5.3.4 Transect near Mark 1

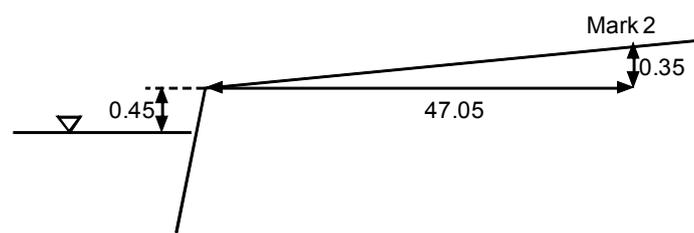
Figure 3.5.3.5 Transect near Mark 2
