5. Distribution and sedimentary facies of tsunami deposits

5.1. Tsunami flow directions on Ghizo and Simbo islands

5.2. Distribution and facies of tsunami deposit

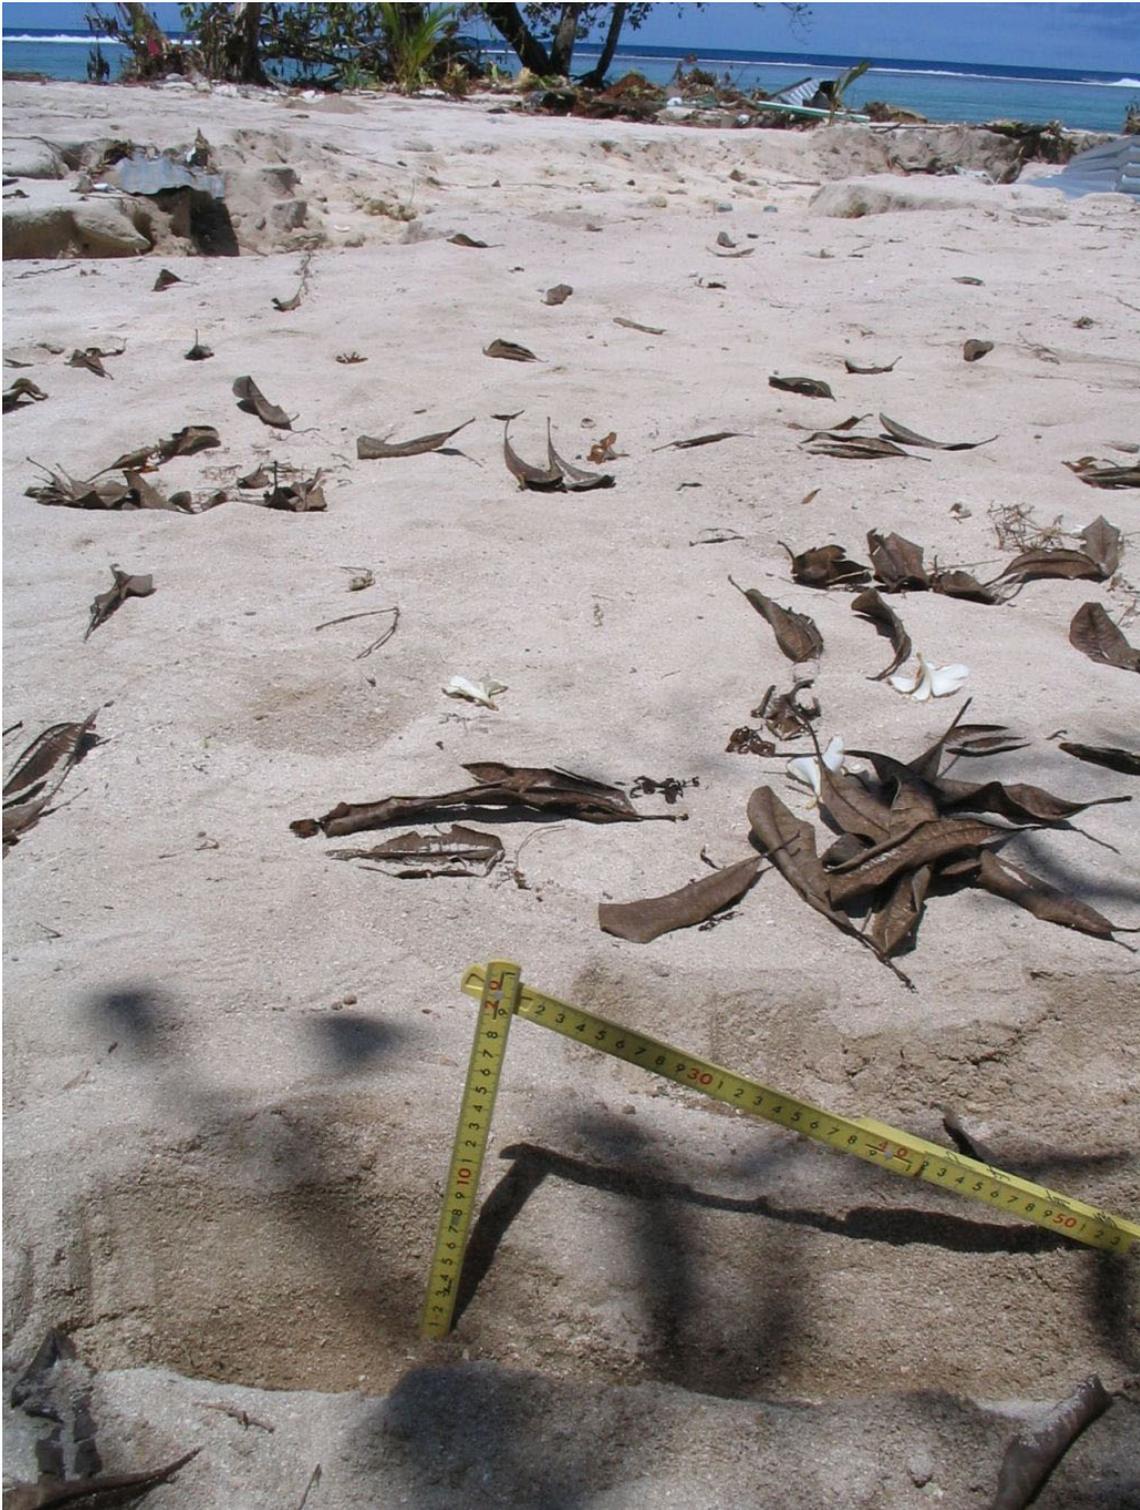
Photo 5.2.1 Tsunami sand sheet in Titiana.

The tsunami generated sheet-like deposits (Photo 5.2.1) of coral beach sand on the flat plain in Titiana. Fig. 5.2.1 shows thickness (cm) of the tsunami deposit in Titiana. Deposit thickness seemed to be strongly affected by microtopography, vegetation, and distribution of buildings. Fig. 5.2.2 shows topographic profile elevations and thickness (cm) of tsunami sand between the shore and inundation limit. Near the beach, the tsunami wave eroded ground surfaces and formed small scarps at 30 m from the sea (hachured line in Fig. 5.2.1, Photo 5.2.2 and 5.2.3). Photo 5.2.3 shows full-sized palm trees leaning to the sea, affected by soil erosion from the tsunami. Just landward of the scarps, tsunami deposits up to 9 cm thick accumulated (Loc.51). The thickness decreased with distance from the sea and was also affected by microtopography. At the limit of sand deposition (Loc. 57), only sparse sand grains were barely observed on the soil surfaces. In an inland area more than 170 m from the shoreline, no sandy tsunami deposits were observed. The upper boundary of tsunami inundation, as defined by accumulation of driftwood and floating debris, was 210 m from the shoreline.

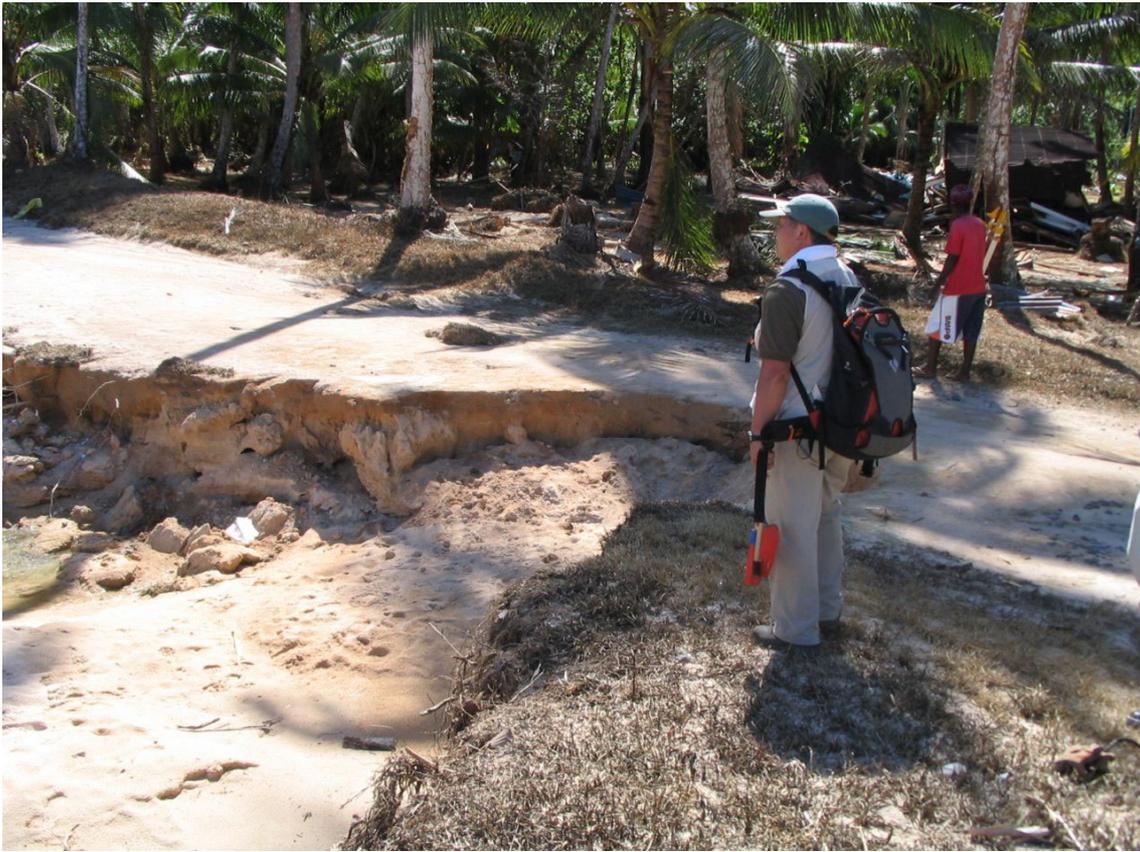
Photo 5.2.2 Tsunami eroded scarp in New Manra, east of Titiana.

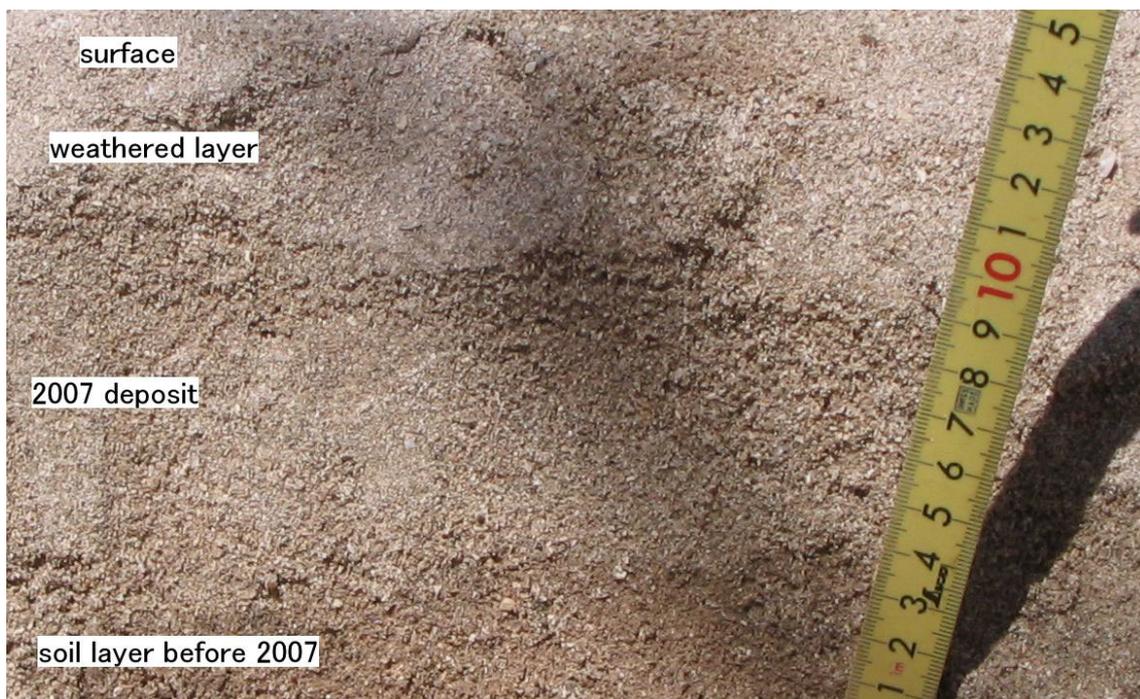
Photo 5.2.4 Tsunami sand layer in Titiana (Loc. 51). The sand layer has the maximum thickness of 9 cm. A few cm at the top is weathered.

Fig. 5.2.3 shows stratigraphy of the 2007 tsunami deposits in Ghizo Island. The tsunami deposits consisted primarily of structureless sand layers with no graded bedding, in Titiana (Photo 5.2.4). However, their surface seemed to be weathered. The contrast between the 2007 tsunami deposit and the underlying sediments, containing humic materials or plant fragments, made identifying the deposit easy and allowed investigation of the contact between the tsunami deposit and the underlying soil layer. At Loc.48, the sand layer contained finer materials, suggesting return flow deposit.

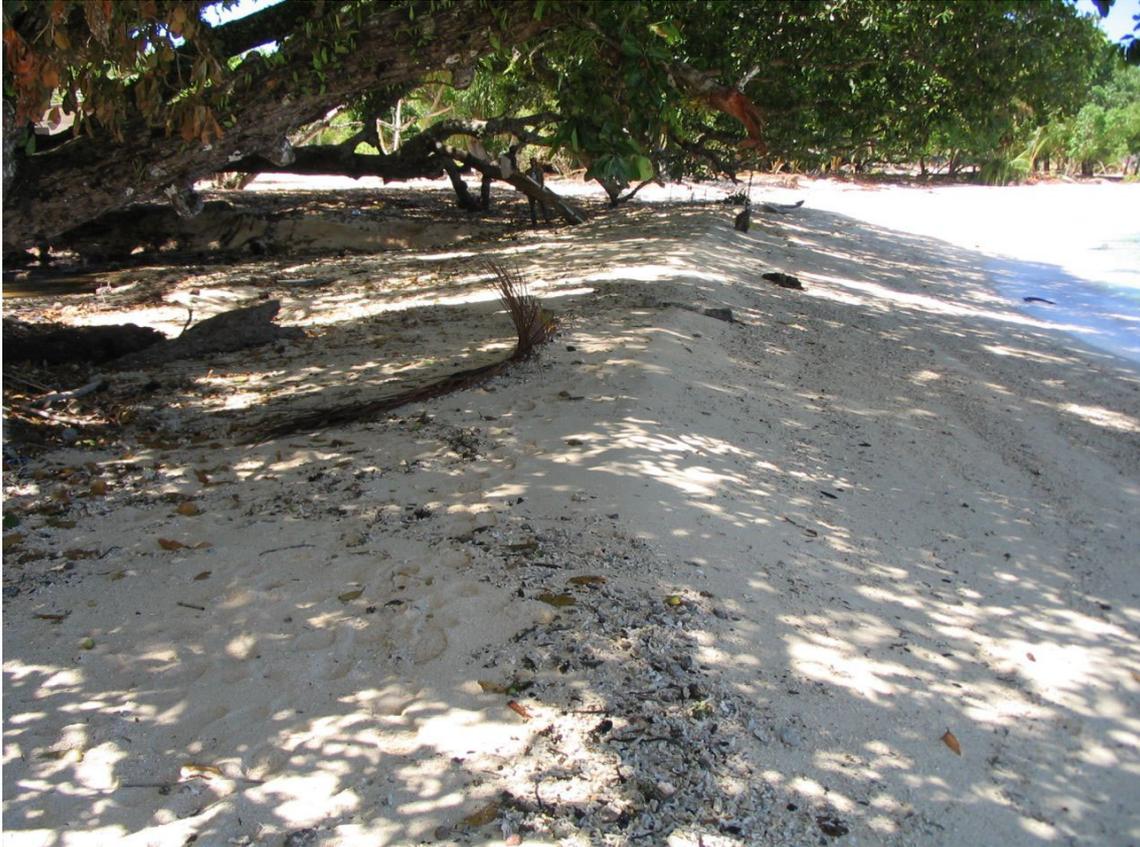
Photo 5.2.5 Sand bar formed by the tsunami, northwestern Titiana. The top of the sand bar is at about one meter above sea level. A small channel, on the left of this photograph, was dammed up here.

Some coastal landforms changed as a result of sedimentation by the tsunami, as well as erosion. For example, 1 m thick sandy deposits formed a small sand bar (Photo 5.2.5) at the northwestern coast in Titiana. This sand bar dammed up a small channel at its mouth.

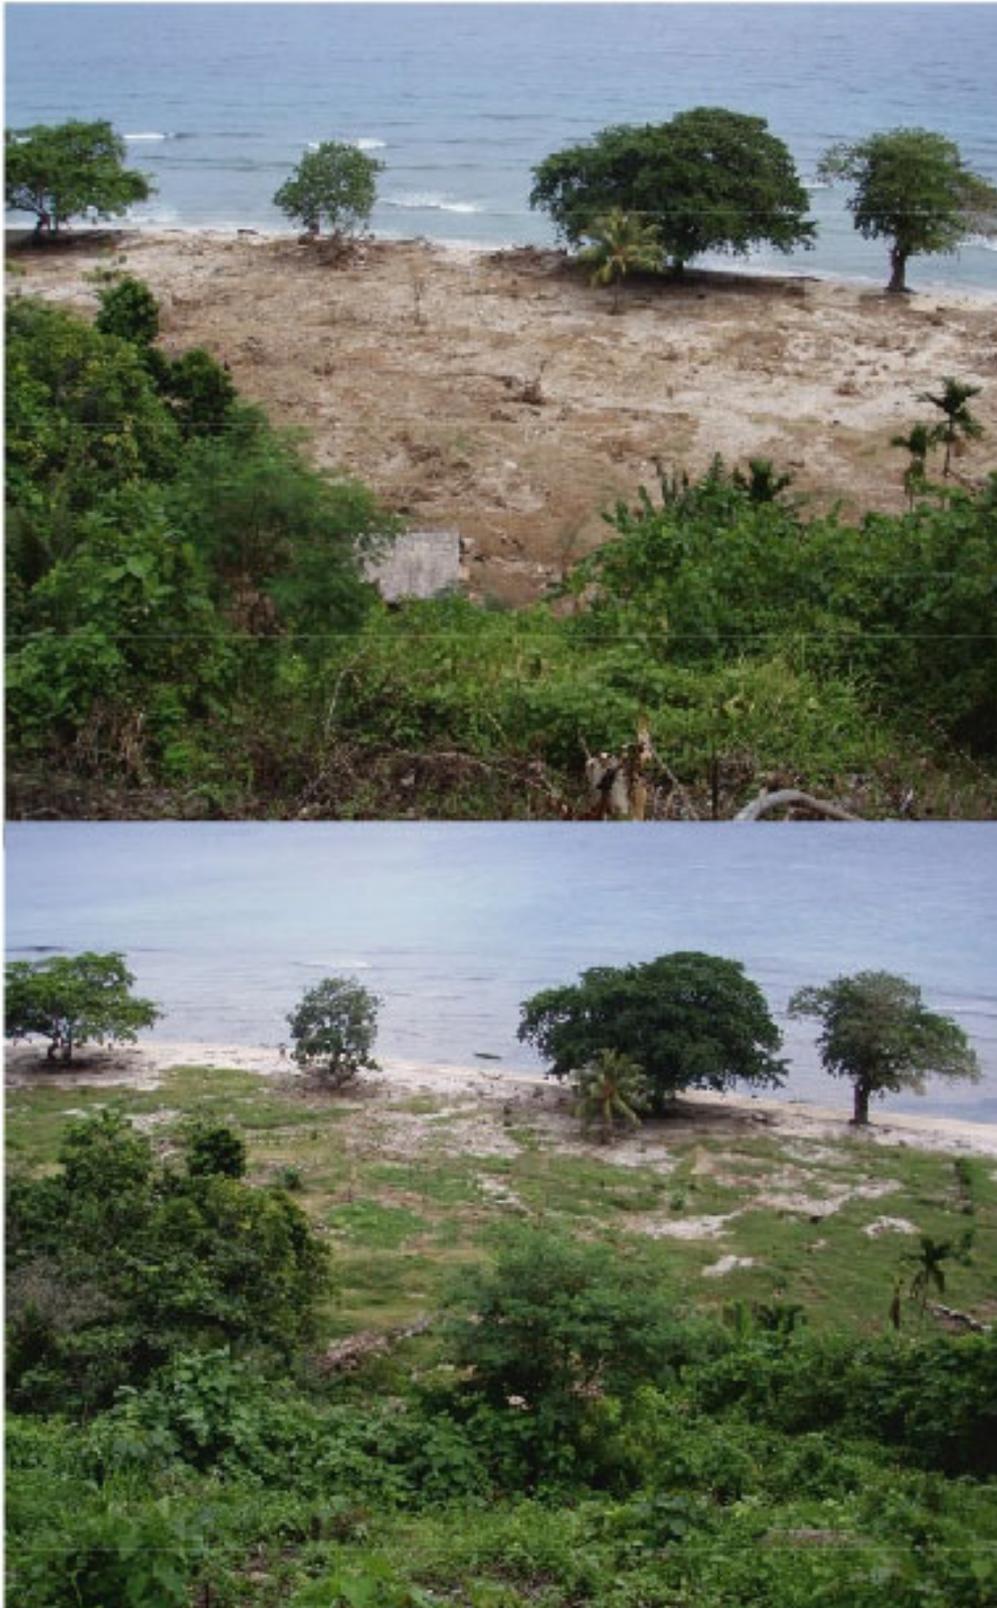
Photo 5.3.1 Tsunami affected area in Tapurai, Simbo Island in April 2007 (upper: two weeks after the tsunami) and in July 2007 (lower: three months after the tsunami).

In the Solomon Islands, plentiful rainfall causes erosion and re-sedimentation of tsunami deposits. Furthermore, the sedimentary structures will be destroyed easily by chemical weathering in the warm and moist environment, bioturbation by plants and animals, and human activities. The sedimentary structures had been preserved until the end of June 2007, but had already been penetrated by plant roots and sandpipes of crabs (Photo 5.3.1, 5.3.2, 5.3.3). We believe that the knowledge of weathering process of tsunami deposits is important for interpretation of sedimentary structures of paleo-tsunami deposits.

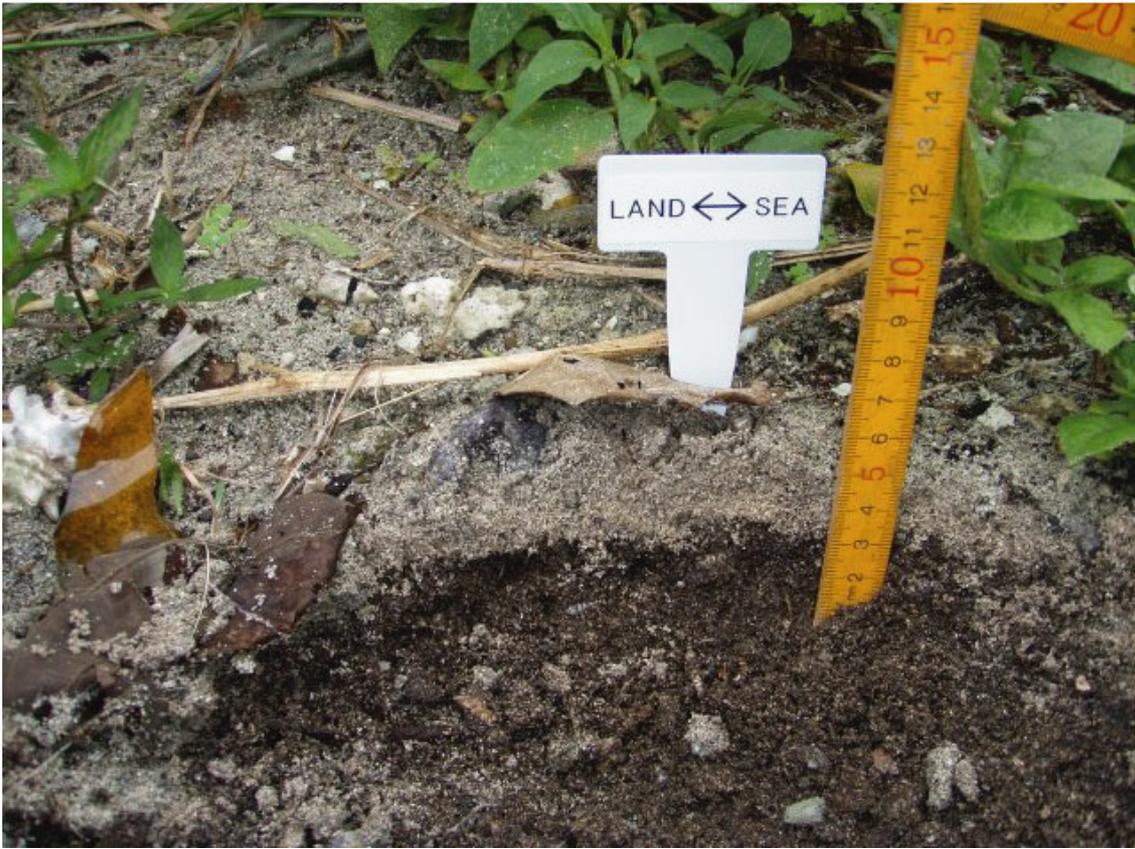
Photo 5.3.2 Tsunami deposit in Titiana, Gizo Island in July 2007.
