# Joint Report for Tsunami Field Survey for the Solomon Islands Earthquake of April 1, 2007

## PARI Tsunami Survey Team

May 2008

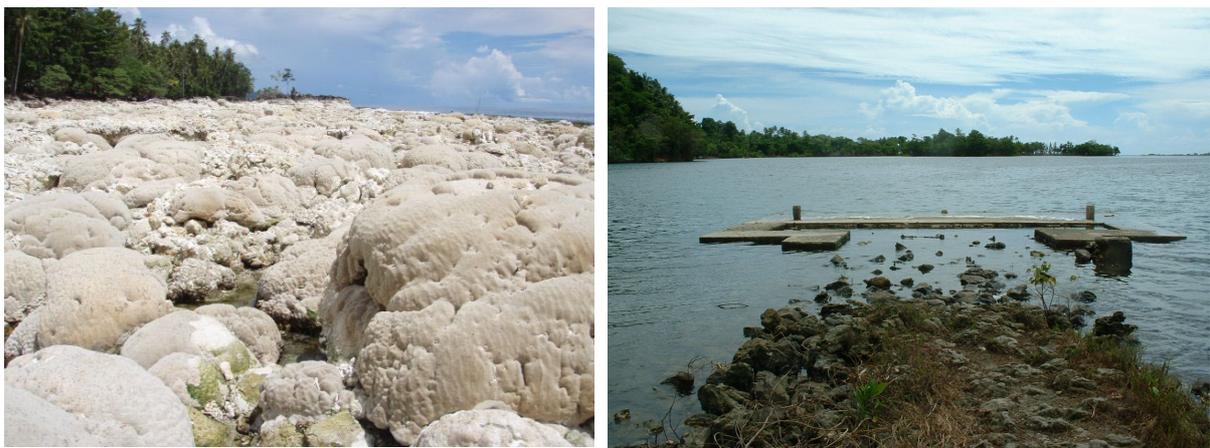
Fig. 2.4 Photos of crustal deformations.

The coseismic crustal deformation survey was conducted in Gizo, Simbo, Ranongga, Vella Lavella, Kolombangara Parara, New Georgia and Rendova Islands (Fig. 2.3). We saw clearly that the whole island of Ranongga was uplifted by the earthquake because a large area of coral flats around the island, which should be grown below a low tide level, now appears above the high tide level after the earthquake (Fig. 2.4a). On Simbo Island, located just 20km south of Ranongga Island, however, we could not find any evidence for uplift, even at the northernmost part of the island. Instead of uplift, we found evidence for slight subsidence from eyewitness accounts at two villages, Lengana and Riguru. For example, a pier at Lengana was submerged after the earthquake (Fig. 2.4b). Those clearly indicate that a pattern of the vertical coseismic crustal deformation was changed between two Islands, Simbo and Ranongga Islands. In Vella Lavella Island, most of the island was subsided except the southeasternmost tip of the island where we found slight uplift (Fig. 2.3). On Gizo Island, slight subsidence was found along most of the coast. On Parara Island, uplift was found only along the west coast. The vertical deformation along the west coast of Rendova Island is small, less than 1m, with slight uplift along the southern part of the coast and slight subsidence in the most northern part of the coast (Fig. 2.3).

(a) Uplifted corals around Ranongga Is. (b) A subsided pier at Lengana Simbo Is.

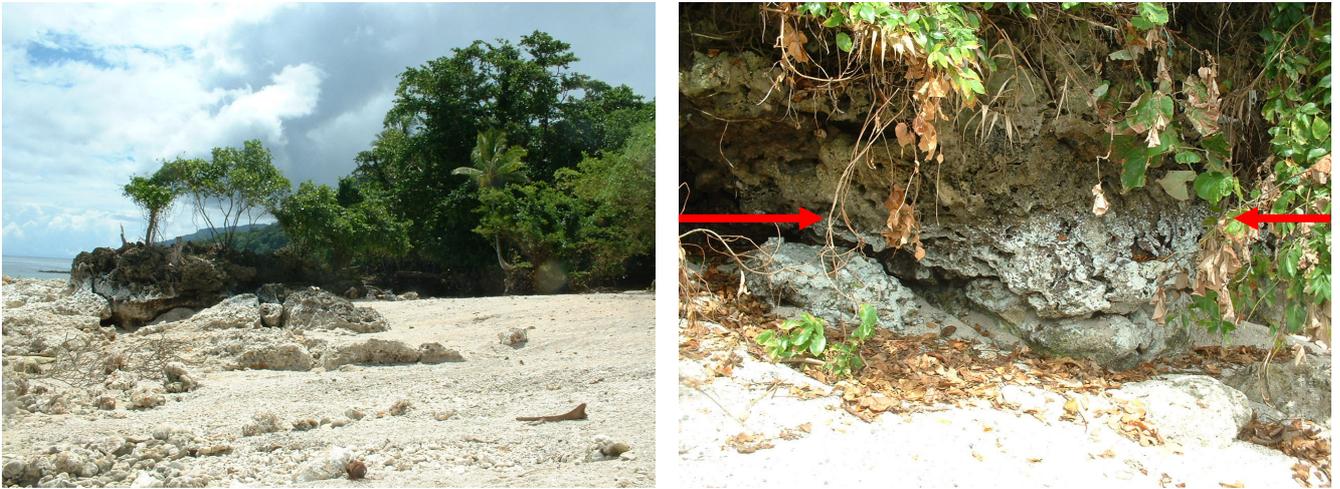
The amount of vertical crustal deformation was roughly estimated from the white lines (Fig. 2.5) showing the mean tide level before the earthquake, the top of dead corals, or eyewitnesses testimony of the pre-earthquake high tide or mean tide level (Appendix 2). Fig. 2.3 shows the observed vertical deformation at the survey points with tide corrections. The details of the observed and corrected vertical deformation are shown in Appendix 2.

Fig.2.5 The white line showing the mean tide level before the 2007 Solomon earthquake

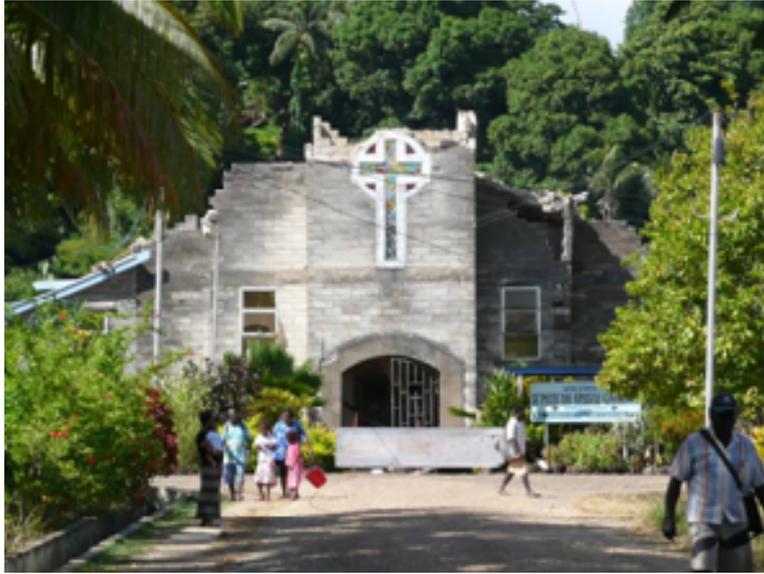
The earthquake also caused strong ground shaking on the island. The Modified Mercalli Intensity scale was VIII which meant the shaking was destructive. Photo 3.1.1.1 shows the destruction of a church in Gizo Town which is located on the eastern coast of the island. Gizo Town is the second biggest town in the Solomon Islands (the biggest one is the capital city, Honiara.).

Photo 3.1.1.1 Structural destruction in Gizo Town of Ghizo Island

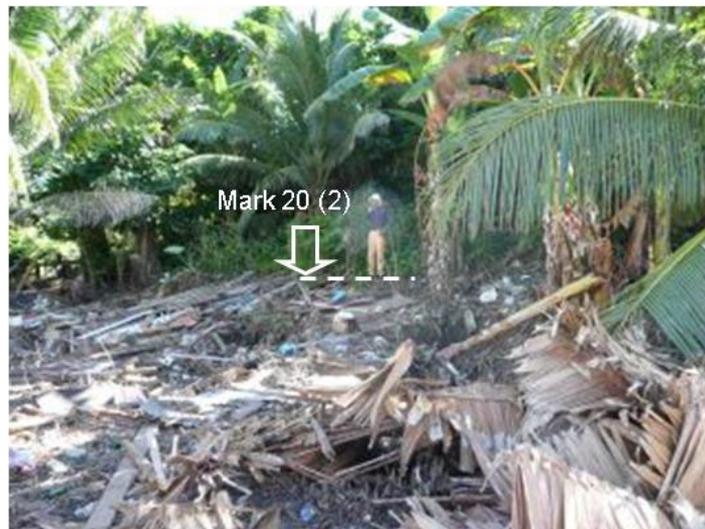
Fig. 3.1.2.2 shows the tsunami traces, Marks 19 and 20(2) which have transects shown in Figs. 3.1.2.3 and 3.1.2.4. Mark 19 was a water mark on a guide wall surrounding the bottom of the main body of a high-floored house. The inundation height above the estimated sea surface at the time the tsunami struck was 4.59 m. Because the legs holding up the house were 1.8 m higher than the inundation depth of 1.71 m, the houses were not inundated by the tsunami. On the other hand, a neighboring house whose ground level was lower by 1.3 m than the house at Mark 19 was inundated. Mark 20(2) indicated a border of discolored vegetation on a hillslope, as shown in Photo 3.1.2.1. The runup height was estimated as 3.72 m.

Photo 3.1.2.1 Mark 20 (2) in Fig. 3.1.2.2

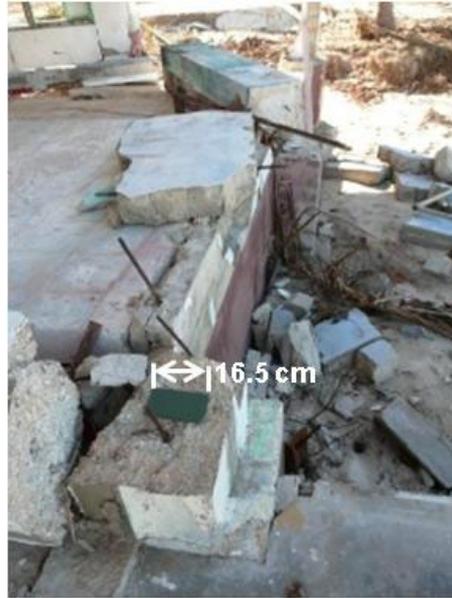
The tsunami caused severe damage in Titiana. As shown in Photo 3.1.2.2, most houses were swept and destroyed by the tsunami. A church was damaged but remained intact as shown in Photo 3.1.2.3. The front and back walls facing the tsunami flow direction were completely destroyed, but side walls had less damage. Photo 3.1.2.4

shows a broken section of the front wall, and a column more than 30 cm thick was broken.

Photo 3.1.2.4 Broken front section of the damaged church

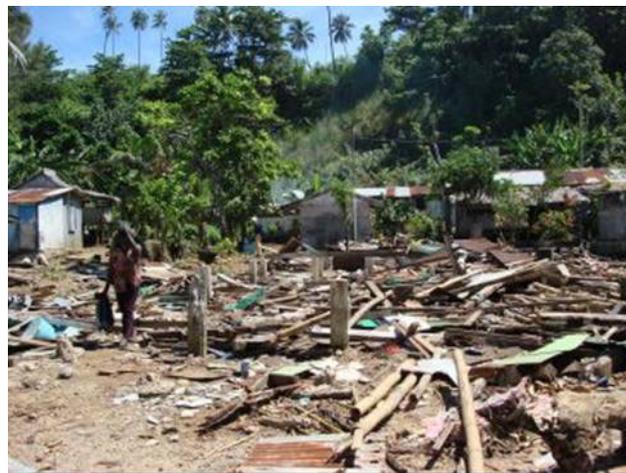
The tsunami destroyed houses closest to the coastline. The dashed squares in Fig. 3.1.4.1 indicate the areas where houses were washed away by the tsunami, as shown in Photo 3.1.4.3.

Photo 3.1.4.3 Situation of damaged areas in Marakerava 3

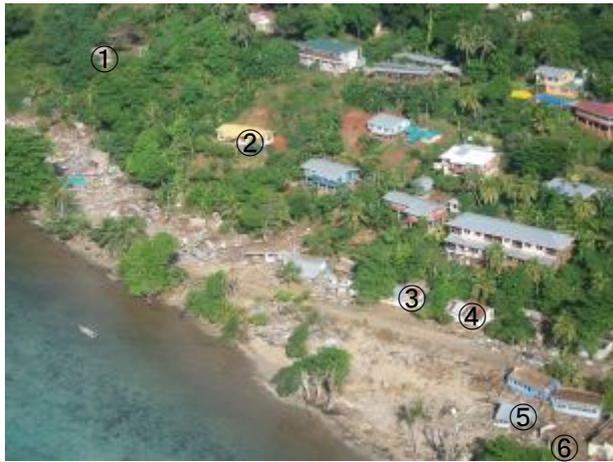
Photos 3.1.5.1 and 3.1.5.2 show the situation of the village after the tsunami (on April 12, 2007), and Photo 3.1.5.3 is an aerial photo before the tsunami. In order to compare these photos easily, houses are numbered in each photo, and the houses with the same number are the same. Comparing among three photos and analyzing results of the field survey, severe damage was caused in the dash-lined area in Photo 3.1.5.3. The reason why the area suffered severe damage, especially in Marakerava 1, is that the tsunami struck directly from the tsunami source, because the alongshore direction of the coastline of Marakerava 1 is east-west, and the coast faces the tsunami source. Moreover, no tsunami reduction by sand dunes, vegetation or structures occurred on this coastline.

Photo 3.1.5.1 Damaged area in the west of Marakerava 1

In Marakerava 1, we confirmed that tsunami damage level depends on structural types of house. For example, the house labeled 7, which was a high-floored house, has the damaged walls but no damaged frames. On the other hand, for the houses numbered 5 and 6, which were constructed directly on the ground surface, the frames were also damaged as well as walls.

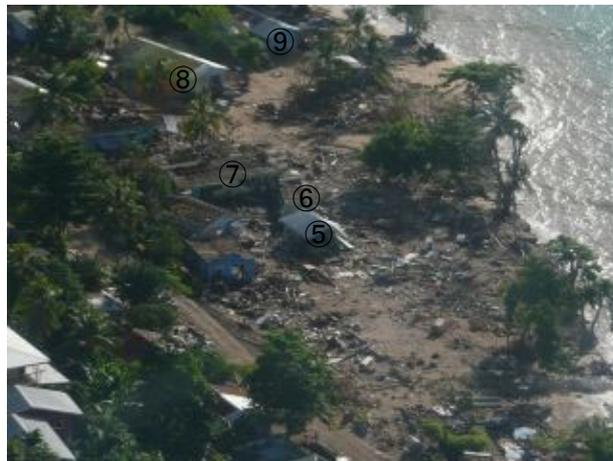
Photo 3.1.5.2 Damaged area in the east of Marakerava 1

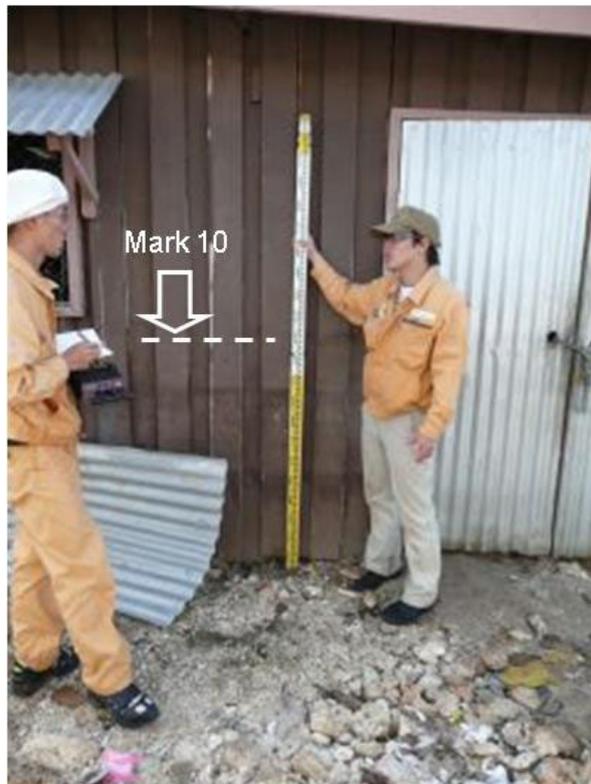
Photo 3.1.6.1 Inundation level of Mark 10

Less damage occurred in the downtown area than nearby. Tsunami traces were measured in Gizo. For example, Marks 11 and 10 were measured at the point shown in Fig. 3.1.6.1 and at the point marked “S” in Photo 3.1.4.1, respectively. Transects of Mark 11 and Mark 10 are shown in Figs. 3.1.6.2 and 3.1.6.3, respectively. Mark 11 is an inundation mark on a leg supporting a high-floored house. The inundation depth was 0.89 m on the ground whose height level was 0.93 m and the resultant inundation height was 1.82 m. Mark 10 was also an inundation mark on an outside wall of a warehouse. The inundation depth was 0.53 m and inundation height was 1.75 m.

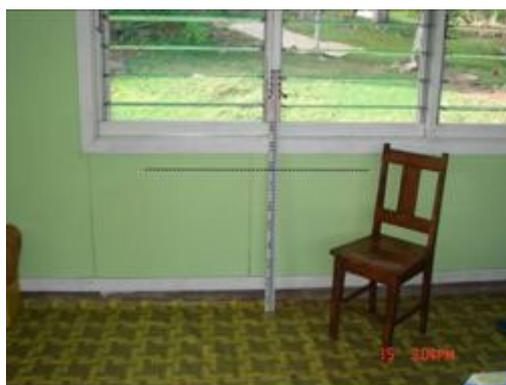
Photo 3.1.7 Inundation level at Logha village (Mark48)

There is a church on the west coast in Logha island (Mark48 in Fig. 3.1.7.1). The tsunami rose up and the church was inundated. The watermark remained, which was estimated as 2.08 m (Photo 3.1.7.1).

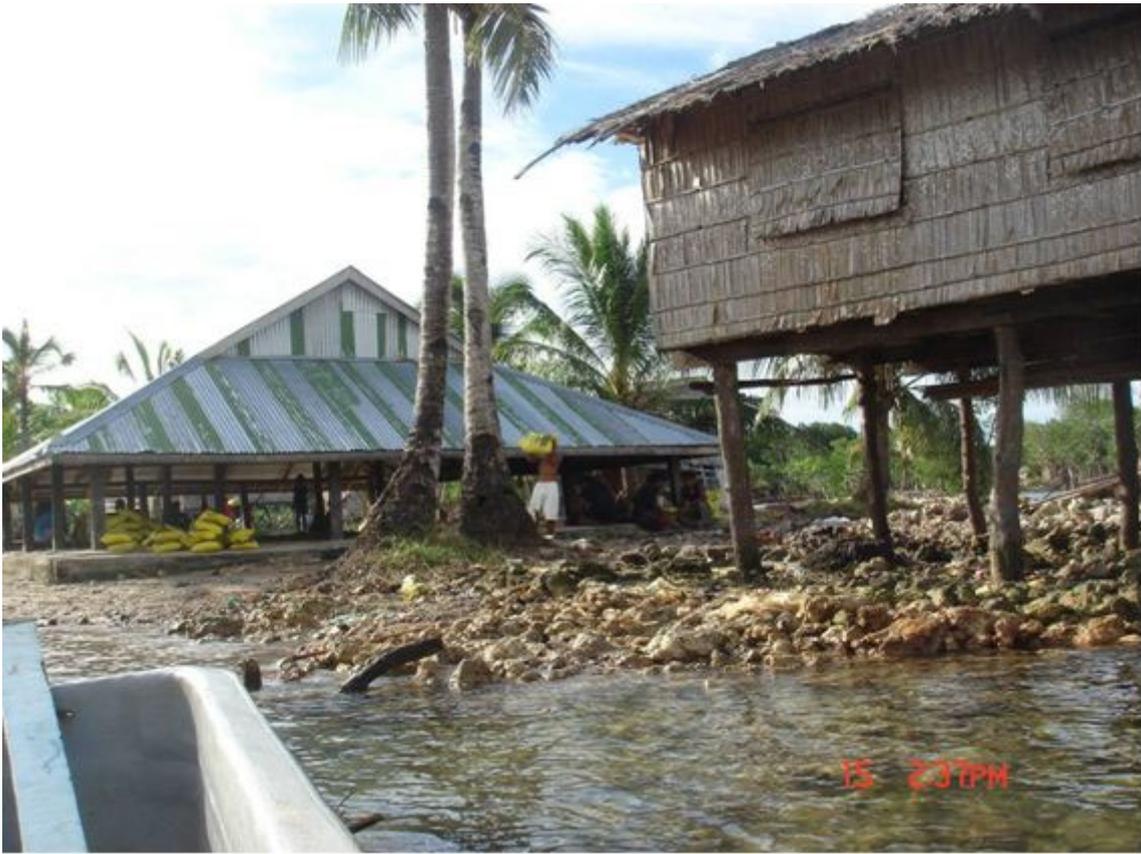
Photo 3.1.9.1 Warehouse of grain at Nusambaraku

Nusambaraku village is about 1 km northwest of Gizo town. In this village, there is a large warehouse of grain shown in Photo 3.1.9.1. According to the inhabitants' eyewitness accounts, the tsunami rose up to the roof of the warehouse (Mark 47, Fig. 3.1.9.1). The watermark was clearly remained inside the roof. The height was measured as 3.27 m. In this village, nine people were killed by the tsunami. The tsunami came three times, and the first wave was small, but the third one was largest. The first wave came 5 minutes after the earthquake. The time interval between the first and second waves was about 3 minutes. Before the arrival of the first wave, the sea level receded, and the sea bed appeared.

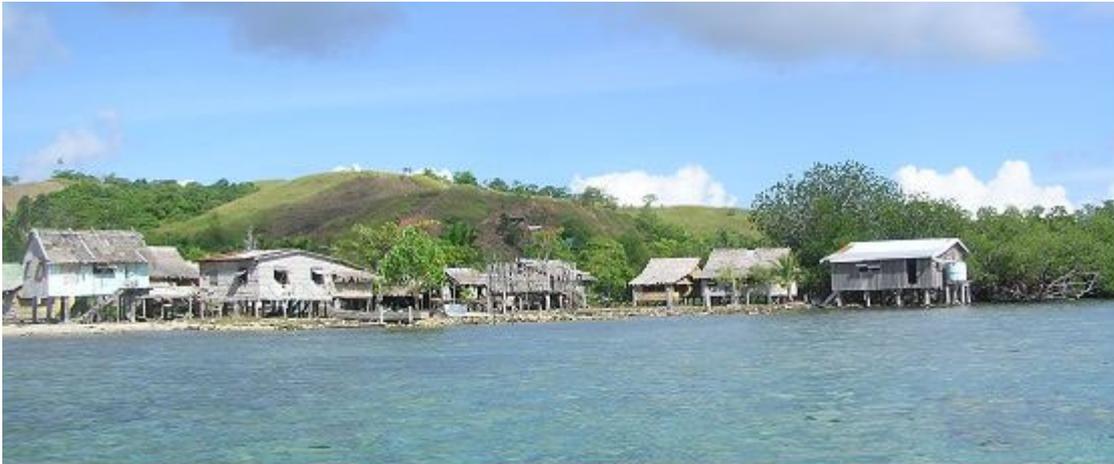
Photo 3.1.10.1 Distant view of the fishing village from the sea

village is on a low-lying flat land and is defenseless. A tsunami inundation trace was found on the wall of a church. The height was 1.4 m above the sea level at the time of tsunami attack. As seen from the photo, most houses are high-floor-type and withstood the earthquake and tsunami.

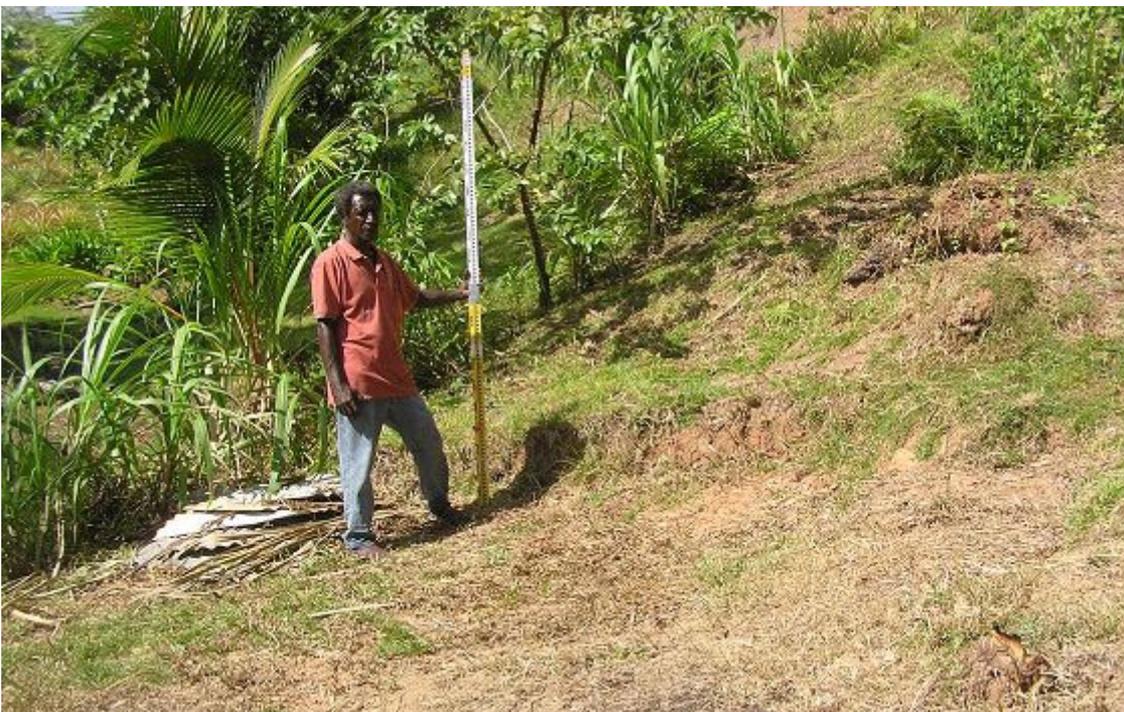
Photo 3.1.10.2 Tsunami measured point decided on the basis of eyewitness accounts of inhabitants

The tsunami run-up height reached 1.7 m on the coast 0.4 km northwest of Fishing Village (see Fig. 3.1.1.2). The coast was protected by a small mangrove forest and the run-up point shown in Photo 3.1.10.2 was decided on the basis of eyewitness accounts by inhabitants. As houses were high-floor-type and located on a slope of hill, no houses were damaged by the tsunami.

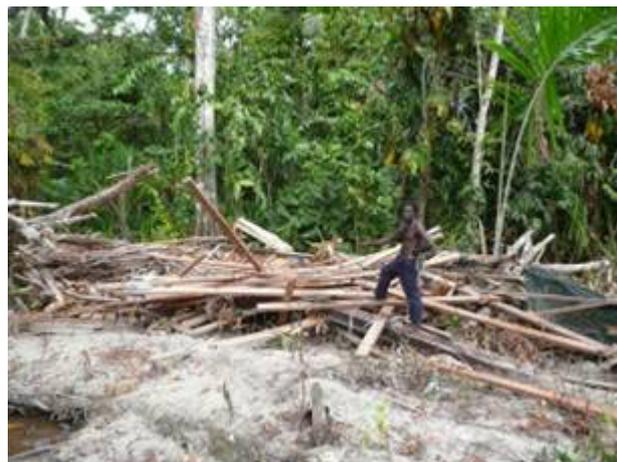
Photo 3.1.12.1 Situation at the runup limit in Sagheraghi

Mark 7 indicated the location of runup limitation determined by residents' accounts. The tsunami reached up to 128 m inland from the coast. At the runup limit much debris was piled up among trees, as shown in Photo 3.1.12.1.

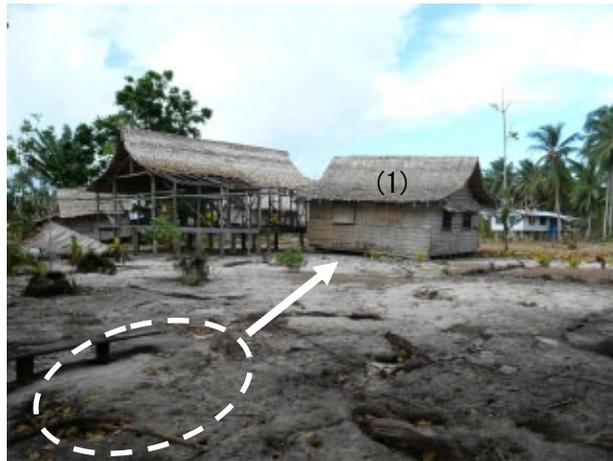
Photo 3.1.12.2 High-floored house swept by the tsunami

Although no one was killed in this village, 43 houses suffered damage. Some high-floored houses were swept by the tsunami. For example, the house numbered (1) in Fig. 3.1.12.2 was swept 15 m from its original location, as shown in Photo 3.1.12.2.

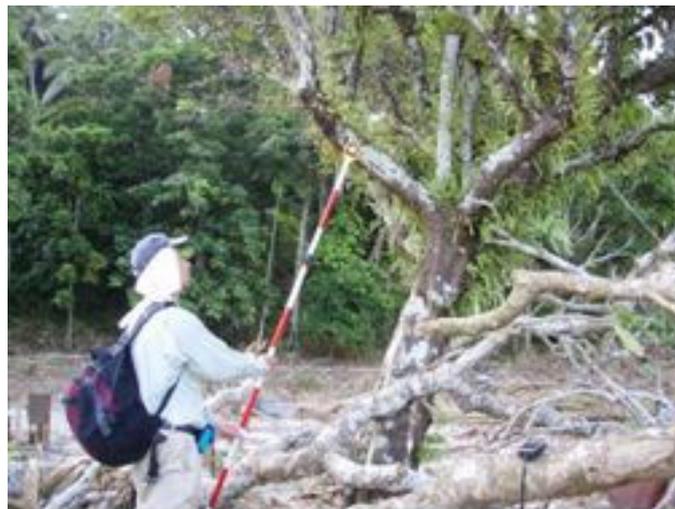
Photo 3.1.13.1 Scratch remaining on a tree in Vorivori village.

Vorivori village is located along the western coast of Ghizo island. Its population is more than 100. Nobody was killed by the tsunami. Because many people had watched an educational video about tsunami disasters given by an NGO, they knew to run away from the tsunami just after the earthquake. The sea level receded at first, and then the land was inundated for about 10 minutes. Because of the inundation, houses floated, moved, and were broken. In the village, much debris remained in trees, and scratches remained on trees (Mark 51 in Fig. 3.1.13.1 and Photo 3.1.13.1). The height was measured as 4.46 m. At the other point, Mark 52, there were a lot of rubble and houses moved inland by the tsunami, and the height was estimated as 1.75 m. Mark 52 is about 60 m behind Mark 51.

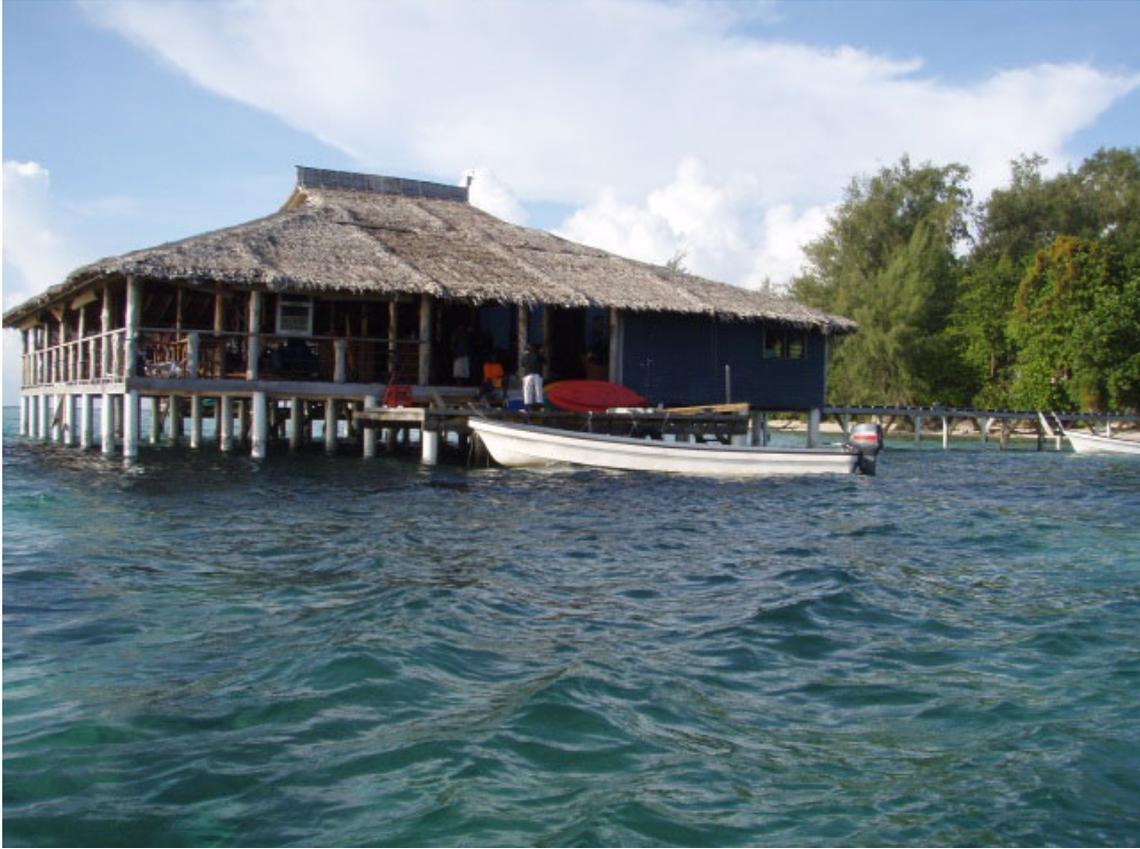
"Fatboys" is a restaurant and bungalows at Mbabanga Island, about 5 km east of Gizo Island (see Fig. 3.1.1.4). Some staffs were working in the restaurant at the time of the earthquake and tsunami. We interviewed them and got information in July 2007. The restaurant is situated 100 meters out of the island and built on the water (Fig. 3.1.16.1). The staffs felt strong shaking but it caused no significant damage on the structure. They said that the water (tsunami) came up to the floor level of the house and caught their feet, but tables and chairs were not moved by the water flow. So, we measured the floor level above the sea surface as the tsunami height. It was 1.24 m.

Fig. 3.1.16.1 Restaurant of "fatboys" at Mbabanga Island. Tsunami came up to the floor of the house

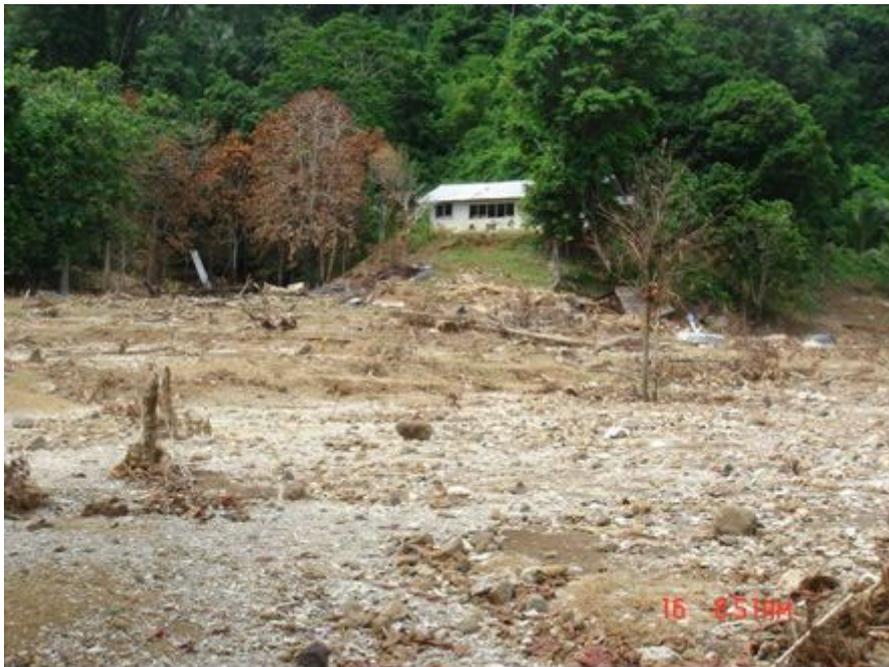
Photo 3.2.2.1 The building of the church in Tapurai. This church and one shed were survived.

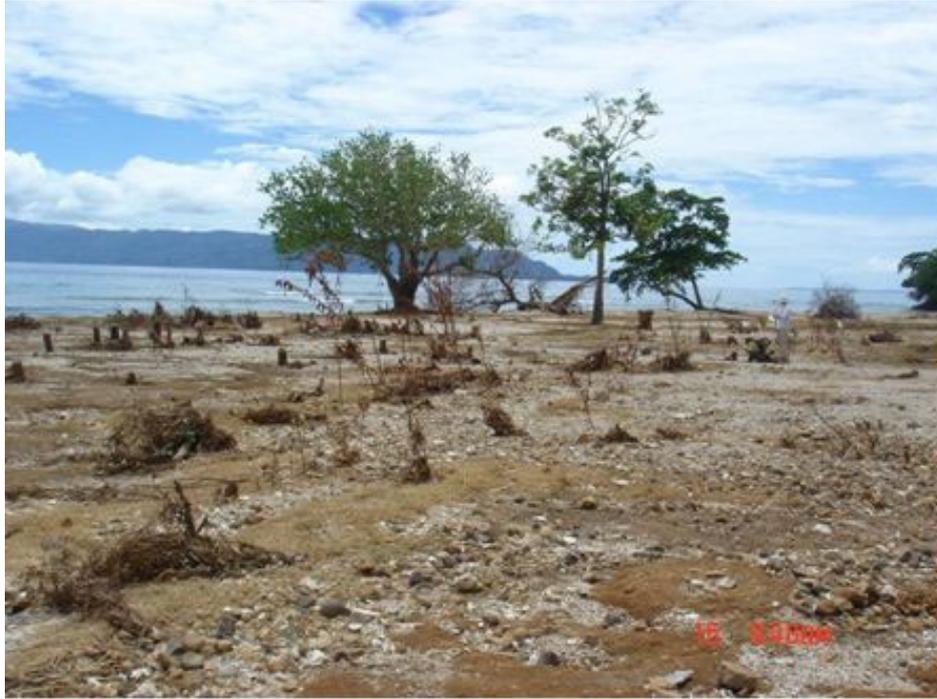
Photo 3.2.2.2 Coastal region in Tapurai. There had been four buildings of the primary school here, but all of them were entirely swept away due to the tsunami.

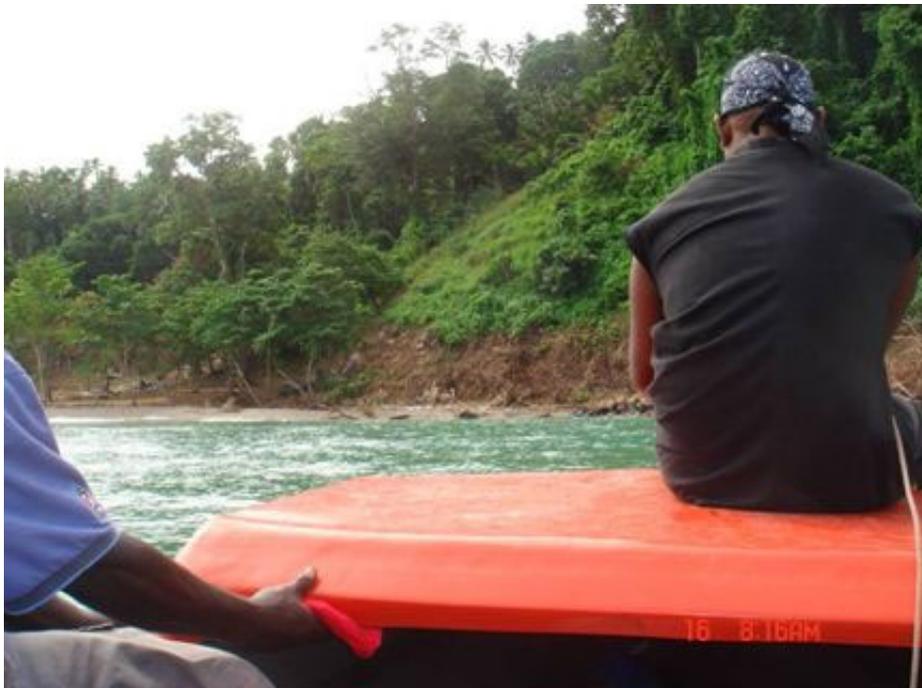
At Marks 59 and 3, seawater rose up to the cliff (Photo.3.2.2.3), and the border line between living and dead grass can be seen easily, which was corroborated by the eyewitness accounts of the inhabitants. The height of 8.5 m at Mark 59 and 9.0 m at Mark 3 (after correction of the astronomical tide) were measured. At Mark 116, the

Photo 3.2.2.3 Tsunami runup limit at the Mark 59 in Tapurai, Simbo Is. We could easily recognize the inundation limit as the green and brown color boundary.

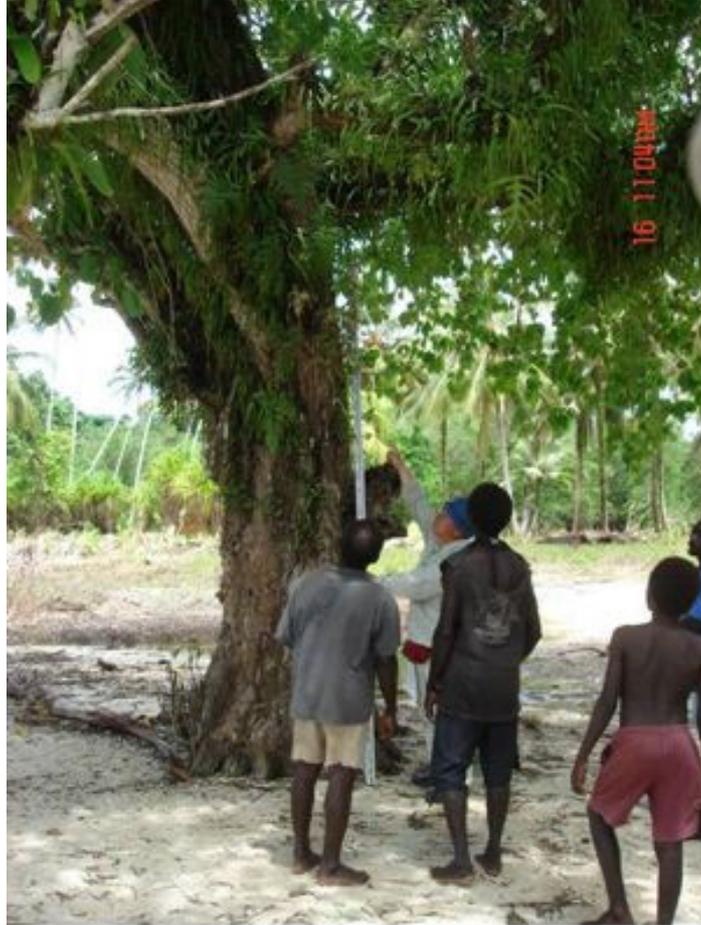
Photo 3.2.3.1 Tsunami inundation at the Mark 36 in Riguru, Simbo Is. We judged the tsunami inundation limit by eyewitnesses' account.

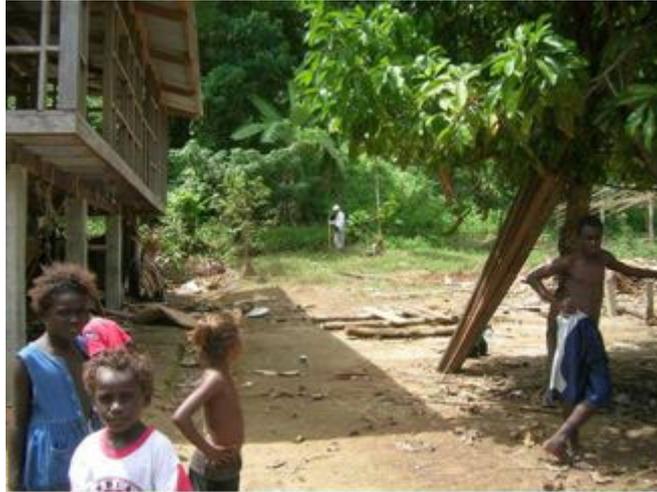
Photo 3.2.5.1 The runup point at Mengge

At this site, two kitchen-cottages near the coastline were washed away by the tsunami. In addition, one house was washed away. This house was already damaged by the earthquake, and floated and washed away by the tsunami. The runup height was measured, whose trace was the debris on the ground.

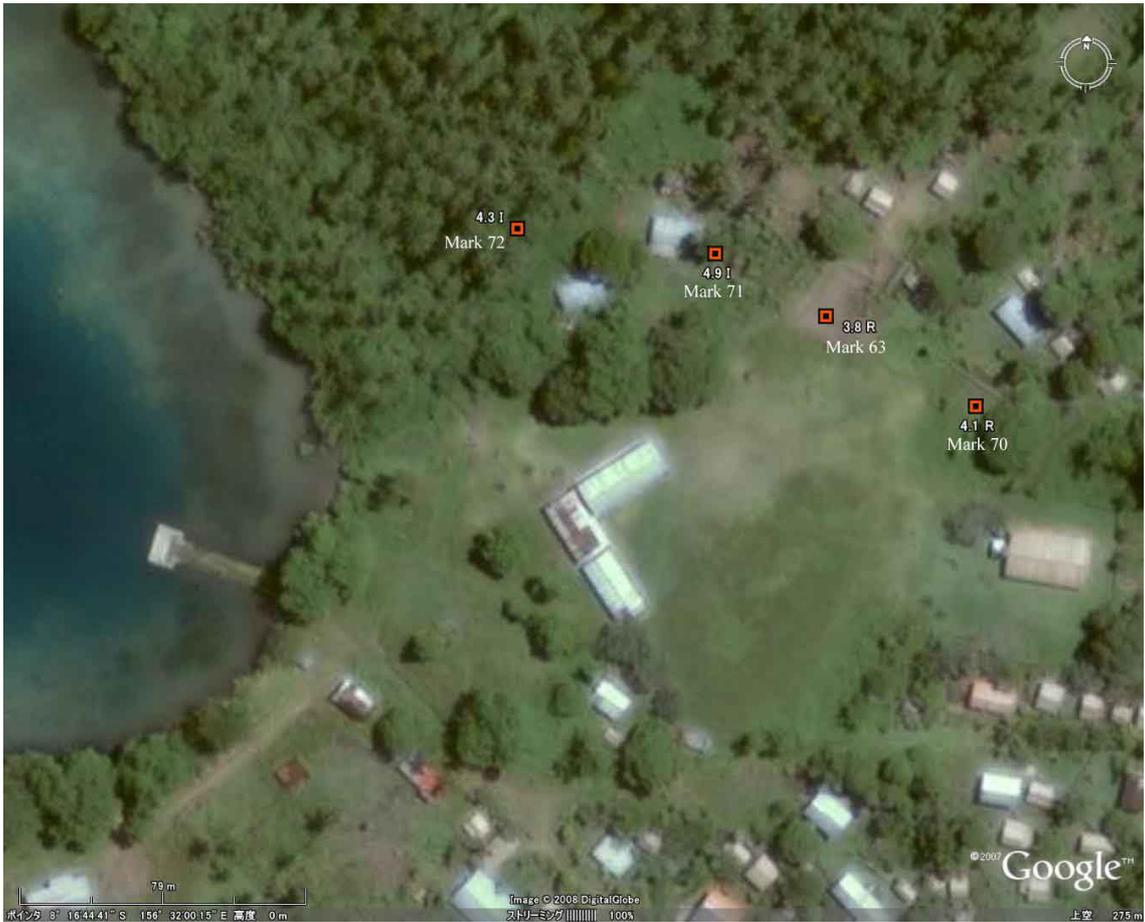
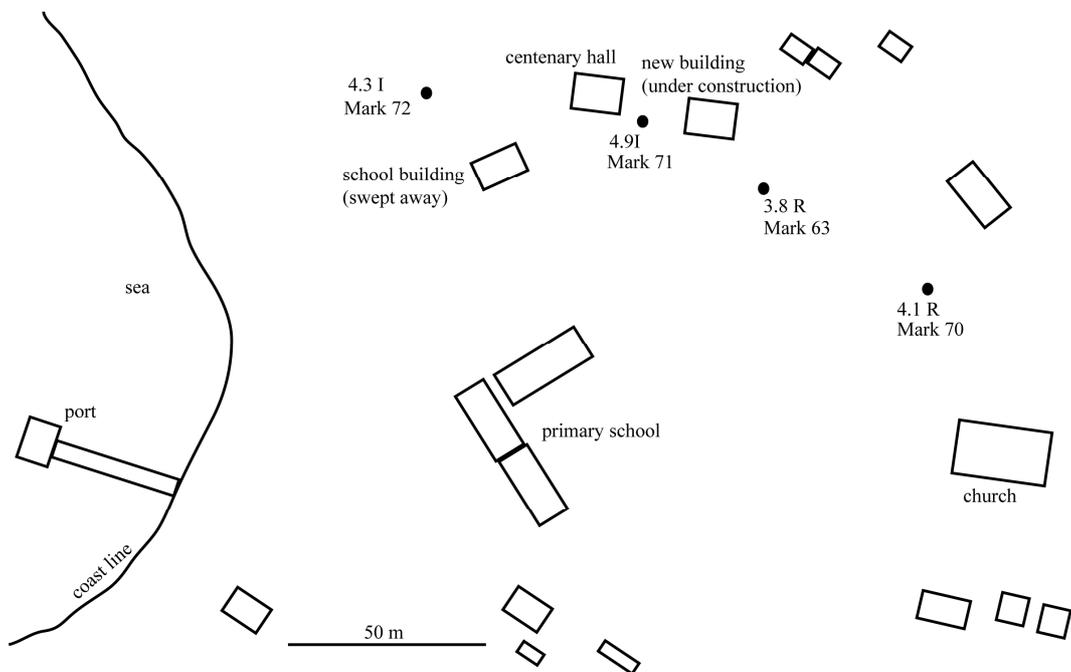
Figure 3.2.6.1 Trace heights surveyed in Lengana

We measured the tsunami heights at four points in Lengana (Fig.3.2.6.1). Two are runup heights and the others are inundation heights. At Mark 71, the wall of "centenary hall" was inundated and there were scratches on a wall (Photo. 3.2.6.2). We regarded the top of the scratch as the tsunami height, and the height was 4.9 m (after correction of the astronomical tide). At Mark 70, we found the clear border line between living and dead leaves. The line was the limit of runup. The height was measured as 4.1 m (after correction of the astronomical tide). We measured the other two heights in the same way.

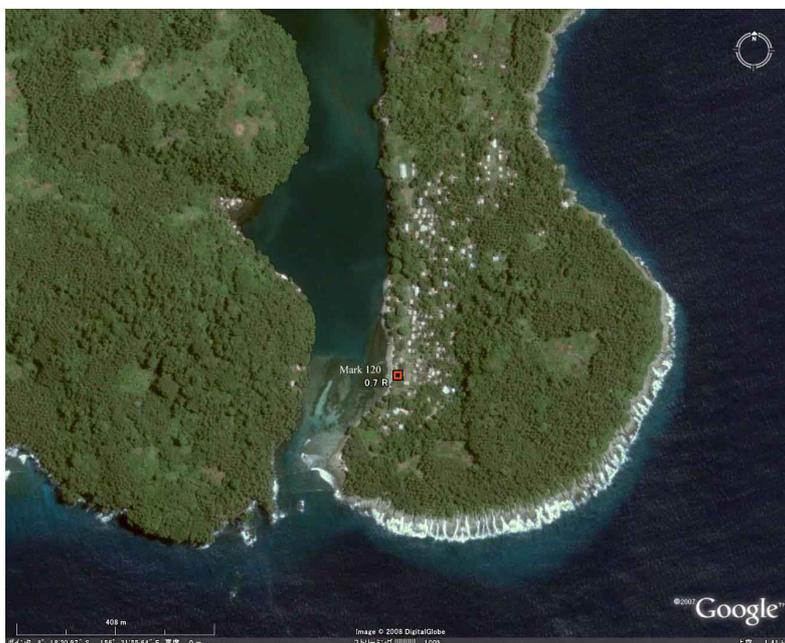
Figure 3.2.7.1 Trace height surveyed in Ove

damaged by the tsunami, although the tsunami trace height was not so high. The measured runup height was 0.7 m as shown in Figure 3.2.7.1. The runup mark was decided as the location of the debris on the ground, and this location was corroborated by the eyewitness account of an inhabitant (Photo 3.2.7.1).

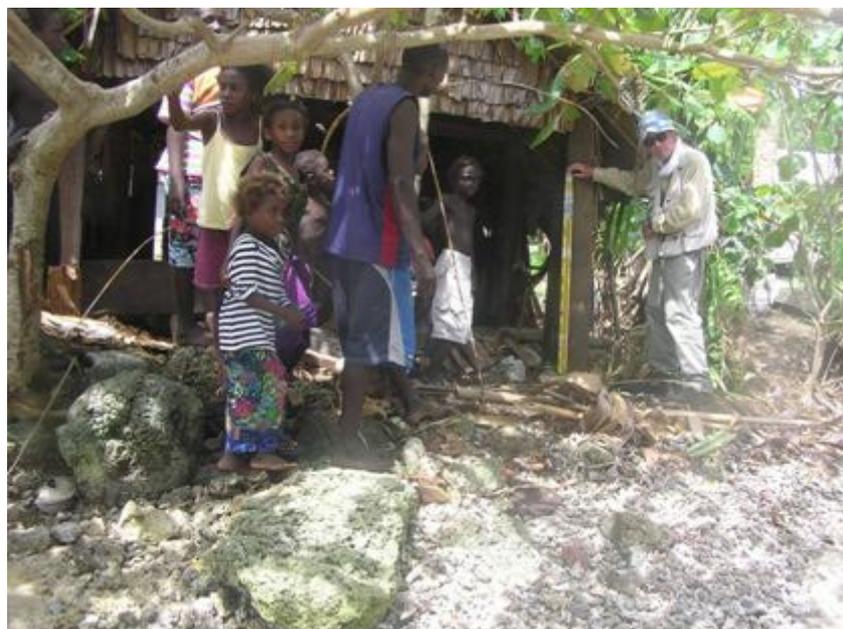
Photo 3.2.7.1 Measured run-up point in Ove, which was also corroborated by the inhabitants. The run-up height was 0.7 m.

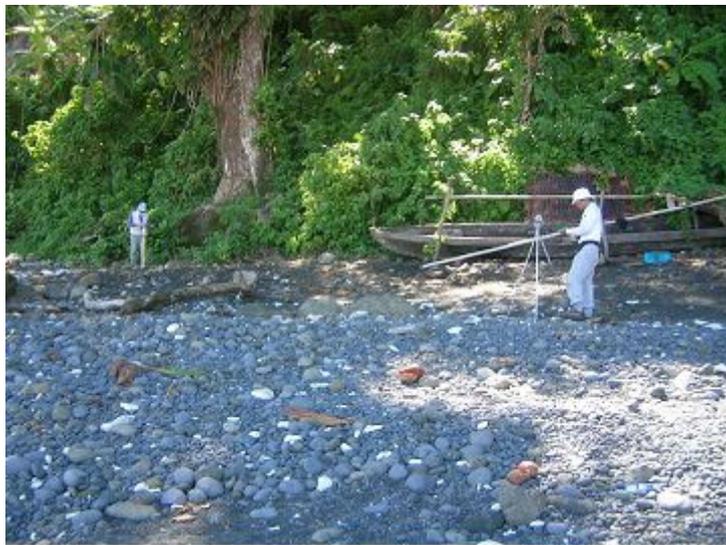
Photo 3.3.5.2 Tsunami measured point at Kundu village

The tsunami run-up height reached 3.5 m. The run-up point was located on the beach and decided on the basis of eyewitness accounts of inhabitants (Photo 3.3.5.2). Residential area is located on a cliff. Therefore, there was no damage from the tsunami.

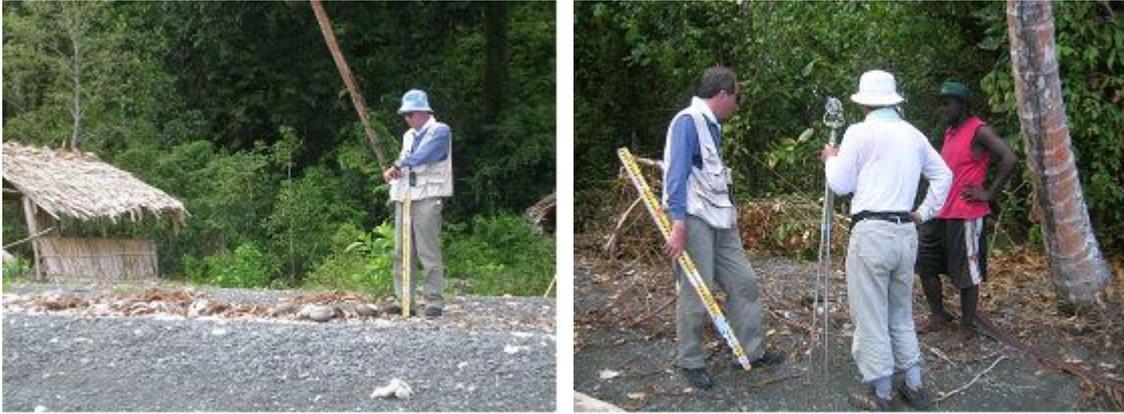
Photo 3.3.7.1 Tsunami measured points at Vori village (left) and Vori Point (right)

The tsunami run-up height reached 1.9 ~ 2.3 m at Vori village, and the tsunami inundation height was 2.3 m at Vori Point. The run-up and inundation points were decided on the basis of both debris and eyewitness accounts of inhabitants (Photos 3.3.7.1). The tsunami at Vori village did not overflow a coastal dune.

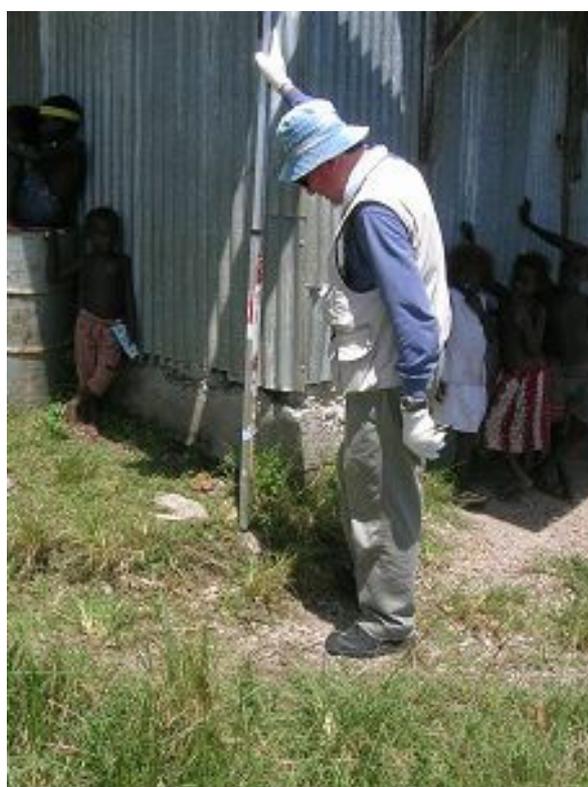
Photo 3.3.8.2 Tsunami measured point at Koriovuku village

The tsunami run-up height reached 1.9 ~ 2.1 m. The measured point was decided on the basis of eyewitness accounts of inhabitants (Photo 3.3.8.2). As the tsunami height was small and the residential area was located on a hill, damage from the tsunami was not recognized at all.

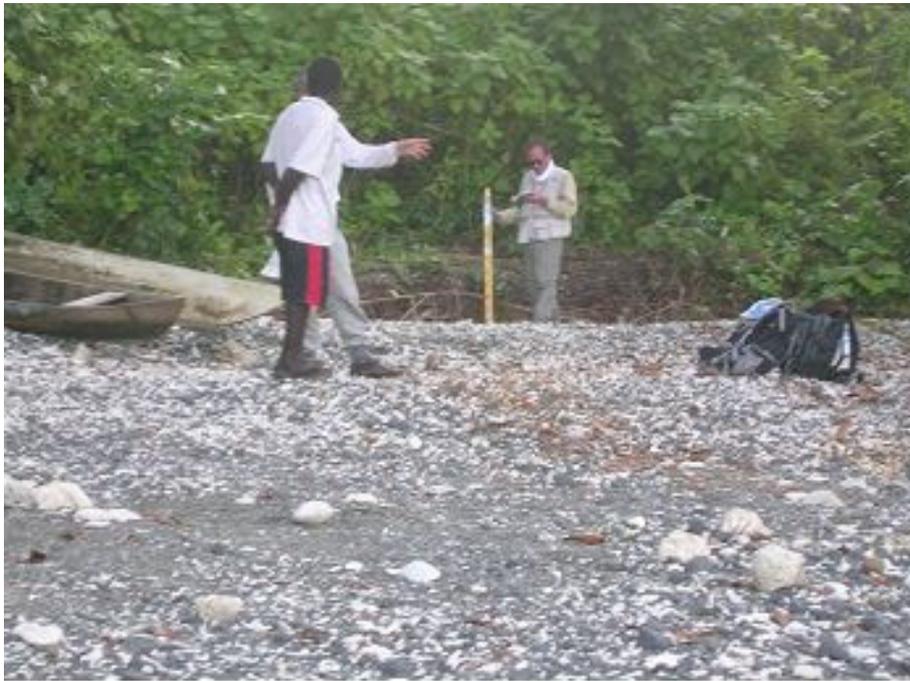
Photo 3.3.10.1 Tsunami measured point at Suava village

The tsunami run-up height reached nearly 3.3 m. The measured point was located on the beach and determined from eyewitness accounts of inhabitants (Photo 3.3.10.2). There was no damage except that caused by the earthquake. Although water tanks were destroyed by the earthquake, new ones had been already supplied by Solomon Islands' government.

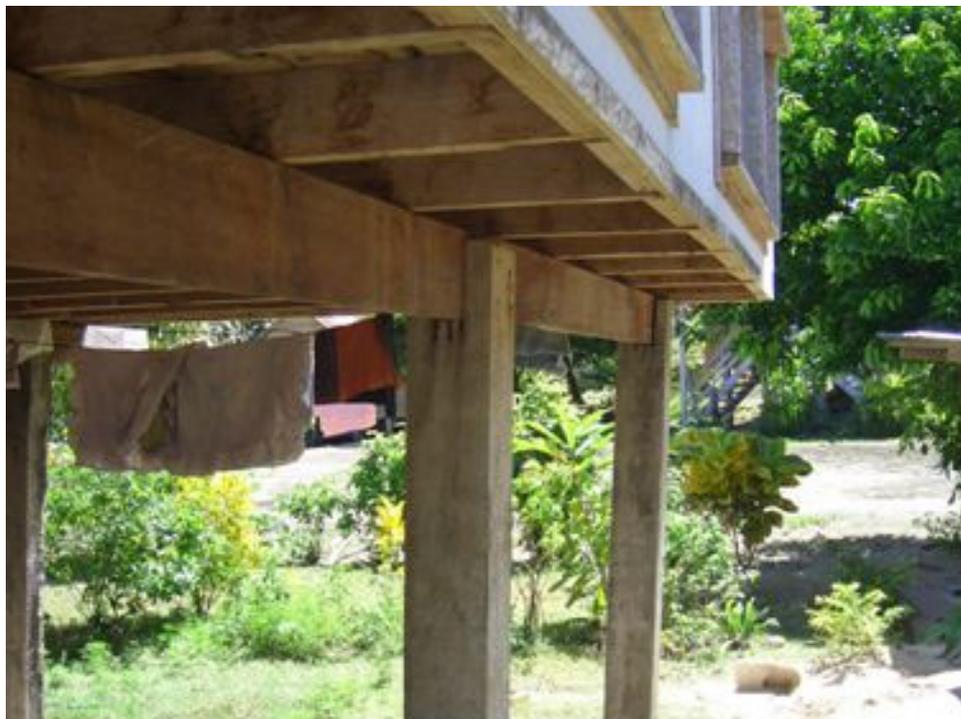
injured from the shaking of the earthquake. Two buildings were completely destroyed. This village was suffered mainly from the shaking but the tsunami also caused some damage. Because most of the buildings in this village sit on raised platforms lacking diagonal bracing, they are easily damaged by the shaking of the earthquake (Photo.3.4.2.1).

Photo 3.4.2.1 Connection between piers and floor in Sambora.

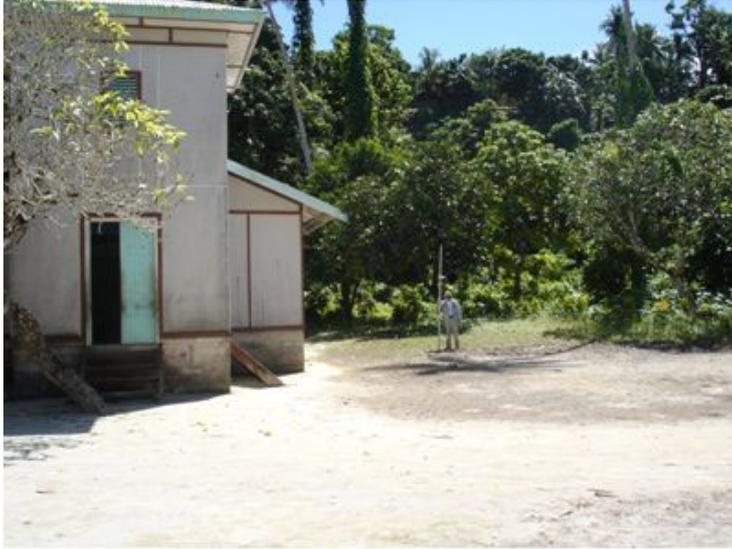
We measured the tsunami heights at two points in Sambora (Fig. 3.4.2.1) judged by a debris line and eyewitnesses' accounts. At Mark 83, which is close to a church, the sea water inundation limit was recognized as the boundary between living and dead vegetation, and moreover we found that the surface of the inundated ground was wet and its color had become darker because of salt (Photo.3.4.2.2). An eyewitness corroborated that the boundary was really the limit of inundation. The height was determined to be 2.1 m above sea level at the tsunami arrival (after correction of the astronomical tide). At Mark 89, we measured the tsunami height to be 2.0 m in the same way.

Photo 3.4.2.2 The tsunami runup limit in Sambora. The tsunami came up to the standing person in the photo.

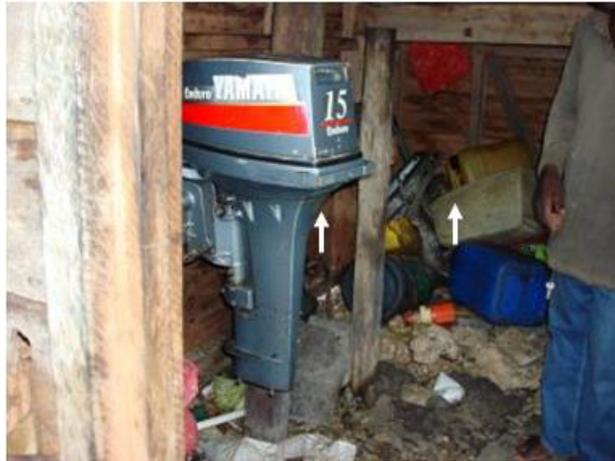
Photo 3.4.3.1 Inundation mark of Mark 18 (2)

Tsunami trace heights were measured at two points, Marks 18 (1) and 18 (2), as shown in Fig. 3.4.3.2. Their transects are shown in Figs. 3.4.3.3. Mark 18 (1) was an inundation mark on a seaward-facing wall of a high-floored house with stilts. The inundation height was 1.09 m. Mark 18 (2) was also an inundation mark on an outboard engine of boat in a storage house along the coast, as shown in Photo 3.4.3.1. The inundation height was 1.03 m. Although the storage house was a wooden structure without stilts, it suffered less damage from the tsunami. Less damage of the storage house results from shallow inundation depth of 0.74 m on the ground, which provides less destruction of house as shown in Photo 3.4.3.2. The low tsunami is caused by topographic characteristics in Vonunu.

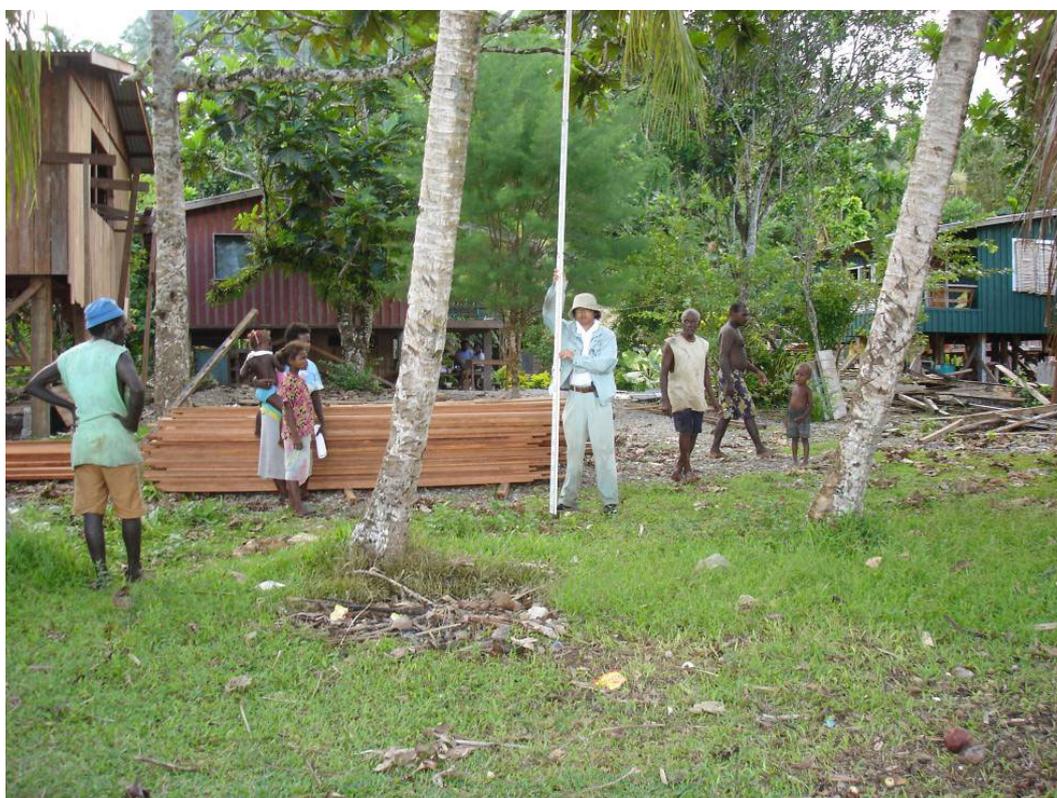
Photo 3.4.4.1 Tsunami inundation at Mark 85 in Maravari, Vella Lavella Is.

We measured the tsunami height at only Mark 85 in Maravari judged by the debris. At that point, tsunami ran up to the dead leaves line (Photo 3.4.4.1), which was also corroborated by the inhabitants. The height of 1.3 m was measured.

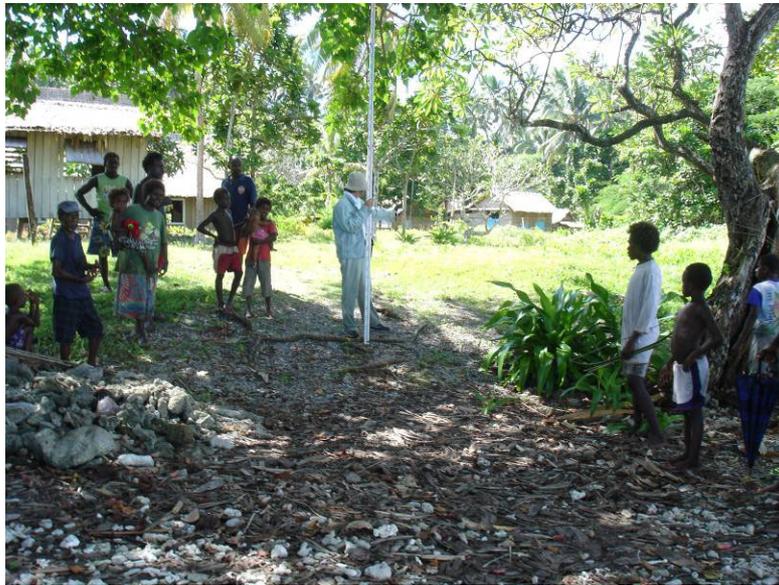
Photo 3.4.5.1 Tsunami inundation at Mark 86 in Niarovai, Vella Lavella Is.

We measured tsunami heights at two points in Niarovai (Fig.3.4.5.1) judged by the debris. At Mark 86, tsunami ran up to the limit of dead leaves (Photo 3.4.5.1), which was corroborated by the inhabitants. The height of 1.1 m was measured. At Mark 91, we could measure the tsunami height in the same way, and the same height as 1.1 m was measured.
