# Joint Report for Tsunami Field Survey for the Solomon Islands Earthquake of April 1, 2007

## PARI Tsunami Survey Team

May 2008

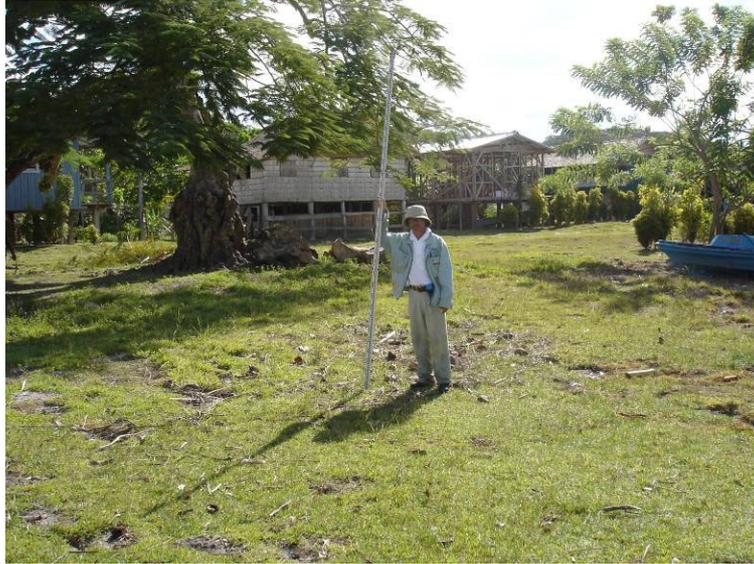
Photo 3.4.6.1 Tsunami inundation at the Mark 87 in Lambu-Lambu, Vella Lavella Is.

We measured the tsunami heights at two points in Lambu-Lambu (Fig.3.4.6.1) judged by the debris. At Mark 87, the tsunami ran up to the limit of dead leaves (Photo.3.4.6.1), which was also corroborated by the inhabitants. The height of 0.3 m (after correction of the astronomical tide) was measured. At Mark 92, we measured the tsunami height in the same way, and almost same the height was measured as 0.5 m.

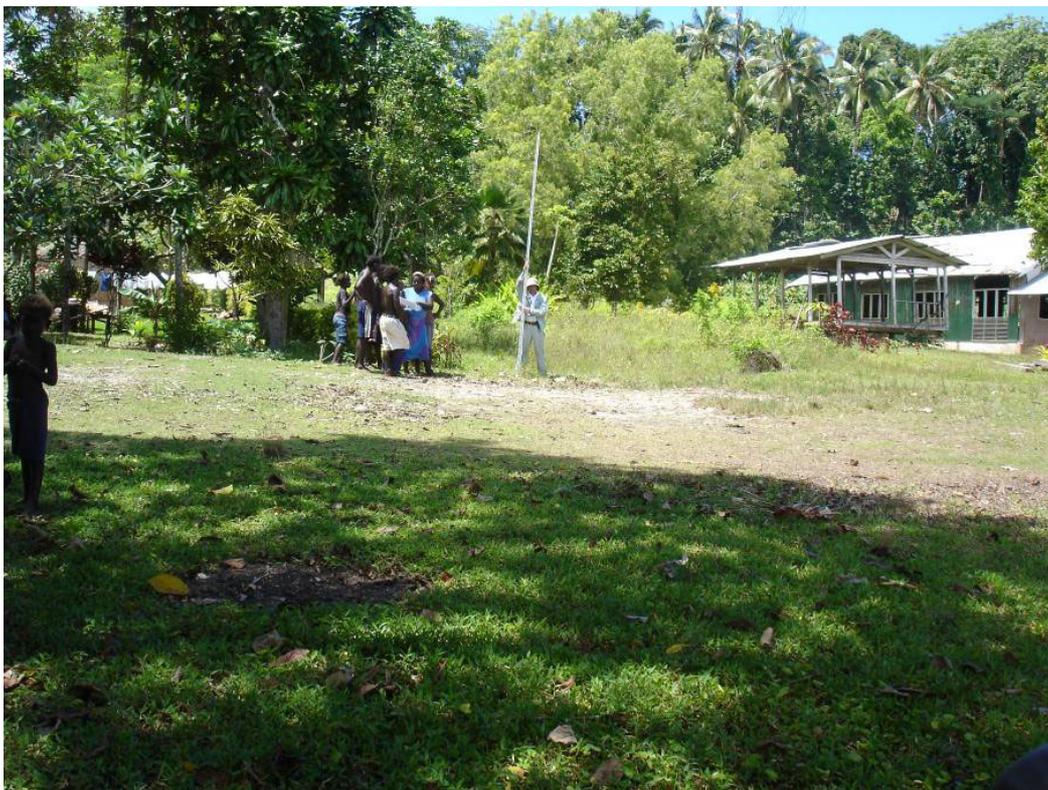
Photo 3.4.7.1 Tsunami inundation at Mark 84 in Varese, Vella Lavella Is.

We measured the tsunami heights at two points in Varese (Fig.3.4.7.1) judged by the trace of dead weeds on the ground. At Mark 84, sea water inundated up to the boundary of the area marked by dead weeds where the person stands in the Photo.3.4.7.1, which was also corroborated by the inhabitants. We measured the inundation height at 2.4 m (after compensation for the astronomical tide). At Mark 90, we measured the tsunami height in the same way, and almost same value (2.5 m) was obtained.

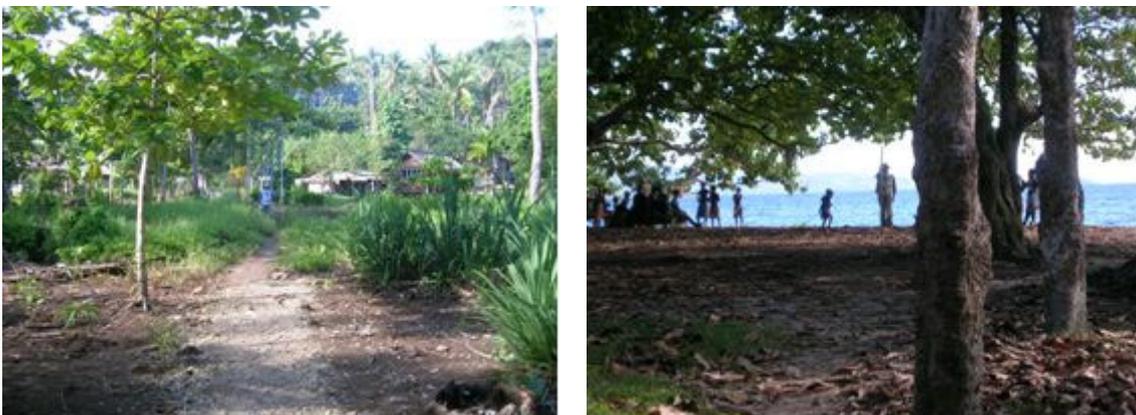
Photo 3.4.8.1 Survey points in Supato (left: inundation limitation, right: top of dune)

The inundation limit was determined by eyewitness account (left photo of Photo 3.4.8.1). The height of the location was 1.0 m above sea level at the tsunami event. However, that ground elevation was lower than the dune near the coastline (right photo of Photo 3.4.8.1). Thus, we measured also the height of the dune, 1.4 m. Unfortunately, we could not know the inundation depth on the dune. The actual water elevation was higher than 1.4 m at the dune.

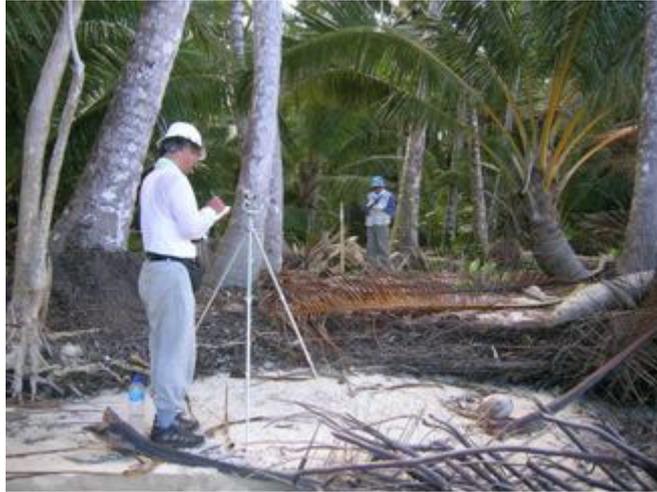
On the east coast of the island, we found some debris near the coastline. The tsunami might have inundated beyond this line, however; the limit of inundation was not clear. Thus, we measured the height of debris, 1.3 m. It is possible that the actual height was higher than 1.3 m.

Photo 3.4.9.1 Debris at the east coast of Baga Island

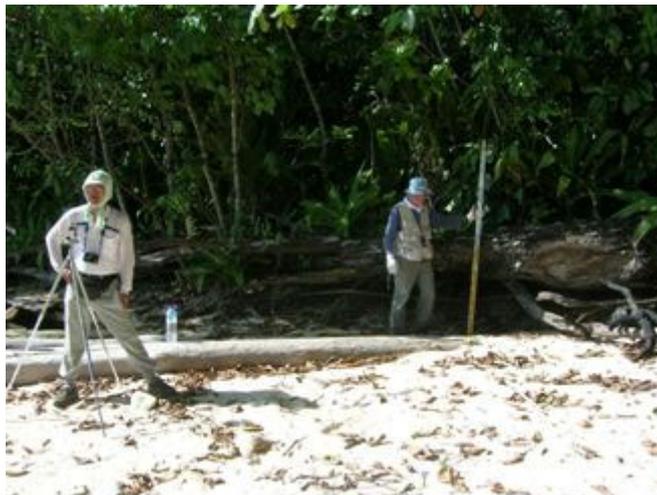
On the west coast of Baga Island, we could not find clear tsunami-traces. The fallen big tree in Photo 3.4.9.2 was not a tsunami trace. However, it was thought that the tsunami could not have exceeded the location of the tree, considering the arrangement of debris and dead vegetation. The height of that place was 1.7 m, thus the runup height was lower than 1.7 m. The runup height of ordinary waves was estimated as 0.7 m, considering the debris on the beach. Thus, the runup height of the tsunami seemed to be higher than 0.7 m and lower than 1.7 m.

Photo 3.4.9.2 Big tree at the west coast of Baga Island (It is thought that this tree is not the trace of tsunami.)

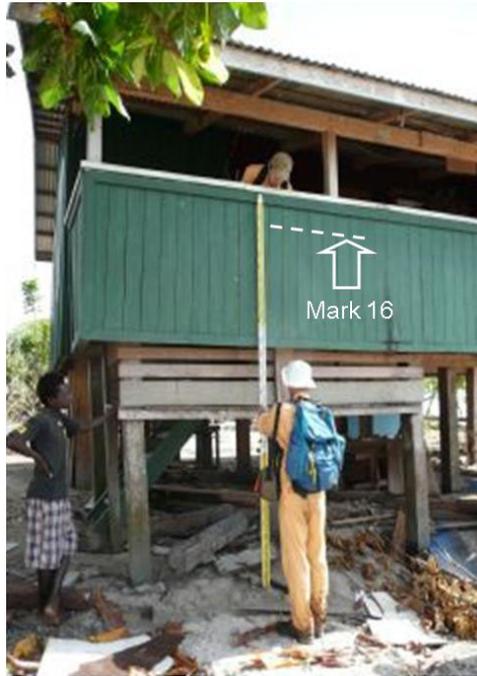
Two tsunami traces were measured in Iringgila: Marks 16 and 17, as shown in Fig. 3.4.10.2. Their transects are shown in Figs. 3.4.10.3 and 3.4.10.4. Mark 16 is an inundation mark on a side wall of a high-floored house located behind a small island, as shown in Photo 3.4.10.1. The inundation height was 4.37 m and inundation depth on the ground level was 2.90 m. Mark 17 is also an inundation mark on a facing-to-sea front door of a clinic located in the southwest edge of the village. The inundation height was 1.86 and inundation depth was 0.77 m.

Photo 3.4.10.1 Inundation level of Mark 16

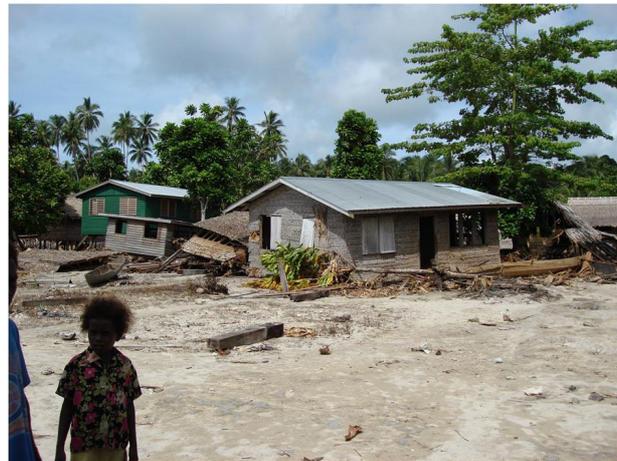
The inundation depth at Mark 17 was lower than that of Mark 16, even though the ground level at Mark 17 was lower by 0.38m than the level of Mark 16. If the tsunami heights were the same, the water flowed deeper over the lower area. Therefore, this difference was mainly caused by the tsunami height changing locally—the tsunami striking in the west side of the village was smaller than that of the east side. The change of tsunami height also provided the change in level of damage to houses, that is, houses in the east side of the village were swept and destroyed as shown in Photo 3.4.10.2, even though houses on the west side suffered less destruction.

Photo 3.4.10.2 House swept inland by tsunami in the east part of Iringgila

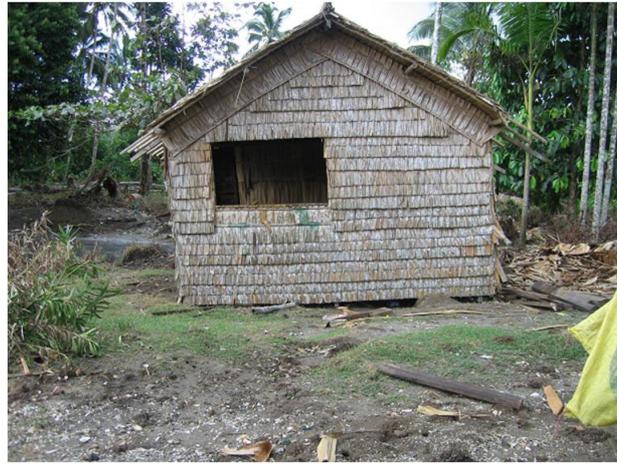
The tsunami moved several houses. One house in Fig. 3.4.11.2, as shown in Photo 3.4.11.1, was moved 9.5 m from the original position. The schoolhouse was also swept 50 m from its original position.

Photo 3.4.11.1 High-floored house in Fig. 3.4.11.2 moved by the tsunami

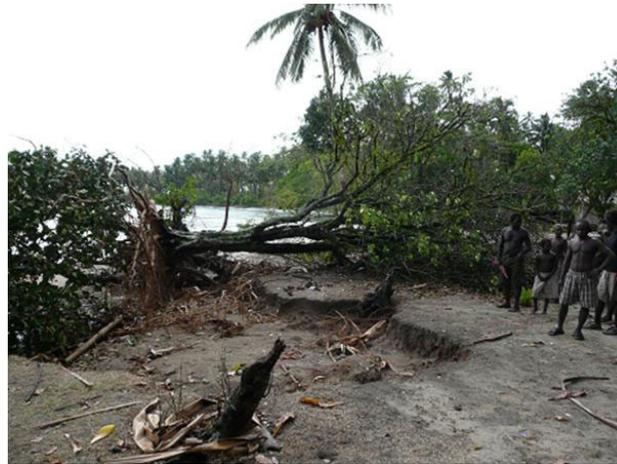
The tsunami, moreover, eroded the beach as shown in Photo 3.4.11.2, and felled coastal trees. The depth of erosion was 0.5 m.

Photo 3.4.11.2 Eroded beach and fallen trees in Reona

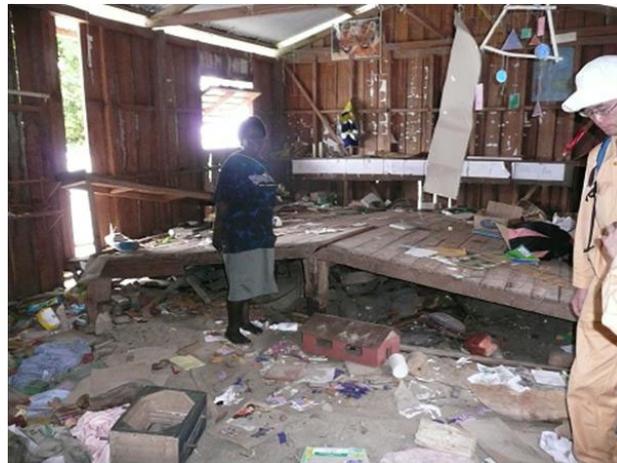
Three tsunami traces were measured in Paramata: Marks 12, 13 and 14. Their transects are shown in Figs. 3.4.12.1 to 3.4.12.3. Mark 12 indicated the inundation limit in a forest nearby the village, and was determined by a resident's witness. The ground level at Mark 12 was 2.71 m. Mark 13 was an inundation mark on an inside wall of the warehouse which had less damage. The inundation height was 2.79 m. Mark 14 was also an inundation mark on an inside wall of a kindergarten. The inundation height was 2.74 m. The walls of the kindertgarten had little damage and the floorboards were uplifted, as shown in Photo 3.4.12.1

Photo 3.4.12.1 Damaged kindergarten in Paramata

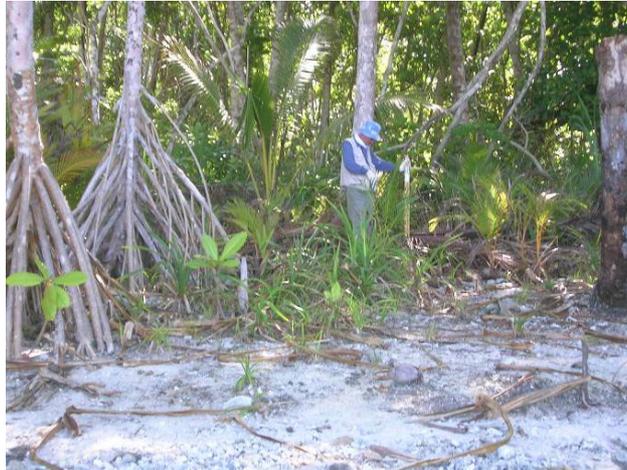
A runup height of 3.3 m was measured at Ndivulani, which is one of the chain of islands on the extending coral reef. Because no one lived in this island, there was no damage to structures here. Debris was found on the slope as shown in Photo 3.5.2.1. However, the debris seemed to have stopped there by being caught on vegetation. Thus, there is a possibility that the actual runup height was slightly higher than this measurement data.

Photo 3.5.2.1 Runup point at Ndivulani

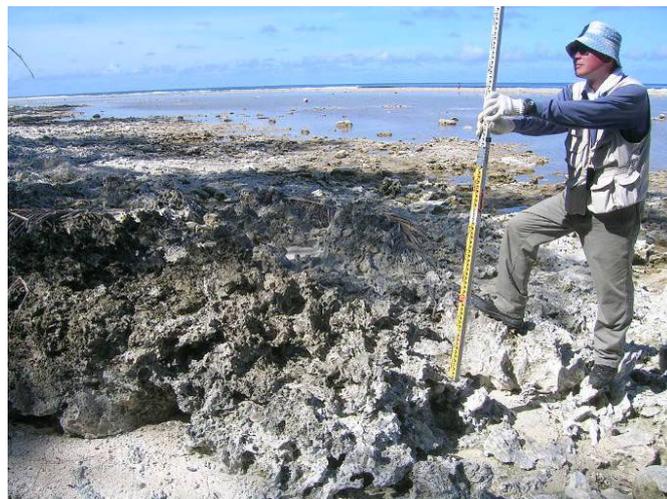
Uplift was clearly observed in this island, e.g. the coral reef was cropped out from the sea surface. The uplift of the ground was estimated as about 1m. The surveying staff in Photo 3.5.2.2 marks the location of the pre-earthquake shoreline, shown as a sharp line from gray to white on the coral rubble.

Photo 3.5.2.2 Exposed coral reef at Ndivulani

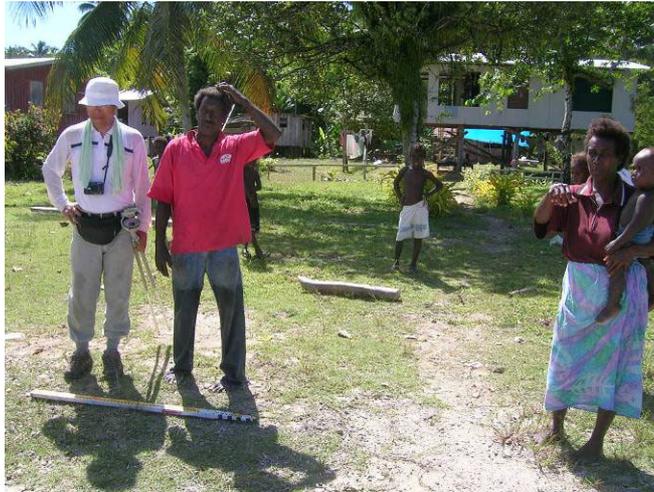
The runup height of 1.3 m was measured at Rarumana, the village on the main island of Parara. The runup point was determined by eyewitness accounts of the tsunami. The place of the staff in Photo 3.5.2.3 shows the runup point. In addition, the residents told us that the first tsunami motion was rundown and the low-tide level before the earthquake was near the white line in Photo 3.5.2.4. The uplift of this location was estimated as 0.8 m. This village suffered no damage, because the coast is sheltered by the extending reef and the ground was uplifted by the earthquake.

Photo 3.5.2.3 Runup point at Rarumana

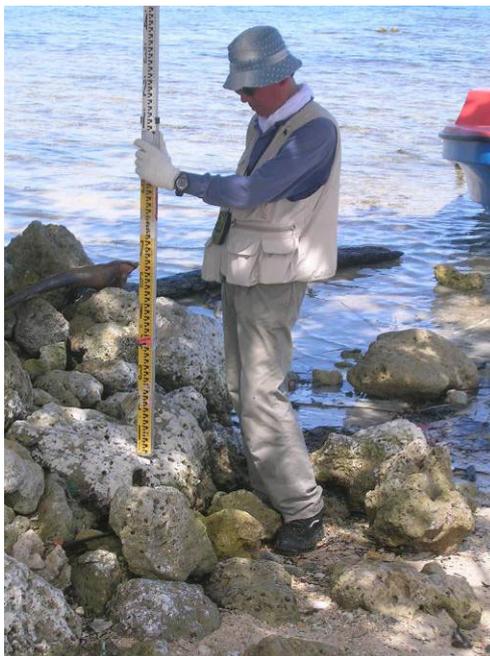
Photo 3.5.2.4 Uplift of ground at Rarumana

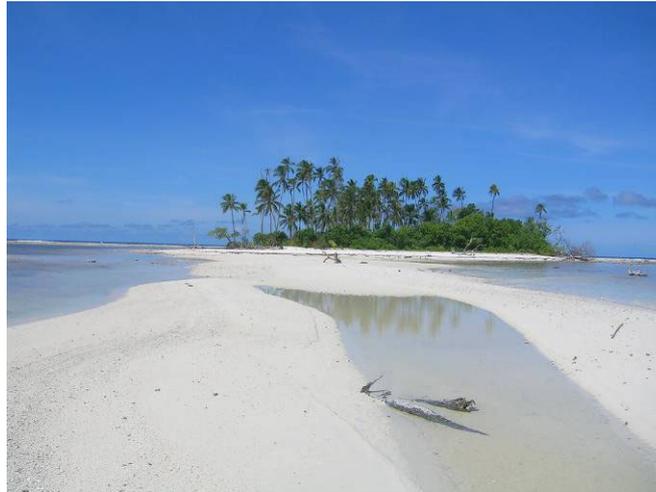
The record of 1.7 m was measured at an unidentified small island (Photo 3.5.2.5) near the end of the keys. The tsunami might intrude the whole island, because the debris was found in every place of the island. While the height of the debris shown in Photo 3.5.2.6 was measured, it is possible that the water level of the overflow on the island was higher than 1.7 m. The uplift of this location was estimated as 1.2 m.

Photo 3.5.2.5 Surveyed island near the end of the chain of keys

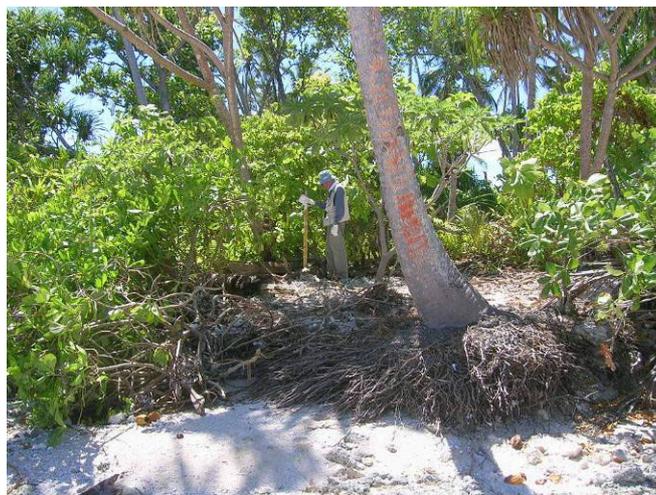
Photo 3.5.2.6 Tsunami trace at the surveyed island

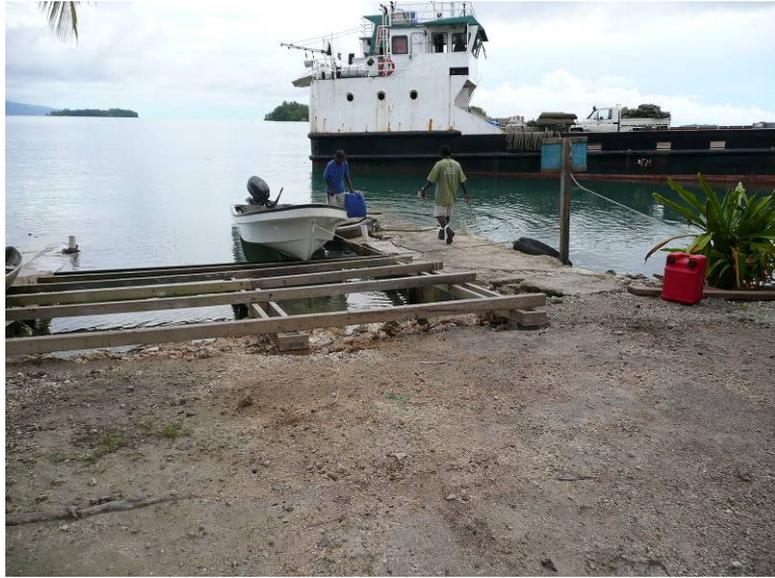
Fig. 3.5.3.2 shows the coastline and reef edges around Munda. Reefs have developed 800 m and 3000 m offshore along the south Munda coast; these reefs act as natural breakwaters. The survey points were in low-lying areas close to the sea surface as shown Photo 3.5.3.1. However, no severe damages were caused there, because the striking tsunami was approximately 1 m high as described later. The reason why the tsunami was not so high could be caused by tsunami reduction by reefs.

Photo 3.5.3.1 Survey location in low-lying area in Munda

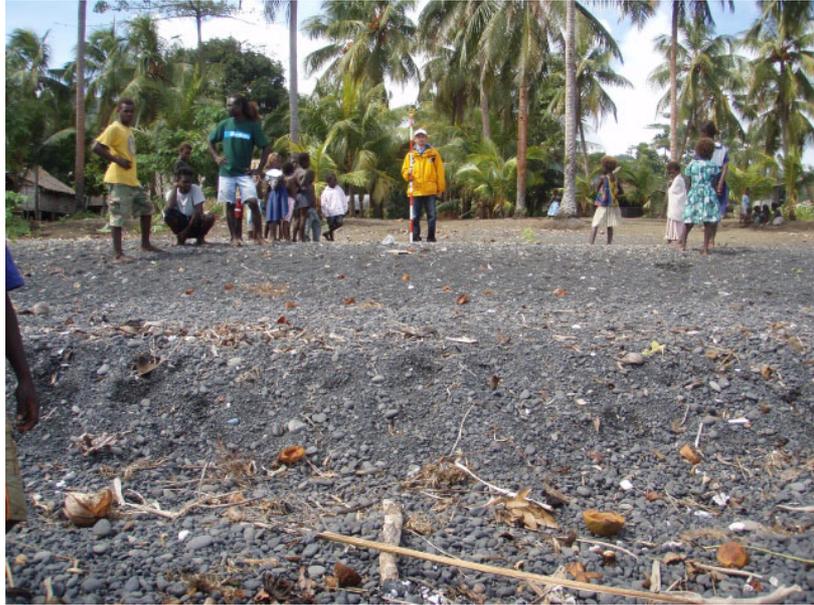
Hoppongo is located at the southwestern coast of Rendova Island. Local people identified coastal uplift and showed the original coastline at high tide. By comparing the original and present high tide lines we estimated the uplift to be 50 cm. Based on eyewitness accounts the tsunami came from the north. Before the tsunami attack, they observed the sea retreating for about 10 minutes. The tsunami did not damage houses. Inundation limit of the tsunami was inferred by a line of pumice that were carried up by the tsunami and re-deposited on the ground surface. The pumice probably originated from the submarine volcano off this island and composed the beach. The estimated tsunami runup height is 2.0 m (Photo 3.5.5.1.1).

Photo 3.5.5.1.1 Uplifted beach in Hoppongo, Rendova Island.

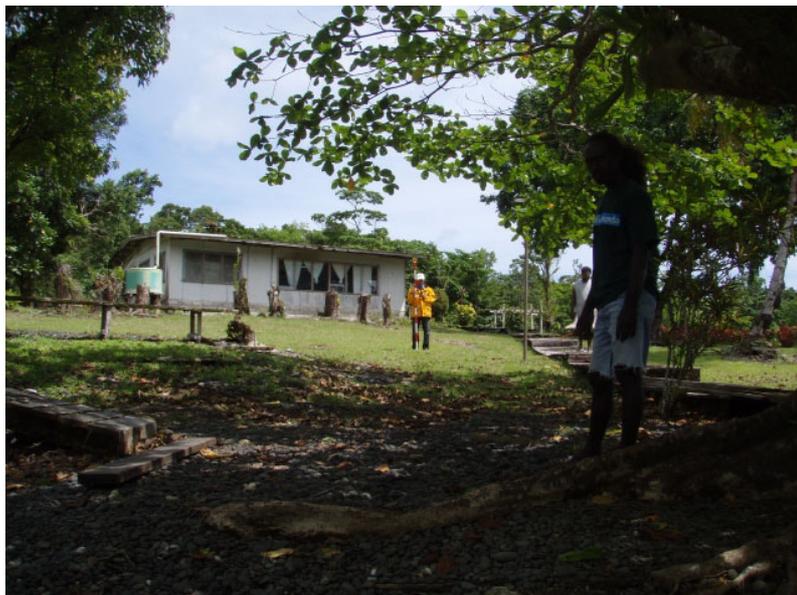
Kenero is located at the middle of the west coast of the island. We interviewed a land owner, Mr. Lawry Wickham, about the earthquake and tsunami. Based on his accounts, we estimated about 20 cm uplift of the land and 2.1 m runup of the tsunami (Photo 3.5.5.2.1).

Photo 3.5.5.2.1 Measuring the tsunami inundation boundary in Kenero, Rendova Island.

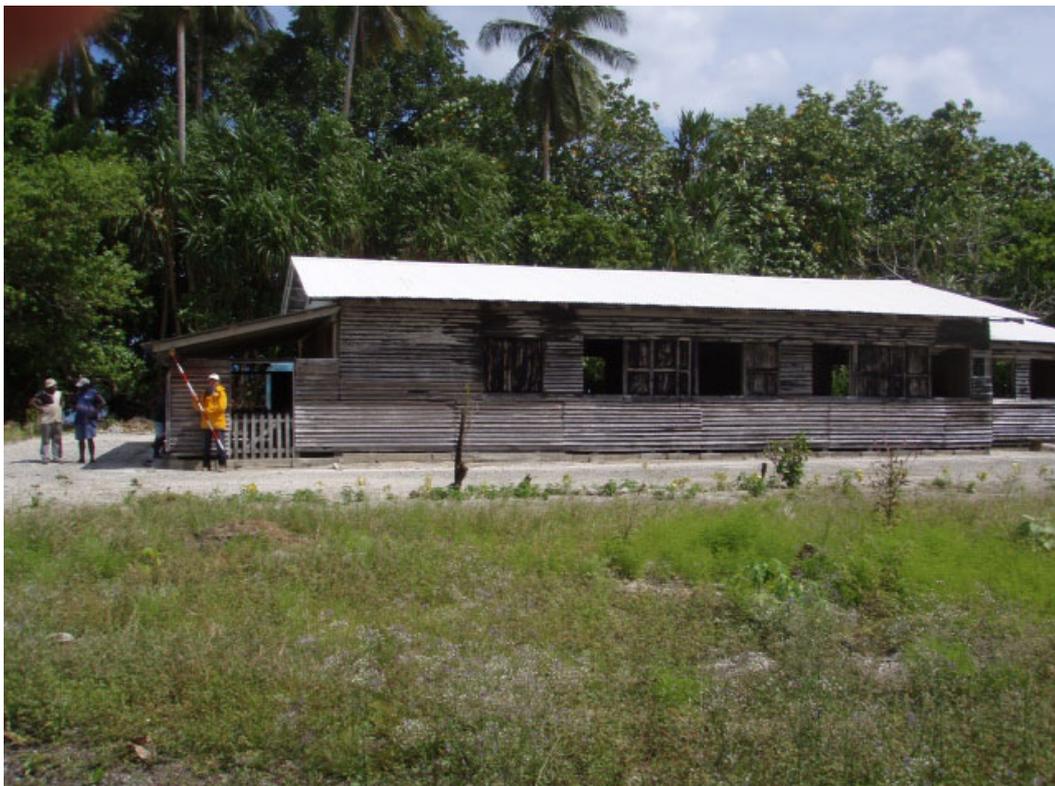
Photo 3.5.5.3.1 Measuring the tsunami flow height on the wall of a church in Randuvu, Rendova Island.

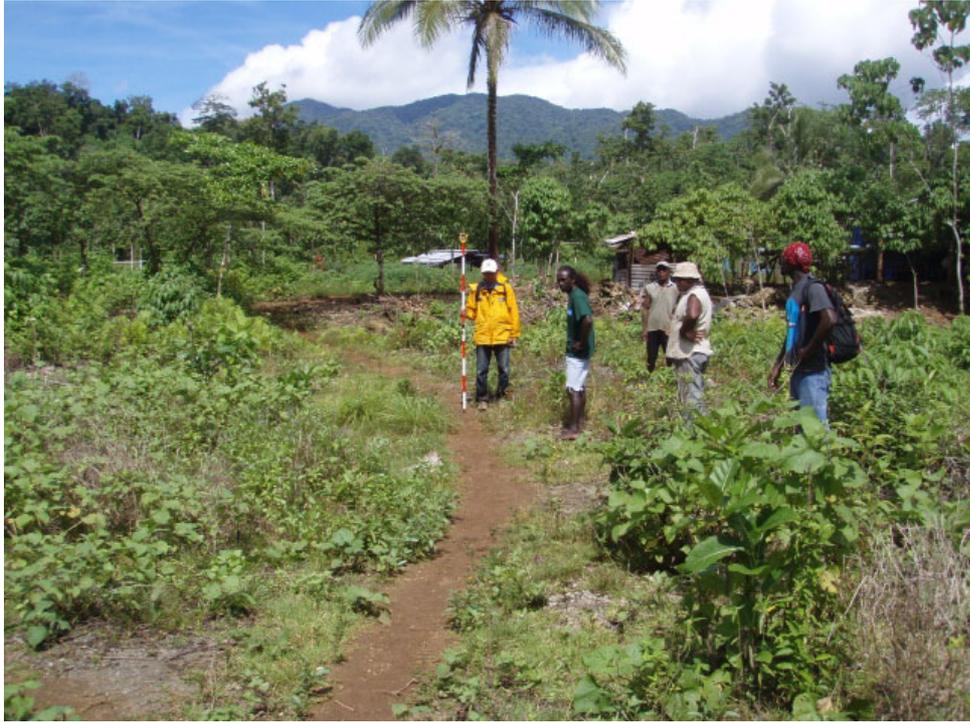
Photo 3.5.5.3.2 Measuring the tsunami inundation boundary in Randuvu, Rendova Island.

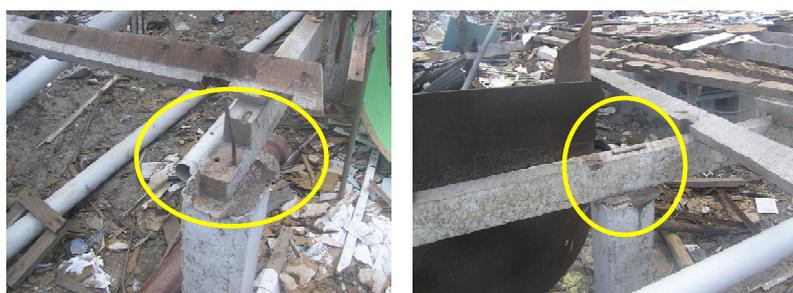
Photo 4.1.1.2 shows examples of the connection of a floor beam to a concrete foundation pile in the area. These concrete foundation piles had a cross section around 20 by 21 cm and were arranged at around 1.8 m intervals. It seemed that the floor had a fairly solid structure.

Photo 4.1.1.2 Examples of the connection of a floor beam to a concrete foundation pile in Medical area

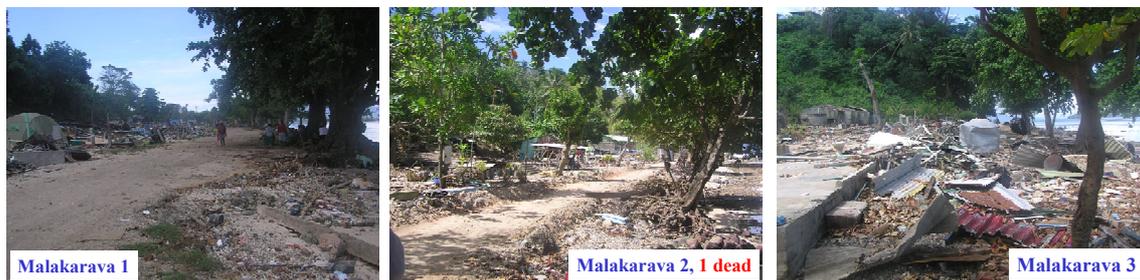
Photo 4.1.1.3 shows the state of damage from the earthquake and tsunami in Malakarava 1, 2 and 3, respectively. In Malakarava 1, almost all houses were destroyed except ones standing on the land side of the road. It seemed that they were protected by solid houses standing on the sea side of the road. Photo 4.1.1.4 shows an example, in which a thatched house indicated by a yellow circle withstood the tsunami.

In Malakarava 2, houses were completely destroyed except two houses. They were prisons located on a mild slope of the hill right behind the village.

In Malakarava 3, houses were completely destroyed except one house standing on slightly higher ground on the land side of the road.

Photo 4.1.1.3 Damage from the earthquake and tsunami in Malakarava 1, 2 and 3

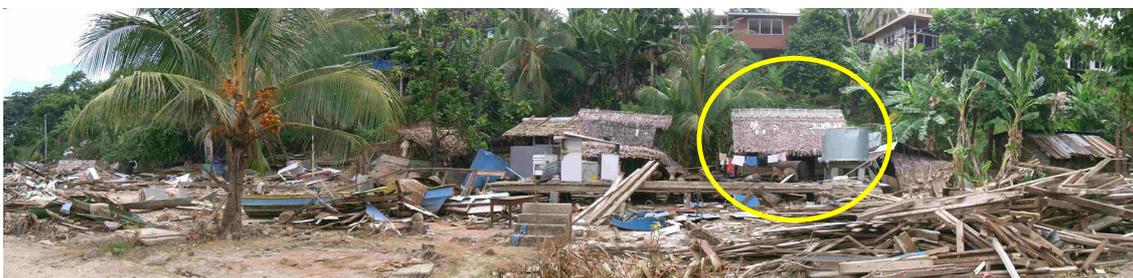
Photo 4.1.1.4 Example of solid houses standing on the sea side of the road protecting a thatched house behind them, indicated by a yellow circle, in Malakarava 1

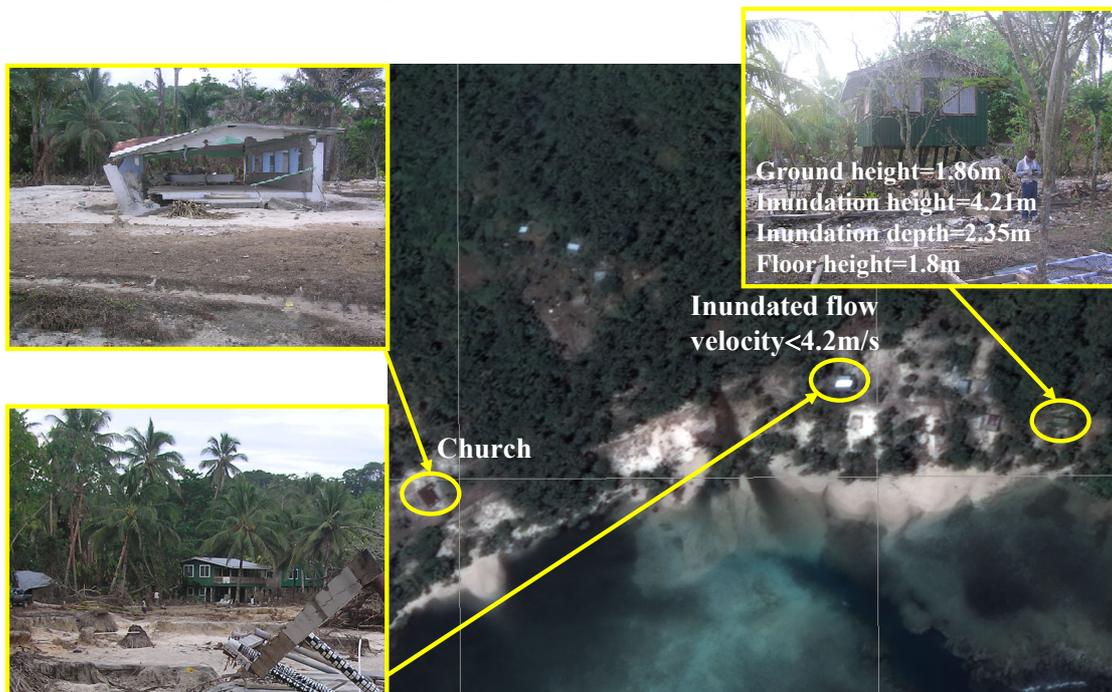
Photo 4.1.1.5 State of the tsunami stricken area in New Manda village (image by Quick Bird)

The ground height along the road was 1.6 ~ 1.9 m above sea level at the time the tsunami attacked. The inundation depth along the road reached 1.3 ~ 2.5 m. The houses on the sea side of the road were completely destroyed except one house with a raised floor, shown in the upper right of Photo 4.1.1.5. The floor height of the house was 1.8 m above the ground and the inundation depth was 2.35 m. Although wooden foundation piles of the house leaned landwards, the house narrowly withstood the tsunami. Raised floor houses seem to withstand tsunamis when the inundation depth above the floor is around 0.55 m or less. In contrast, a house adjacent to the house on the east, which had a concrete floor and stood at the ground height of 2.5 m, was completely destroyed, leaving only its concrete floor.

The concrete house shown in the upper left of the photo is a church and seemed to be destroyed due to both the earthquake and tsunami. The ground erosion around the church due to the tsunami seems to be related to the degree of damage.

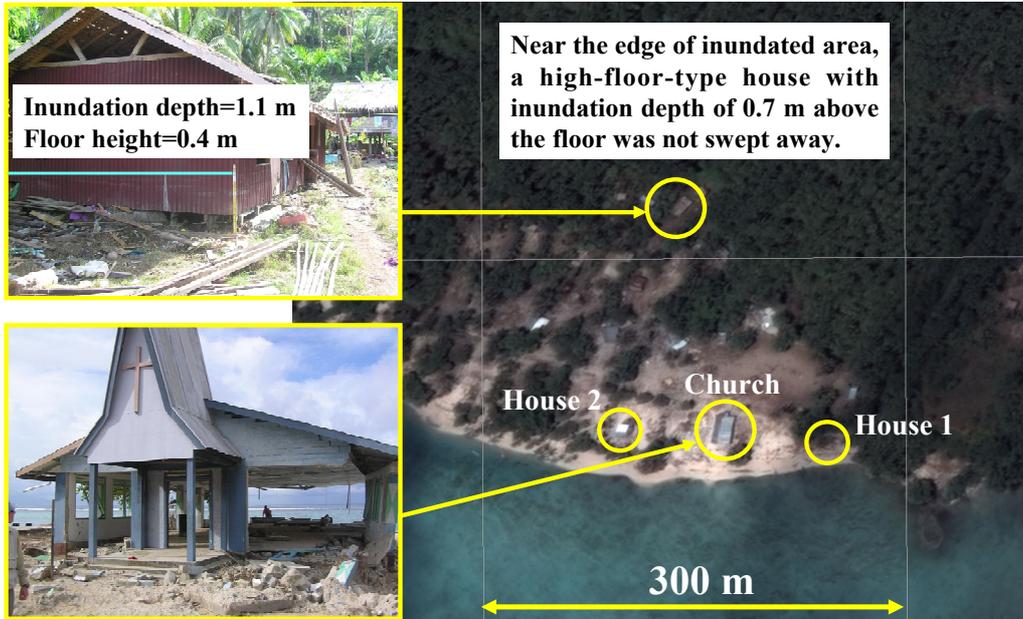
Examples of the damage to the houses are shown in Photo 4.1.1.6. The concrete house shown in the lower left of the photo is a church and seemed to be destroyed by both the earthquake and tsunami. The ground erosion around the church caused by the tsunami seems to be strongly related to the degree of damage.

Photo 4.1.1.6 State of the stricken area in Titiana village after the earthquake and tsunami (image by Quick Bird)

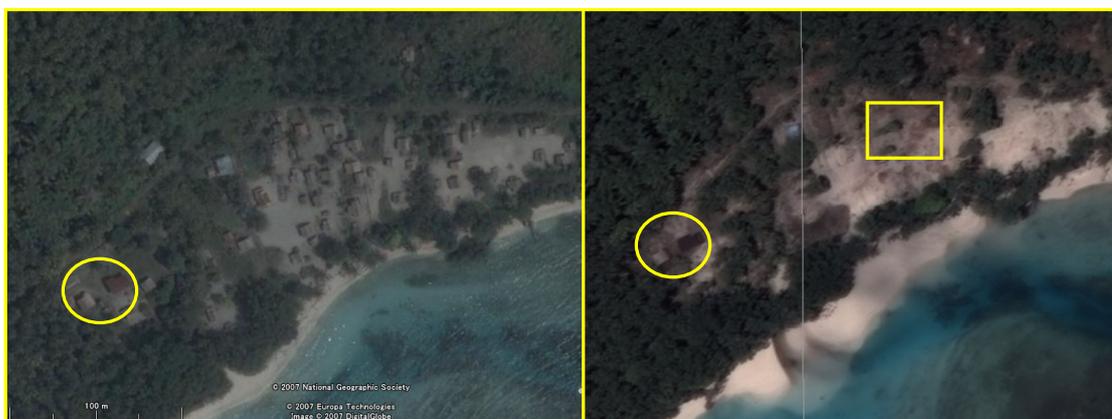
Suve village is protected by a thin coral reef as shown in Fig. 4.1.1.4. Although no one was killed by the earthquake and tsunami in the village, the degree of damage to the houses was severe. Figure 4.1.1.5 shows a comparison between arrangements of the houses in the village before and after the tsunami. The ground heights at places indicated by a yellow circle and square in the right of the figure were 2.4 m and 1.6 m above the sea level at the time of tsunami attack, respectively.

Fig. 4.1.1.5 Arrangements of the houses in Suve village before and after the tsunami (left: before, right: after) (images by Google Earth and Quick Bird)

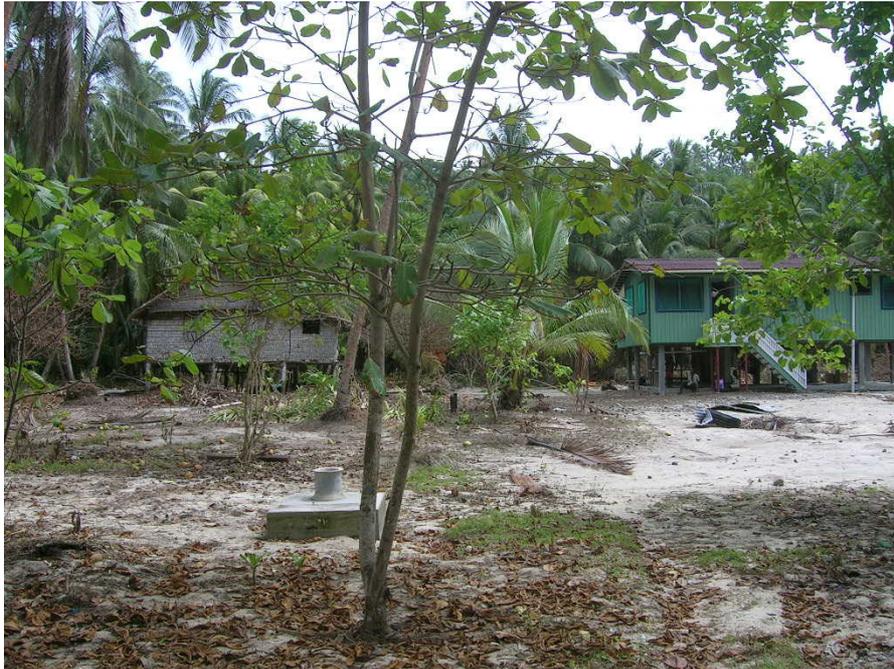
Photo 4.1.1.8 Surviving residential houses at the circled place in Fig. 4.1.1.5

Two houses at the circled place withstood the fluid force of the tsunami, and are shown in Photo 4.1.1.8. One is a thatched house with the floor height of 1.4 m from the ground. Its wooden foundation piles had a cross section around 17 by 18 cm. The inundation depth at the house was around 1.7 m from the ground. The other is a green-colored wooden house with the floor height of 1.9 m and the inundation depth at the house was nearly 1.9 m.

The inundation depth at the place indicated by the square was unknown, because all houses which would have the floor heights of around 1.5 m were washed away, leaving only wooden foundation piles leaned landwards.

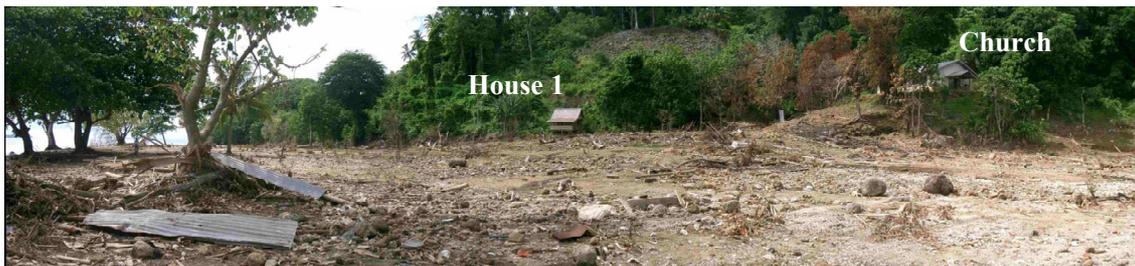
Photo 4.1.2.1 Tapurai village where all houses were swept away except one church on a small hill and two residential houses (House 1 and 2)

One building that survived (and avoided) the tsunami was a church on a small hill, as shown in Photo 4.1.2.1. Others were residential houses, as shown in Photos 4.1.2.1 and 4.1.2.2. House 1 stood near the edge of the tsunami inundation area and its wooden foundation piles leaned a little seaward very likely because of the return flow of the tsunami. The ground height at House 1 was around 4.7 m above the sea level at the time of tsunami attack. House 2 stood on a steep slope of another hill, where the tsunami did not reach.

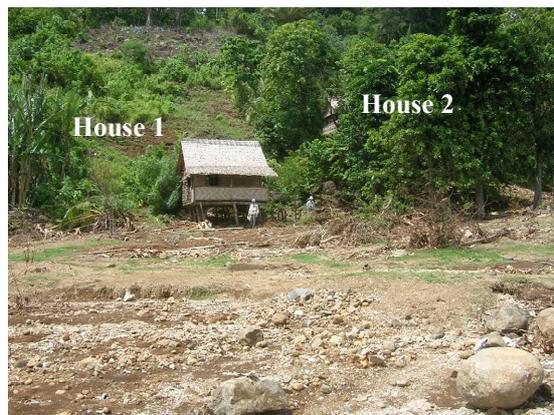
Photo 4.1.2.2 Surviving residential houses in Tapurai village (House 1 stood near the edge of tsunami inundation area and House 2 on a steep slope of hill)

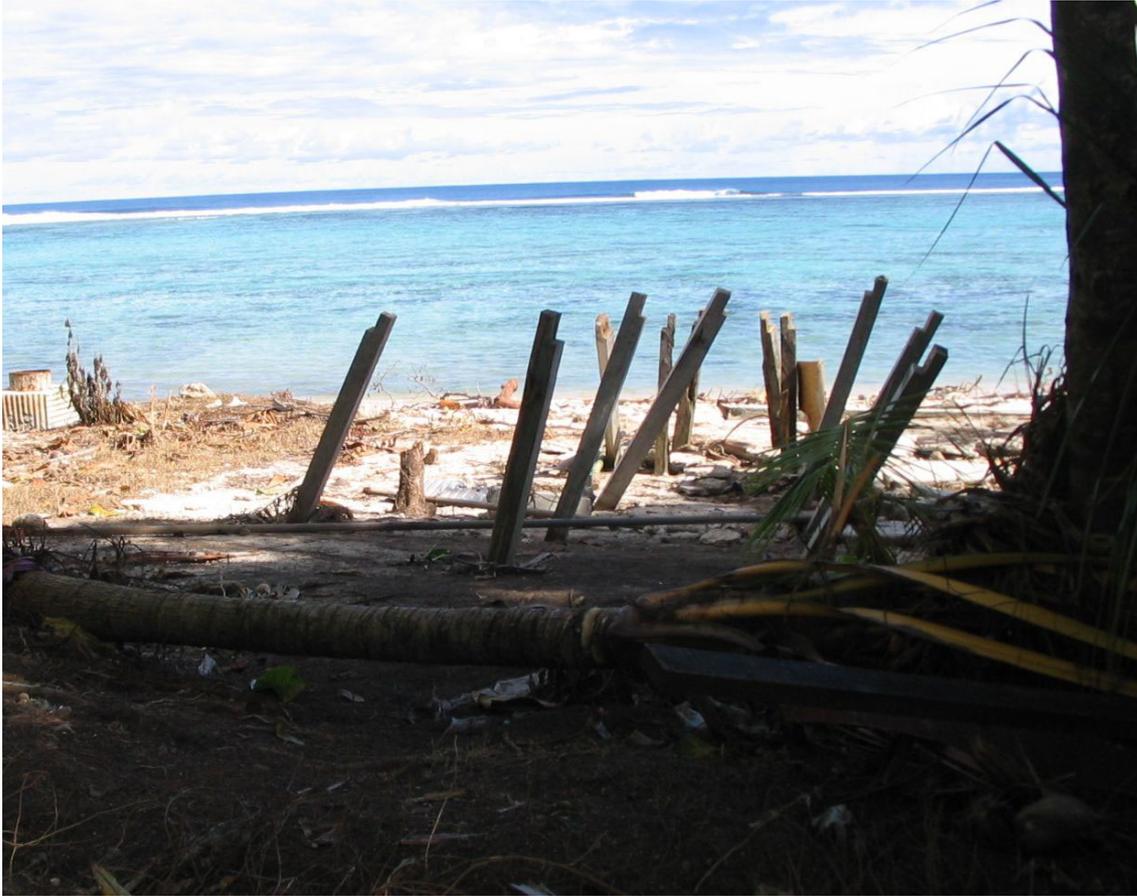
Flow directions of the tsunami wave in Titiana and Suva, on the southern coast of Ghizo Island (Fig. 5.1.1), were estimated from 42 indicators such as damaged trees, grasses, and buildings (Photo 5.1.1). 81% of them fell down indicating landward-directed flow, whereas grasses and shrubs indicated seaward-directed flow. The former seems to be affected by up-flow, and the latter by return-flow.

Photo 5.1.1 In many places, the tsunami waves destroyed and moved wooden houses. Remaining timber or concrete piles indicate the flow direction of the tsunami (Titiana).

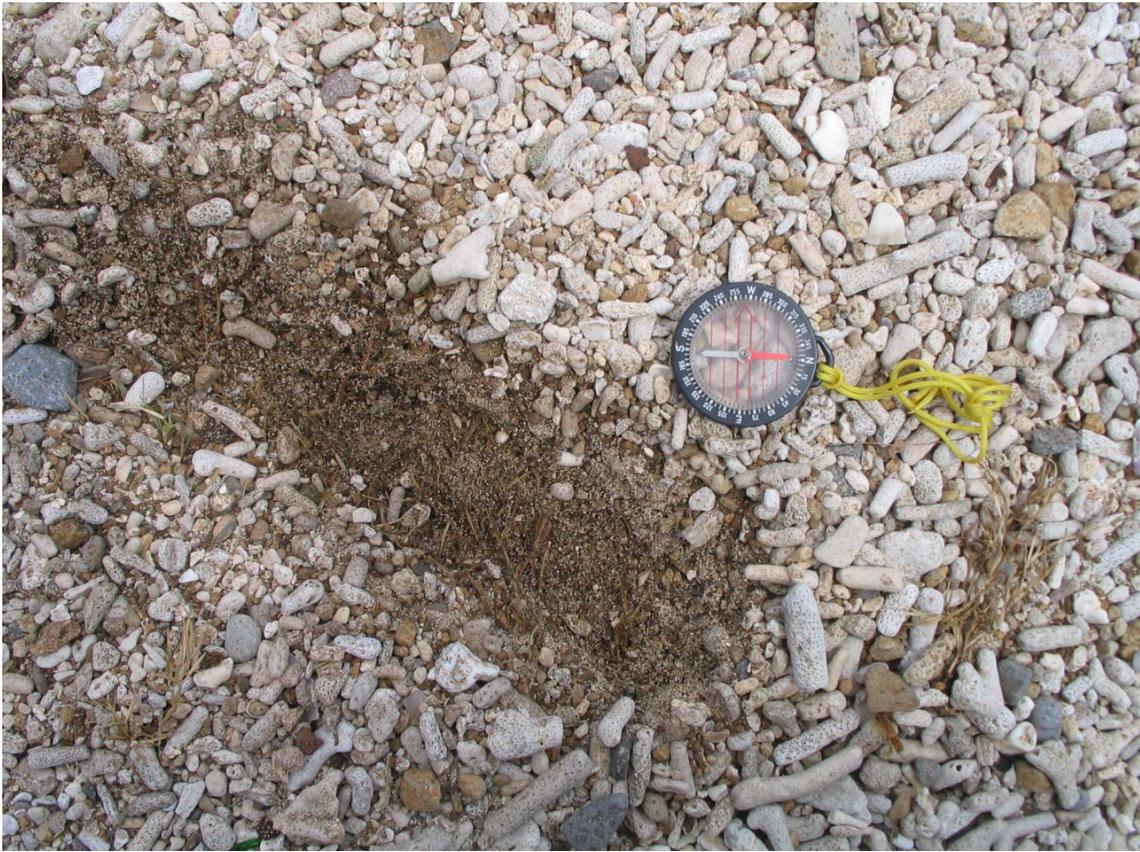
The tsunami layers had a maximum thickness of 10 cm in Tapurai, northern Simbo Island. The upper half of the layer contained a large amount of coral fragments (Photo 5.1.2) as well as sand grains, whereas the lower half contained only sand grains. The tsunami layer directly covered humic soil layers and small rooted grass.

Photo 5.1.2 Coral fragments aligned nearly parallel with the return-flow direction toward northwest, whereas buried grass stems show the up-flow direction toward west (Tapurai, Simbo).

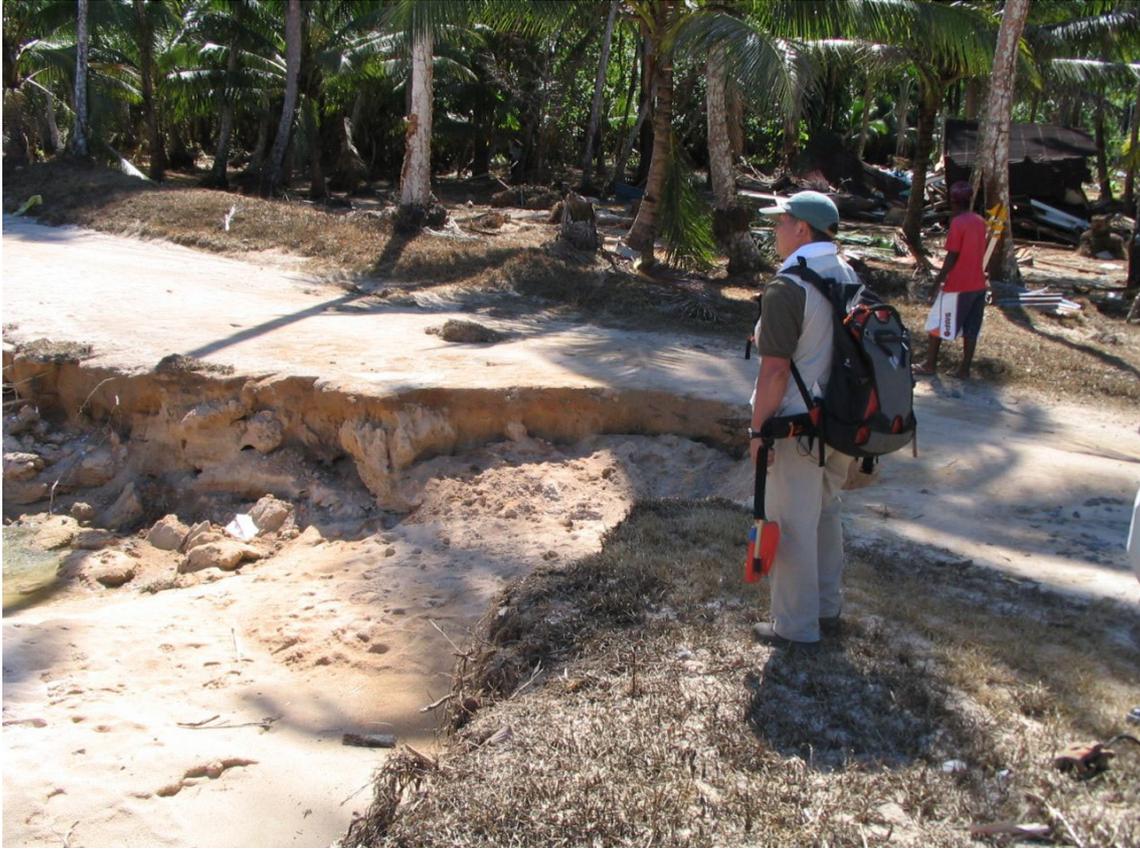
Photo 5.2.2 Tsunami eroded scarp in New Manra, east of Titiana.

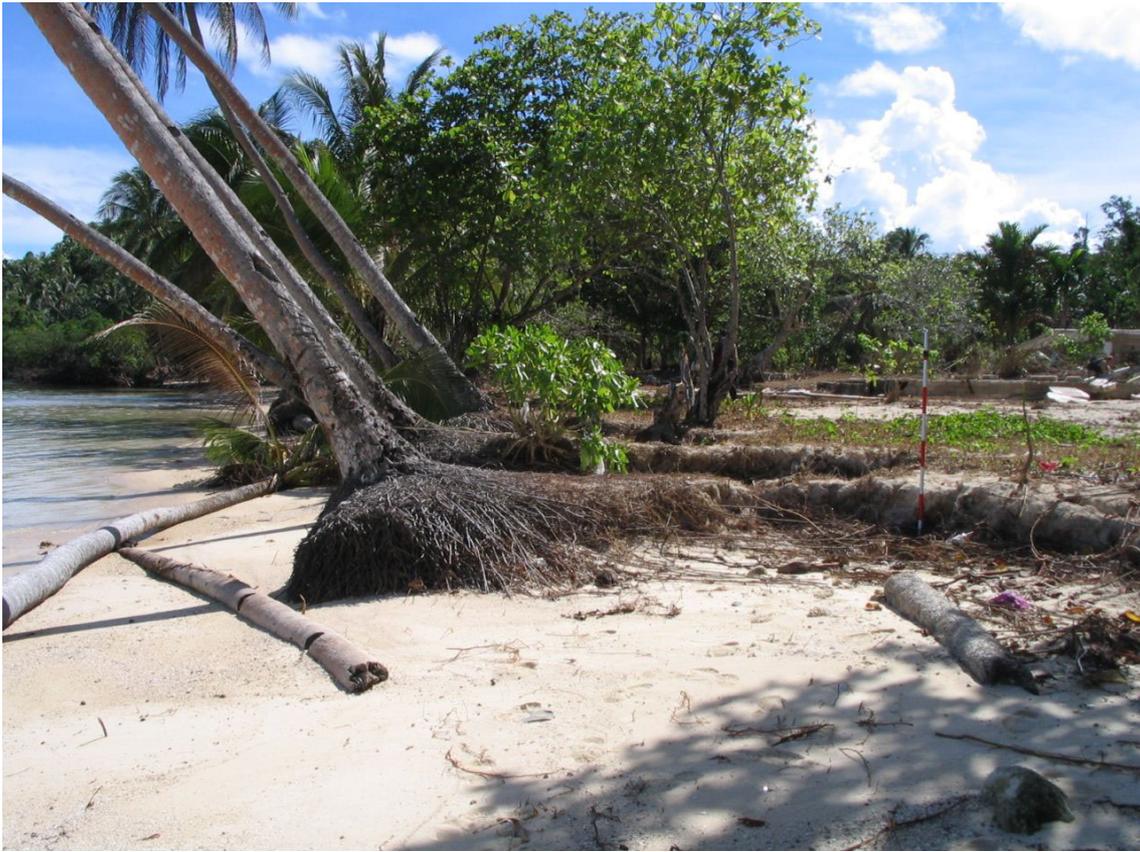
Photo 5.2.3 Palm trees leaning to the sea, affected by the soil erosion (New Manra, east of Titiana).

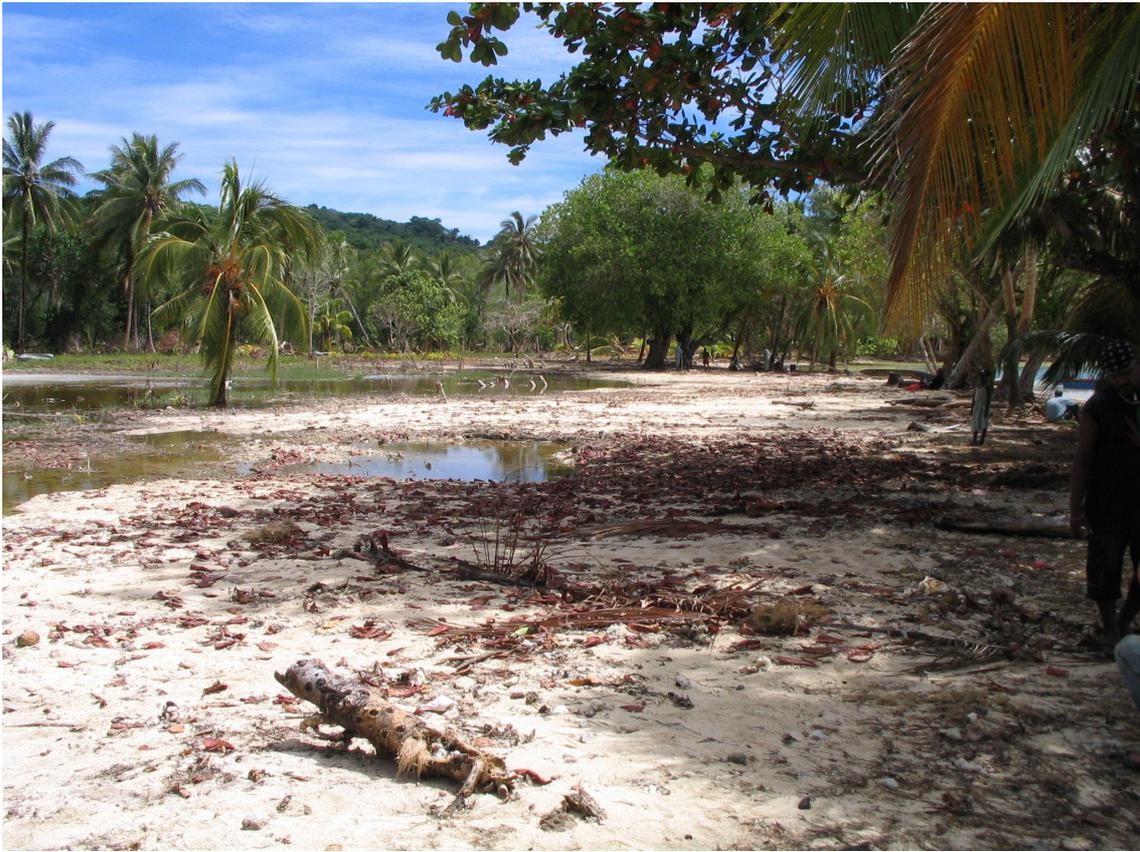
Photo 5.2.7 Wetland formed after the tsunami (Riguru, Simbo). A ruined building shows that the area was inhabited before the tsunami devastation.

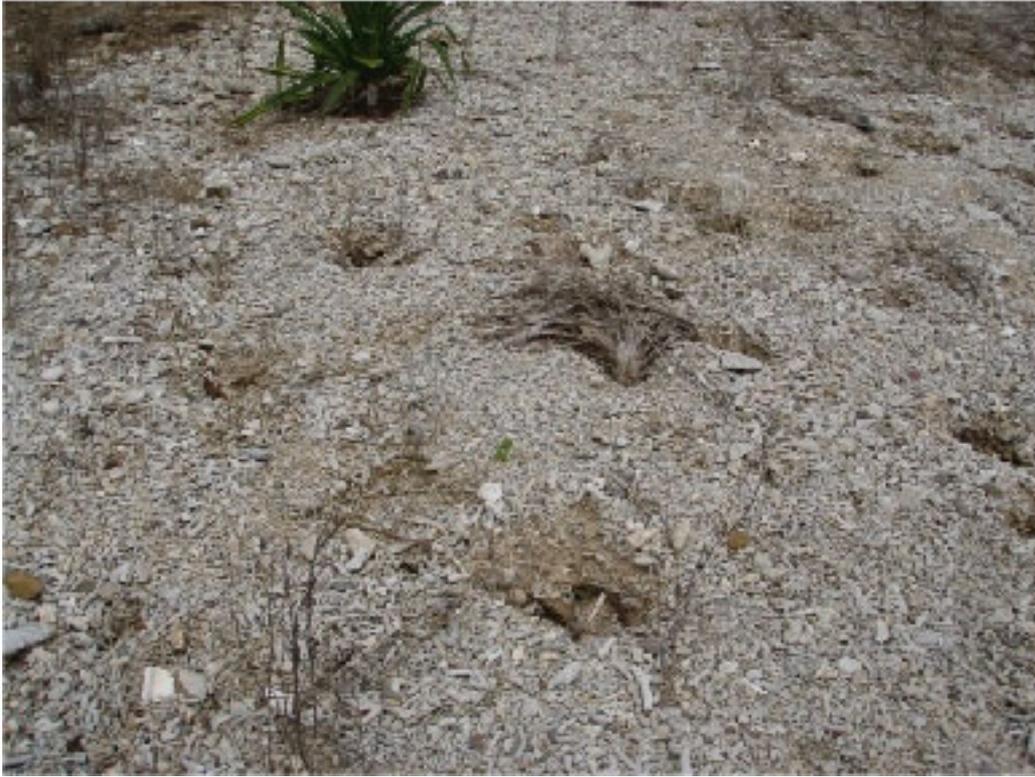
Photo 5.3.3 Tsunami deposit in Tapurai, Simbo Island in April 2007. The deposits are significantly reworked by crabs.
