# Joint Report for Tsunami Field Survey for the Solomon Islands Earthquake of April 1, 2007

## PARI Tsunami Survey Team

May 2008

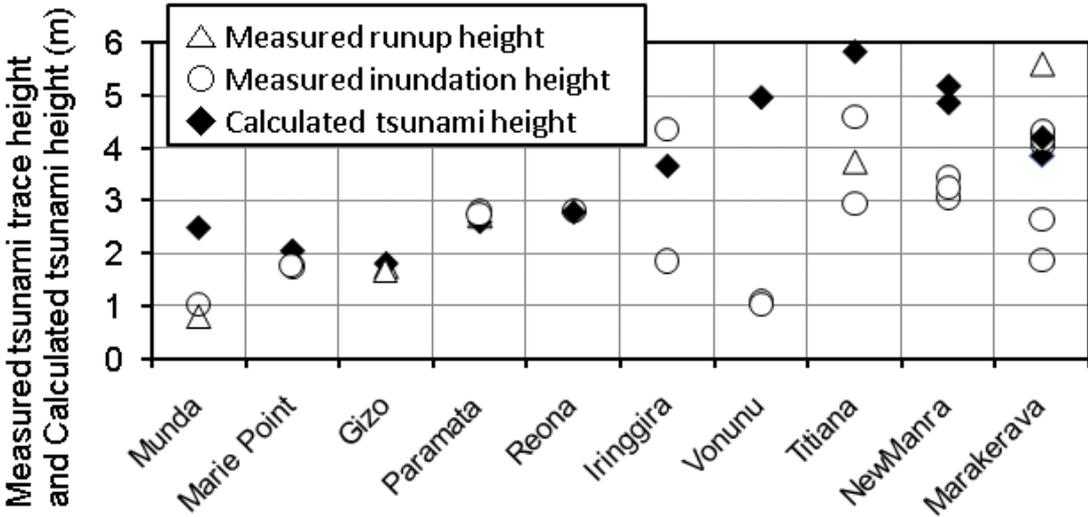
Island and Vonunu in Vella Lavella Island, and from Titiana to New Manra in Ghizo Island are bigger than the measured trace heights. This is probably because the computational grid of 600 m is applied in Munda and Vonunu, and offshore reefs in these areas are not sufficiently resolved in the computational area. If offshore reefs are considered in the computation so as to create real bathymetry and configuration, they can reduce the tsunami in comparison with the results in Fig. 6.2.5. The configuration of the widely developed reefs from Titiana to New Manra in Ghizo Island and the water depth on them is also insufficiently resolved in the computation.

On the other hand, the calculated tsunami heights along other coasts are almost same as the measured heights. Especially good agreement between the two occurs in Marie Point and Gizo Town along the north coast in the east part of Ghizo Island, and Paramata and Reona along the west coast of Vella Lavella Island, where reefs have not developed widely.

Figure 6.2.5 Computed tsunami heights (◆) and measured tsunami trace heights (runup: △, inundation: ○)

Therefore, more detailed bathymetry and topography data is needed for accurate numerical simulations of the tsunami.

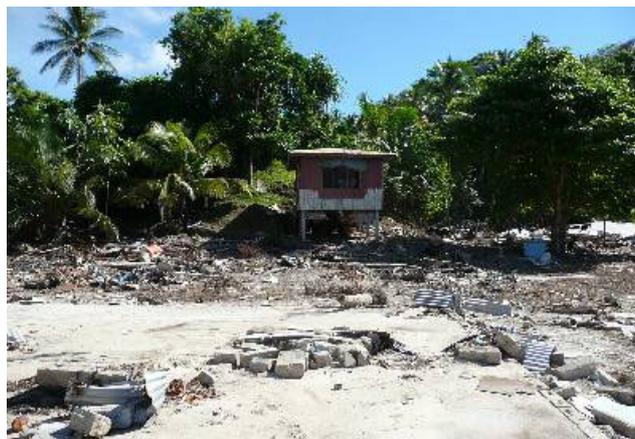
The experience of the 2007 event showed that some high-floored houses with stilts, as shown in Photo 7.2.2.1, remained after the tsunami if the tsunami inundation depth was lower than their floor level. This means that the high-floored house were available for an emergency tsunami shelter. On the other hand, the tsunami washed out some high-floored houses whose wall parts underwent tsunami wave pressure. Comparison between two examples on high-floored houses indicates that a high-floored house built on a place as high as possible is safer against future tsunamis. Houses on high ground suffered less damage from the tsunami, of course. Photo 7.2.2.2 shows a church on a hill side in Tapurai where almost all houses were completely destroyed by the tsunami. From these instances, it is recommended that floor-level of house should be designed in consideration of the ground height so as to be higher than the expected maximum inundation depth due to possible tsunamis. The high-floored house on higher ground is safer against tsunamis.

Photo 7.2.2.1 High-floored house remaining after the tsunami, Titiana, Ghizo Island

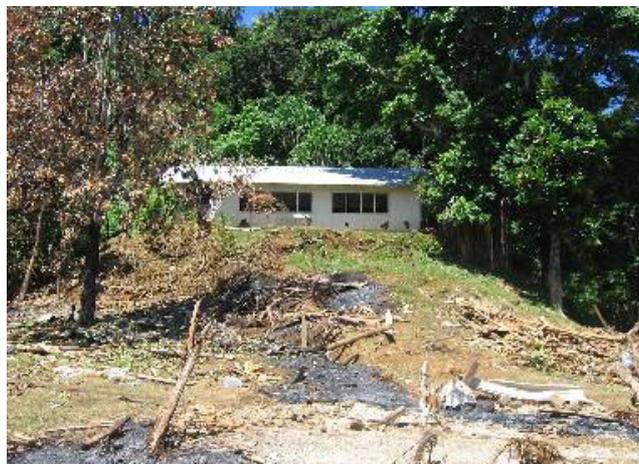
Photo 7.2.2.2 Remaining architectural structure (Church) on a hill side, Tapurai, Simbo Island
