3. SURVEY RESULTS ON TSUNAMI DAMAGE AND TRACE HEIGHT

3.1 Male'

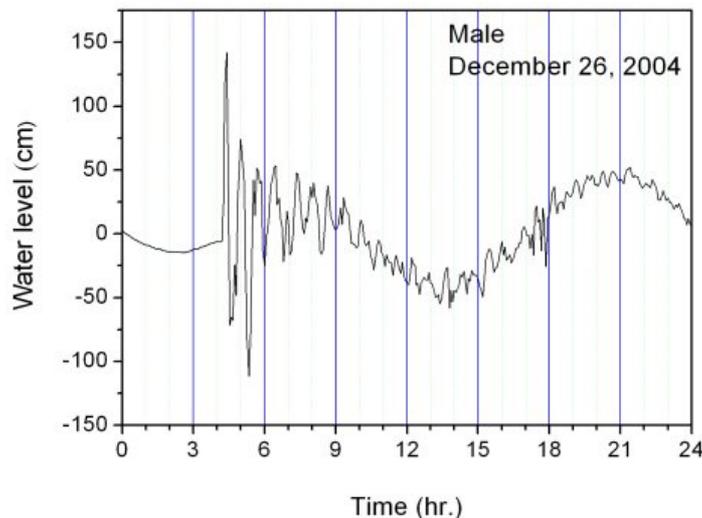
Figure 3.1.1 Tide record at Male' (time in UTC, tide level in centimeter from M.S.L., measured and provided by Sea Level Center, University of Hawaii)

Figure 3.1.1 shows the tide record at Male', where the sea surface elevation from the mean sea level (M.S.L.) is drawn in centimeter. This figure suggests that the sea level at the tsunami arrival was almost the same as the M.S.L., -5~6cm, and the maximum tsunami height was approximately 1.45m. Note that the tide gage is installed in the atoll side, thus this tsunami height is that in the north side of Male'.

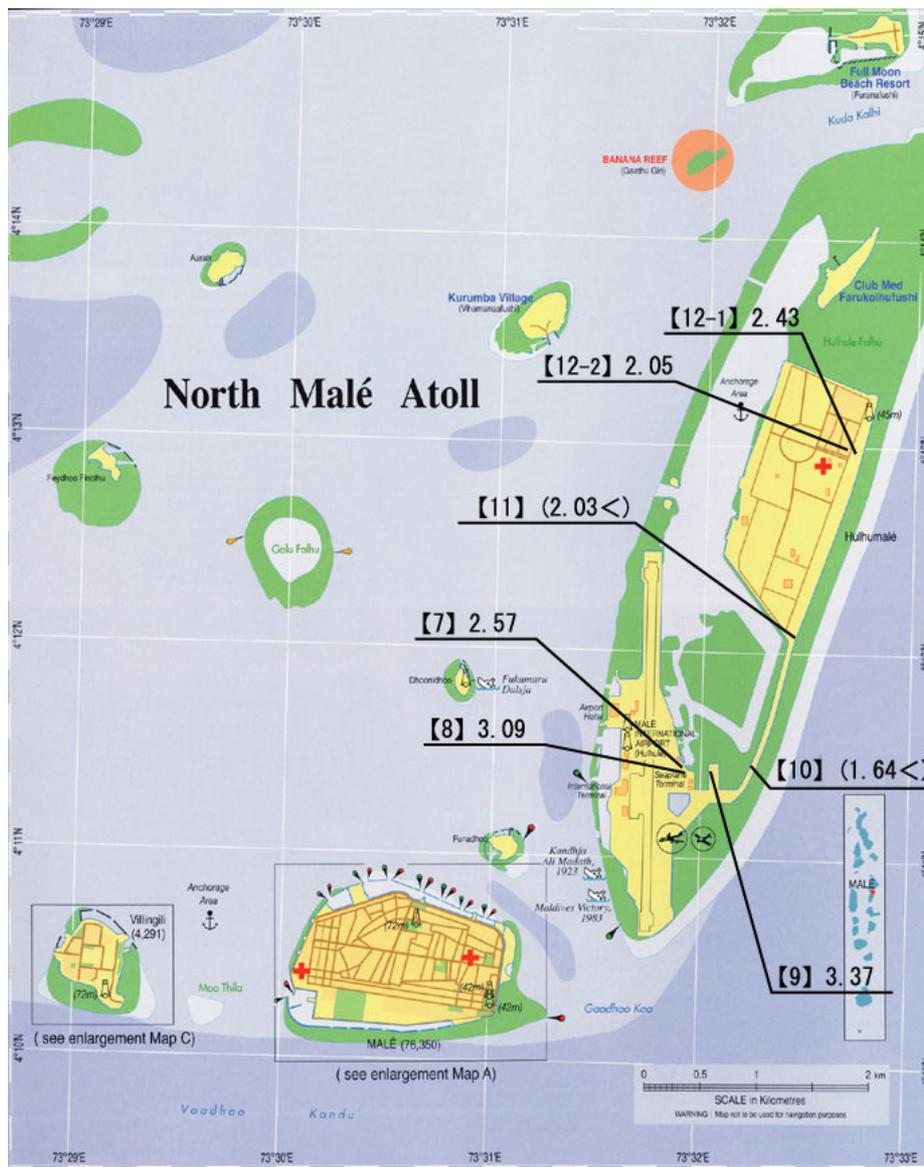
Figure 3.2.2 Tsunami trace heights

A summary of the measured tsunami trace heights is shown in Figure 3.2.2. The height of the tsunami attacking the airport was more than 2m approximately. At Points 7, 8 and 9 in the bottom of the inner sea area between the causeway and the airport, there were high records. According to tsunami observers at Points 8 and 9, three tsunamis attacked and the first tsunami came from the east direction around 9:20 in local time. The second tsunami came a few minutes later after the first tsunami came and it was the biggest among all of the tsunami waves. Since the high tsunami trace heights were found around the bottom of the inner sea area, it seems that the second tsunami came through the inner sea from the north direction and it lost the places to go there. However, if the second tsunami passed in the north of Hulhumale' and changed the propagation direction into the inner sea area by the west reef edge, the time interval between the first tsunami and second tsunami is about 12 minutes, in which the inner sea area is assumed to be 5km long and 5m deep. If the second tsunami came from the west of the Airport Island, the propagation time is almost the same. These time intervals are different from the hearing results. Therefore, the tsunami in the bottom of the inner sea area was probably affected by local topography change and existence of structures. To clarify the characteristics of the high tsunami, we need a more detailed numerical simulation on the tsunami.

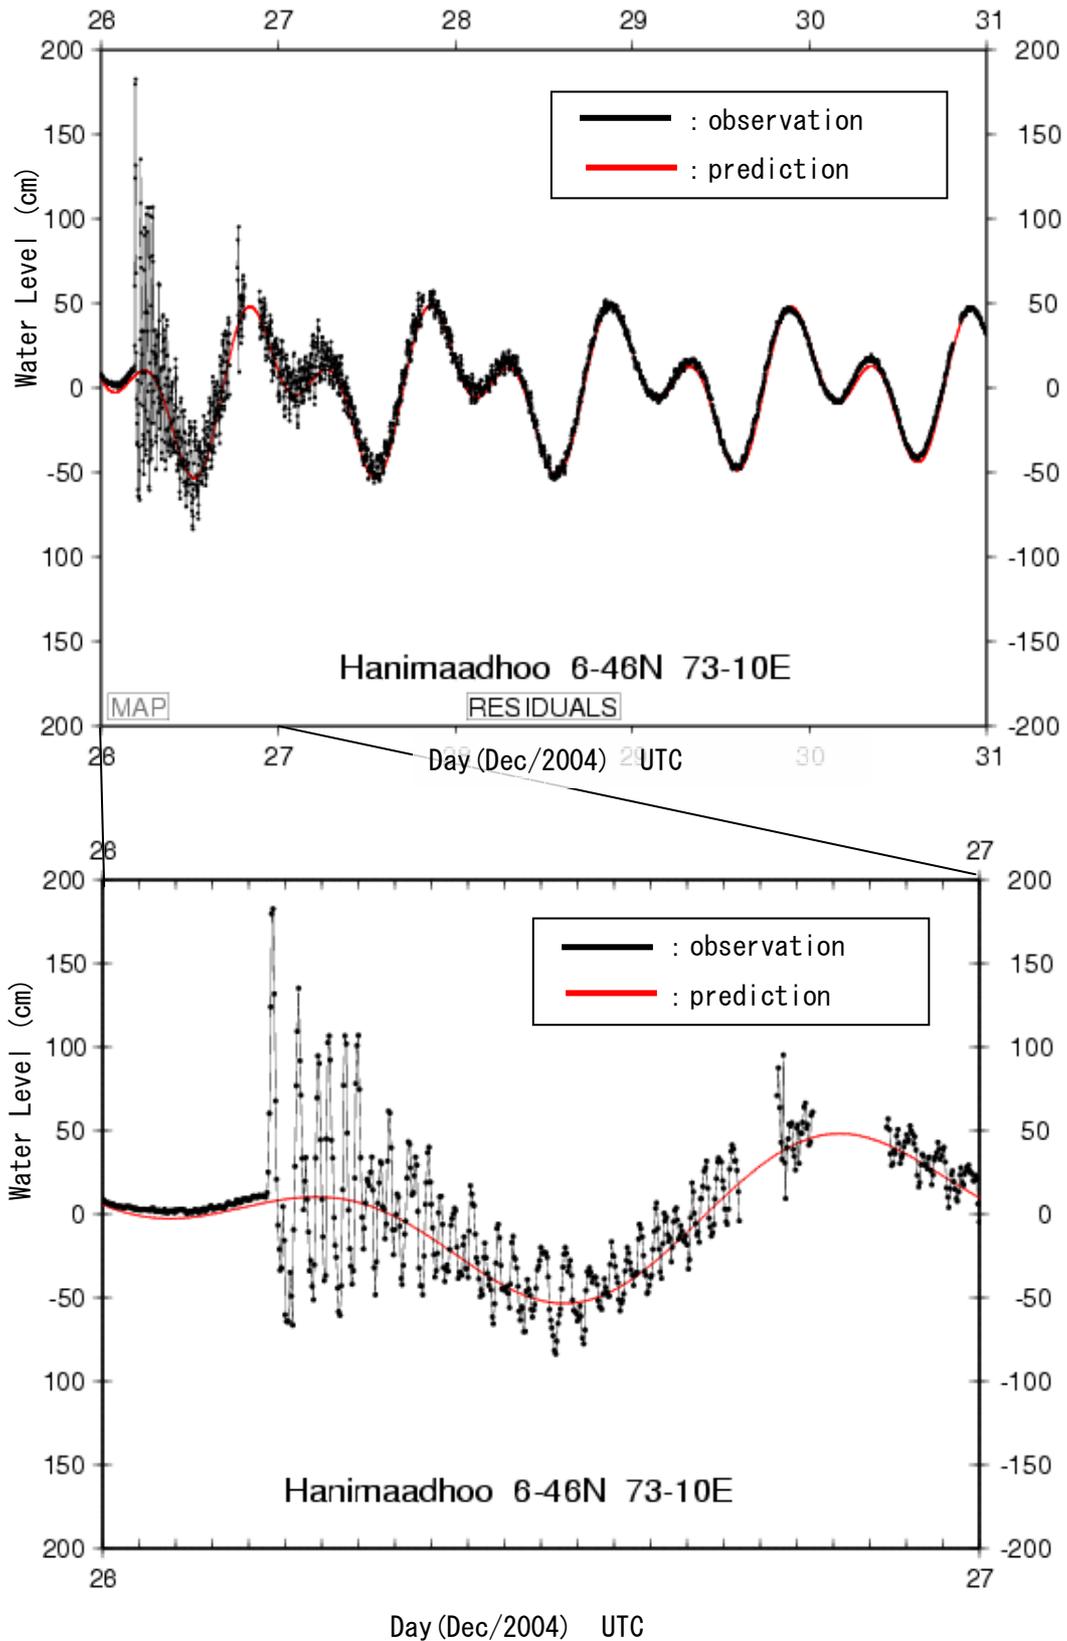
Reference : <http://ilikai.soest.hawaii.edu/uhscl/iotd/> modified by H. FUJII
 Figure 3.3.2 Tide record at Hanimaadhoo(time in UTC, tide level in centimeter from M.S.L., measured and provided by Sea Level Center University of Hawaii)

In Is. Hanimaadhoo of Haa Dhaalu Atoll (see Figure 3.3.1), height of the tsunami should have reached 1.7 m above the sea level, approximately. In this island, UHSLC has been collecting the data of sea level changes, and the record shows the abnormal fluctuations (Figure 3.3.2).

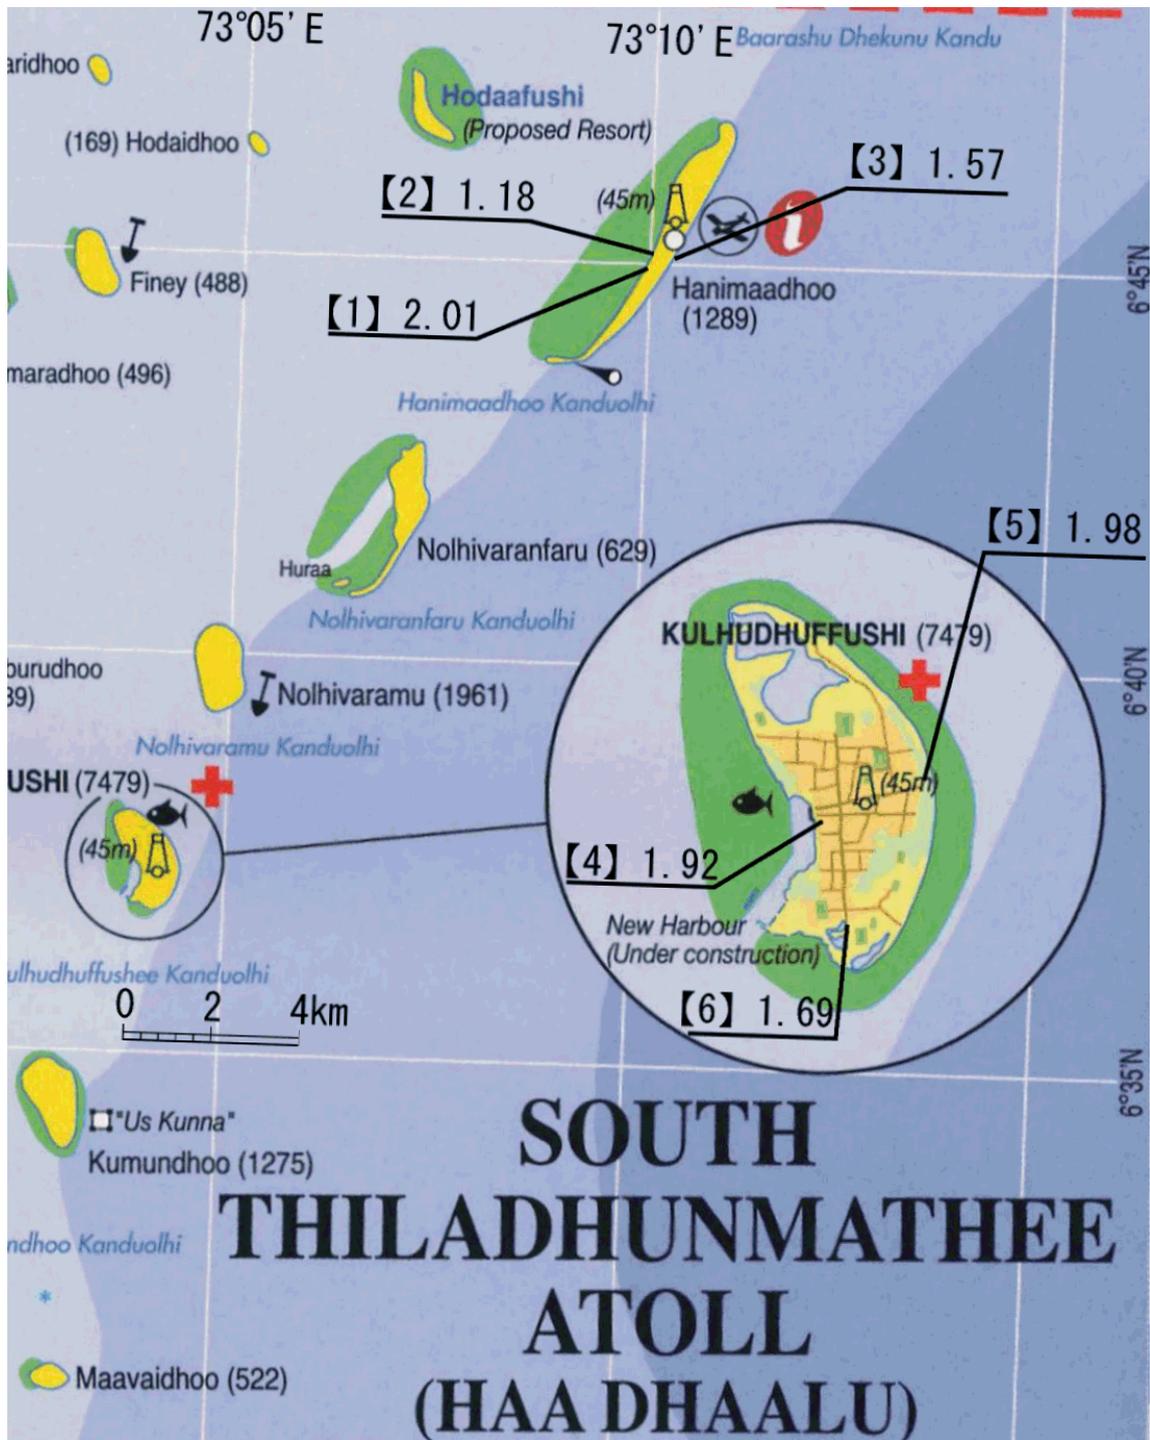
Figure 3.3.3 Surveyed Sites and the Tsunami Trace Height in Is. Hanimaadhoo and Is. Kulhudhuffushi (unit: m; Based map is from Atlas of the Maldives, 2004, ©Atoll Editions.)

Since no clear marks of tsunami were found, hearings were conducted on the residents, and the heights of tsunami trace were measured. Figure 3.3.3 shows the location of measurement and the results. Photo 3.3.2 shows the sites.

In Is. Kulhudhuffushi, three clear tsunami marks were found and the heights were measured. One site, which a residence's witnessed, was also measured. Figure 3.3.3 shows points of measurement and tsunami trace height. The measured sites were photographed as shown in Photo 3.3.4.

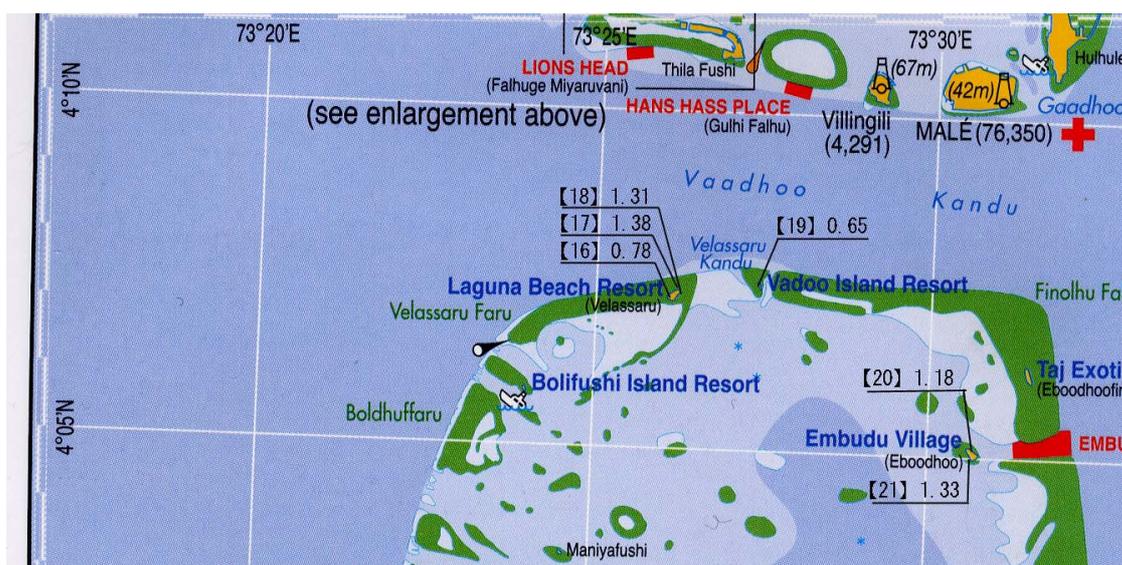
Figure 3.4.1 Tsunami trace heights in South Male' Atoll

The tsunami trace heights along the channel shown in Figure 3.4.1 were 0.65 to 1.38m. Laguna Beach Resort (photo 3.4.1) and Vadoo Island Resort (photo 3.4.2) were safe and no facilities in the islands were damaged. The maximum height 1.38m is almost same as the tidal gage record at Hulhule Island (International Airport). These results suggest that the tsunami energy progressed along the channel did not reduce well, and the right-angled energy against progressing was also almost same along there.

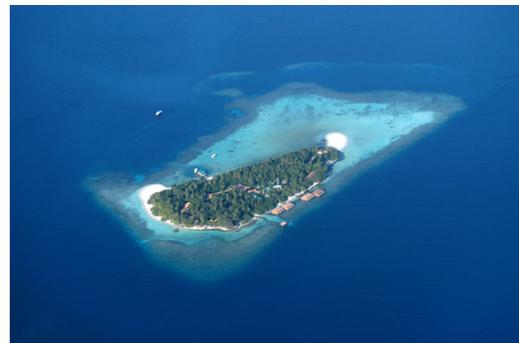
Photo 3.4.3 Embudu Village

The height of water level at the inside of the atoll in Embudu Village (photo 3.4.3) was 1.33m, which was higher than that at the outside, 1.18m. This difference implies that the tsunami energy was held in the atoll. This island resort was also safe and was not damaged.

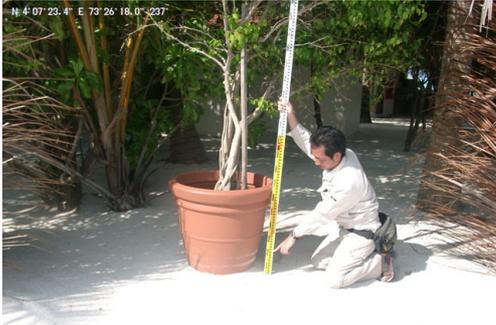
Photo 3.4.4

Trace at Laguna Beach Resort

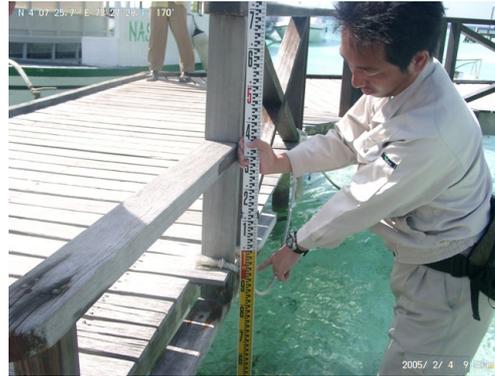
Photo 3.4.5

No.19: Scuba diving instructors had measured this height at a step of pier (photo 3.4.5). They recognized the tsunami already had come to the Maldives before the water level raised because they found quite fast currents had occurred in a channel between Vaadhoo Channel and inside of this atoll.

Trace at Vadoo Island Resort

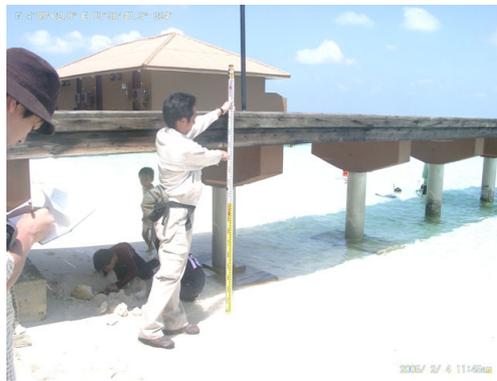
Photo 3.4.6

No.20: One resort-beach staff in Embudu Village looked the tsunami and took the picture by his mobile phone near the pier which connects to cottages on the water (photo 3.4.6). The tsunami water level was a little lower than this island ground level. Some part of wind wave on the tsunami only ran and moistened the ground.

Trace at Embudu Village

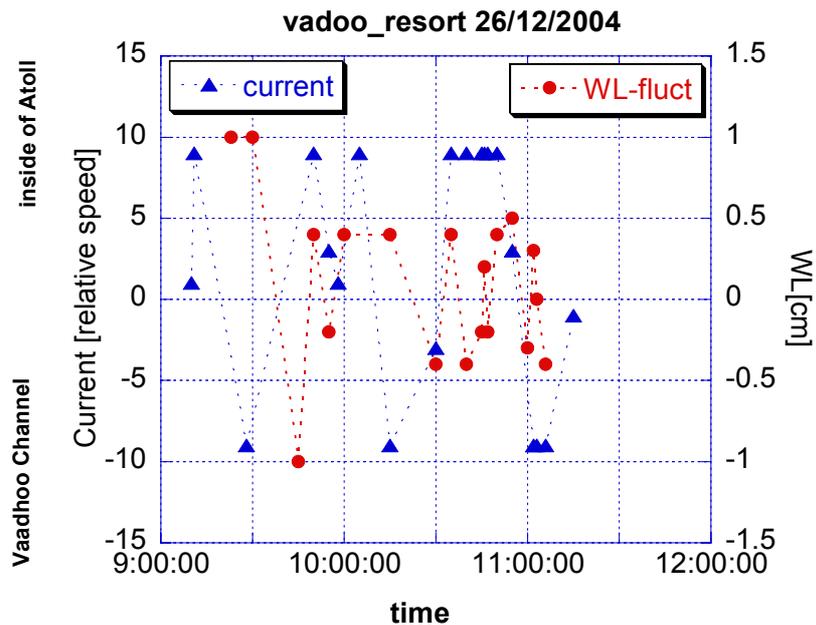
Figure 3.4.3 Tsunami records at Vadoo Islands Resort

At 9:11 AM on 26th December, Japanese scuba diving instructors of Vadoo Islands Resort received the initial impact of tsunami in a small channel along this island. They noted down the currents and water level fluctuation to a sheet, which is shown in Figure 3.4.2 and Figure 3.4.3.

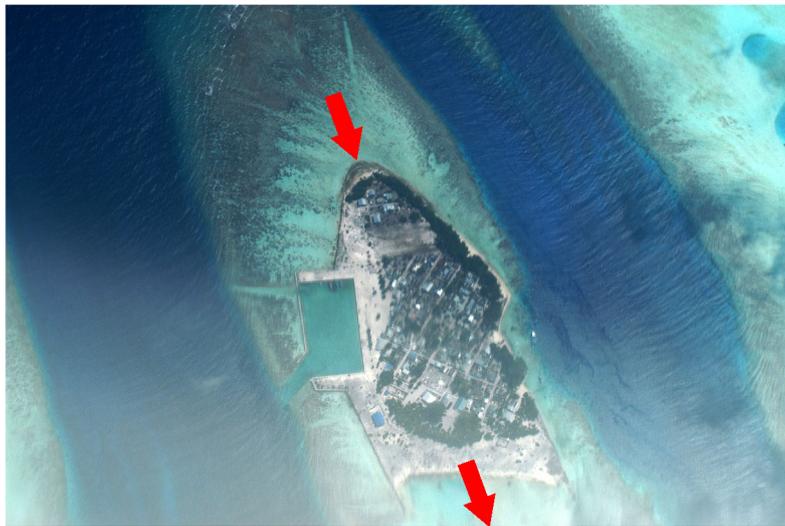
Keyodhoo is located in the center of east side of the Vaavu atoll, Nobody died in the island. According to hearing on the residents, the tsunami came two times. The leading wave went through from east to west (see Photo 3.5.1), and the second intruded the both sides of the coast at the same. Moreover, the ground water in the well changed salty after the tsunami attack. The tsunami trace heights measured in this island are indicated in Figure 3.5.1. Photo 3.5.2 describes trace of tsunami in house. Everywhere were inundated about 1m above the ground in the island.

Photo 3.5.1 Direction of tsunami in Keyodhoo

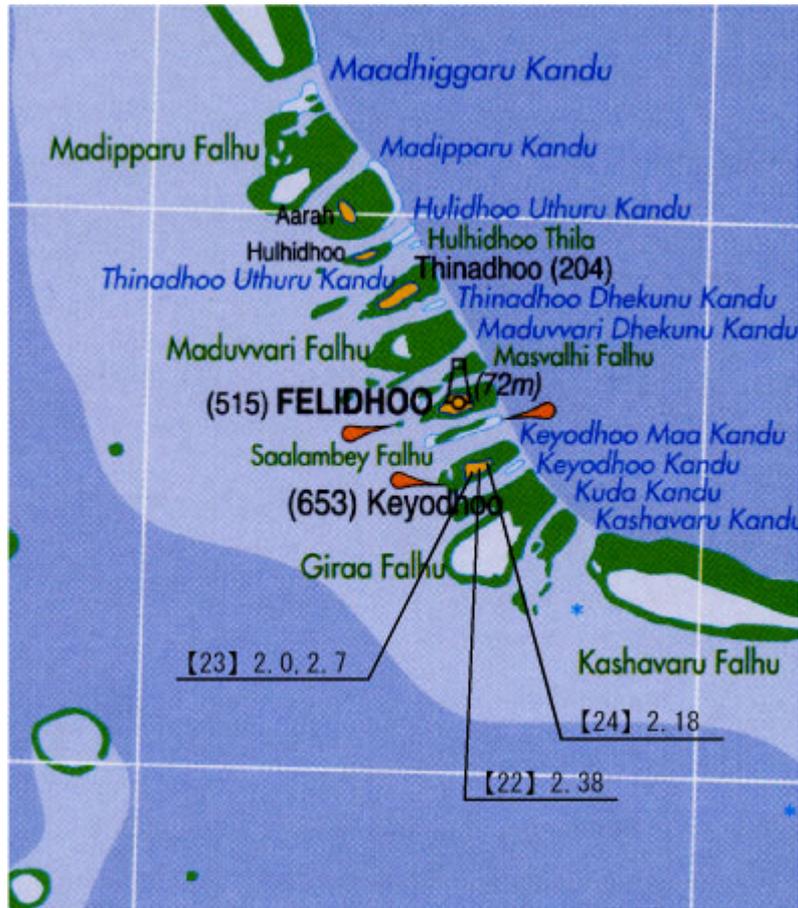
Figure 3.5.1 Measured tsunami trace heights (inundation and run up) in Keyodhoo (Vaavu Atoll)

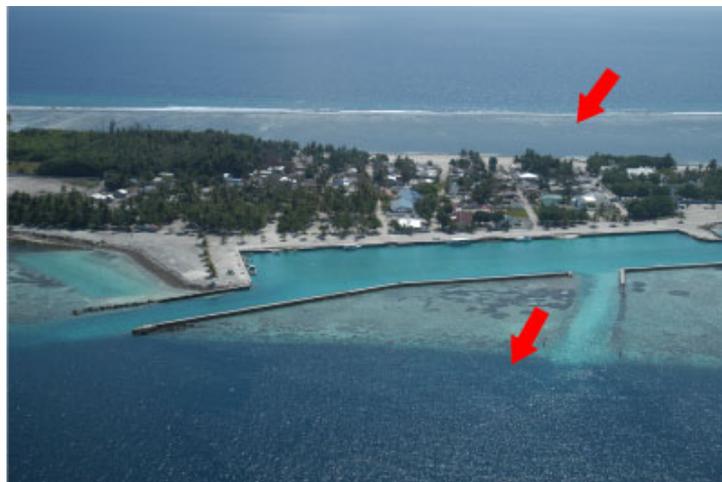
Muli is located in the south east of the Meemu atoll, 5 people died and 1 person is still missing. According to eyewitnesses, the tsunami went through from east to west, and the leading wave was the highest. That can be explained from the measured inundation height as shown in Figure 3.6.1. The tsunami trace heights were recorded approximately 3m in the east side and 2m in the west. Photo 3.6.2 shows coastal erosion by the tsunami in west side. It is understand that step of several dozen centimeter is formed.

Photo 3.6.1 Direction of tsunami in Muli

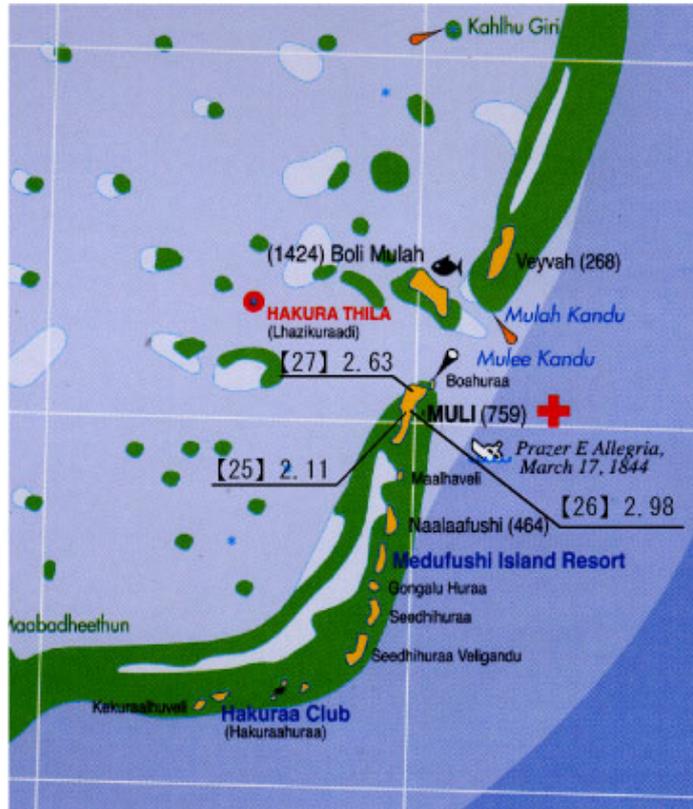
Figure 3.6.1 Measured tsunami trace heights (inundation and run up) in Muli (Meemu Atoll)

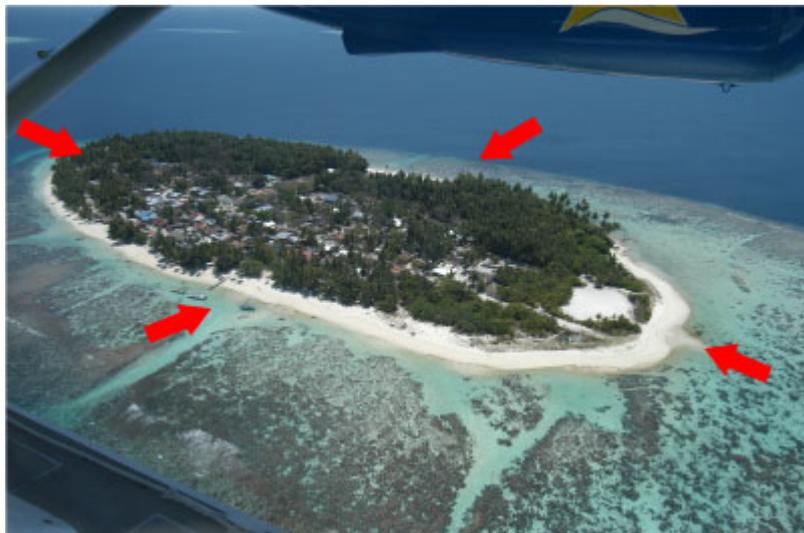
Ribudhoo is in the north-east inside the Dhaalu atoll, there are no deaths in the island. The wave came two times and intruded the east and west sides at the same in Photo 3.7.1. After that, all over in the island is inundated and the water level repeated up and down during the tsunami coming. Photo 3.7.2 indicates the tsunami was raised to the line of the breast. In Figure 3.7.1, it is found that the tsunami trace heights cross over 3m even if the island is located inside atoll.

Photo 3.7.1 Direction of tsunami in Ribudhoo

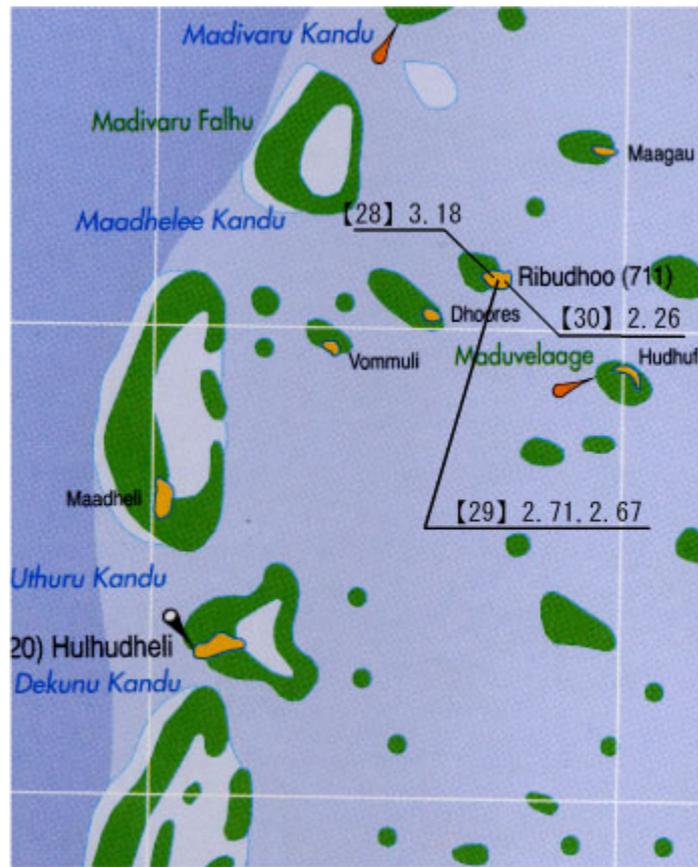
Figure 3.7.1 Measured tsunami trace heights (inundation and run up) in Ribudhoo (Dhaalu Atoll)

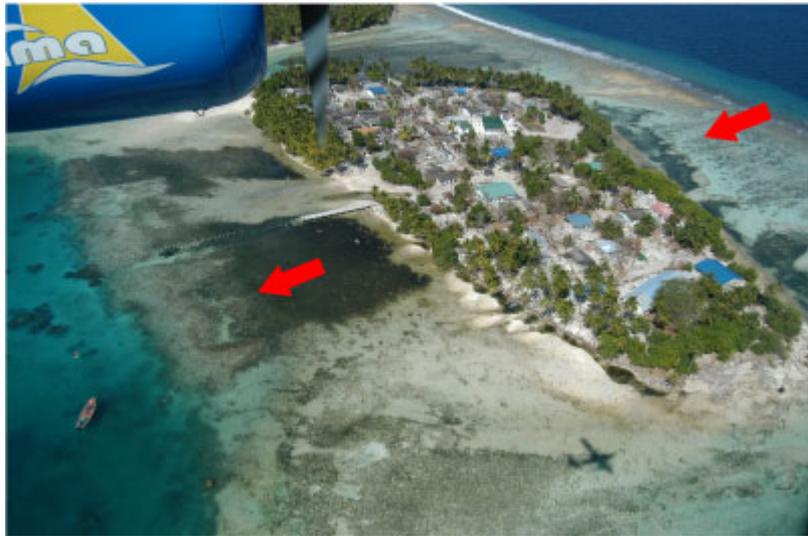
Gemendhoo, located in the center of east side of the Dhaalu atoll, is one of the island which suffered the most serious damage in the Maldives. 5 people were killed and 3 people are missing in the island. The tsunami went through from east to west (see Photo 3.7.3), about 3m of tsunami trace heights were investigated at each point as shown Figure 3.7.2. Since a lot of houses and physical plants were destroyed in the island (see Photo 3.7.4), most residents evacuated to a shelter in other island. Photo 3.7.5 shows damage of erosion by the tsunami. Resident in the island indicates at the ground surface level lower 10cm approximately.

Photo 3.7.3 Direction of tsunami in Gemendhoo

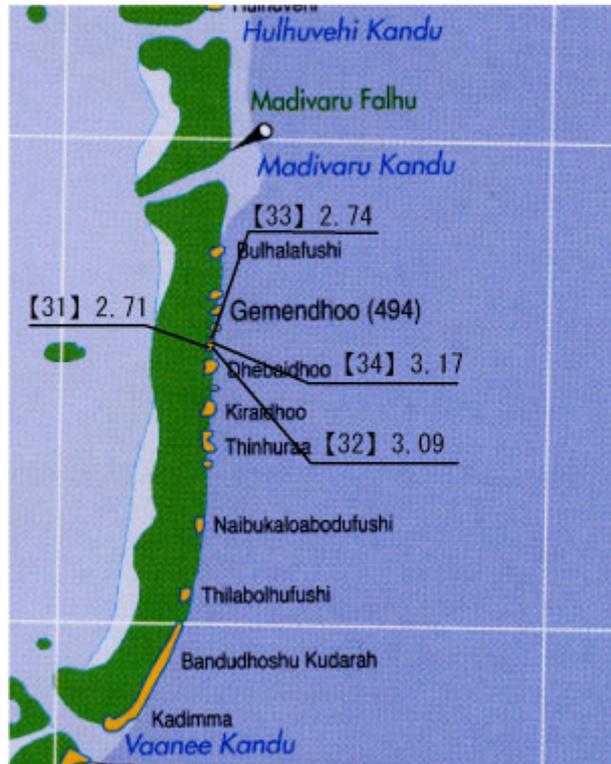
Figure 3.7.2 Measured tsunami trace heights (inundation and run up) in Gemendhoo (Dhaalu Atoll)

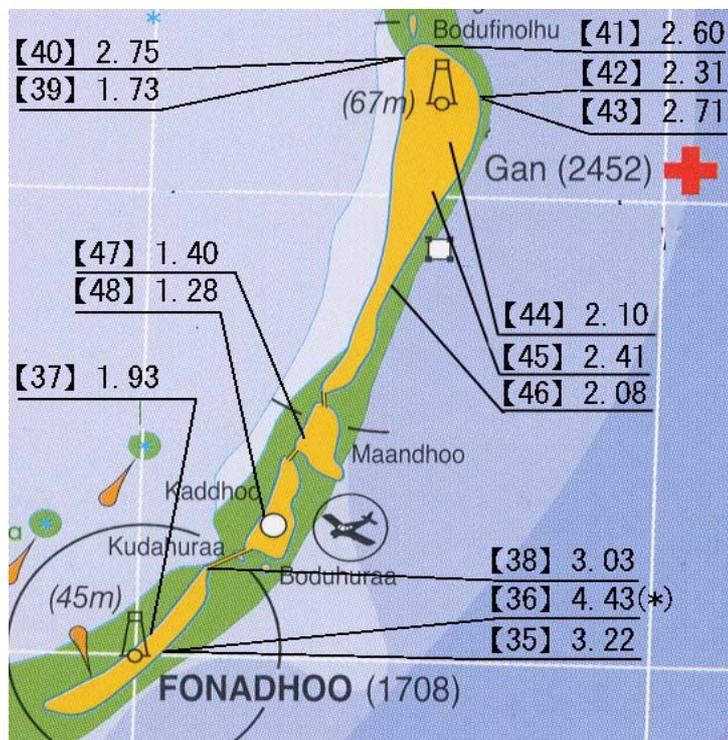
Figure 3.8.1 Tsunami trace heights in Laamu Atoll

Tsunami trace heights were surveyed in four islands named Gan, Maandhoo, Kaddhoo, and Fonadhoo. Each island is close to a neighboring island and those are connecting by a road of sand banks. Inundation heights in the islands were 2.08 to 3.22m in the ocean side (east of the islands) and 1.28 to 1.93m in the atoll side as shown in Figure 3.8.1. Only the houses at the ocean side were damaged (photo 3.8.3), particularly in Fonadhoo where four

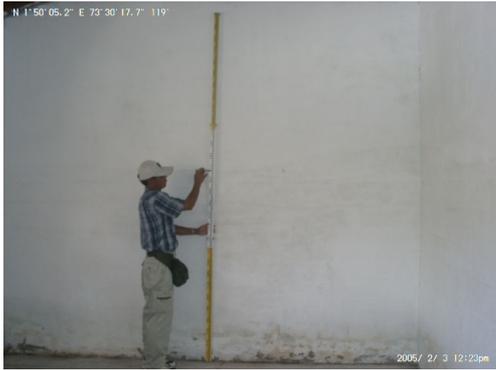
Photo 3.8.4 Trace at the No.35 in Fonadhoo

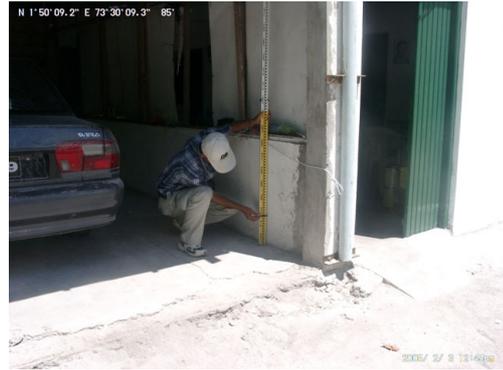
Photo 3.8.5 Trace at the No.37 in Fonadhoo

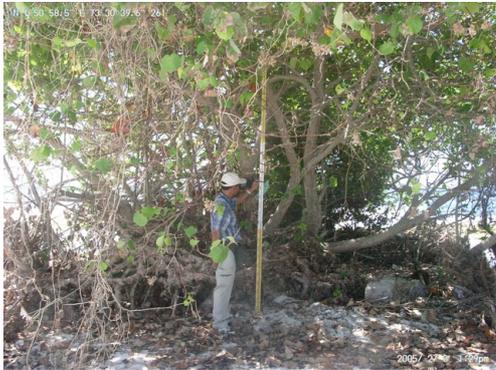
Photo 3.8.6 Trace at the No.38 in Fonadhoo

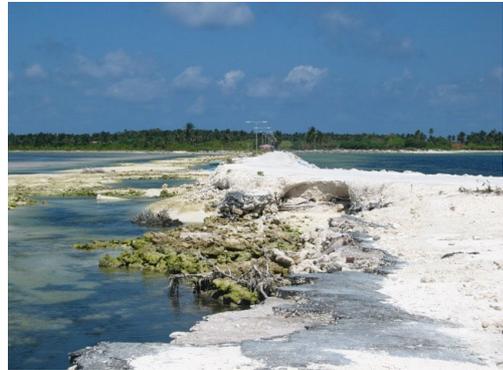
Photo 3.8.7 Collapsed connecting road

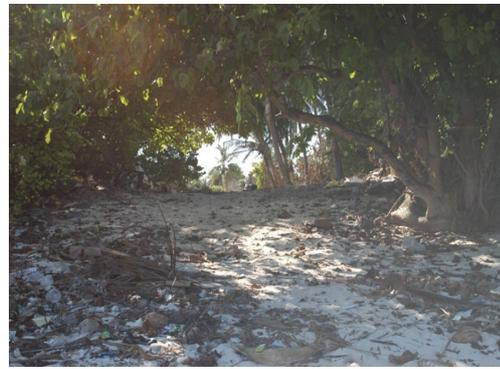
By comparing of damaged houses in these islands, we believe that a little high ground level and sandy berm and a little large forest reduced the tsunami energy much. Photo 3.8.13 shows typical situations along the Gan coast. Particularly, ground level is important to reduce that. Figure 3.8.2 shows the comparison of ground level elevation on the four measured line. The berms in Gan are higher than that in Fonadhoo which was damaged heavily. It is very important to preserve natural resistances like sand berms and forests against a tsunami.

Photo 3.8.13 Typical shape at Gan coast

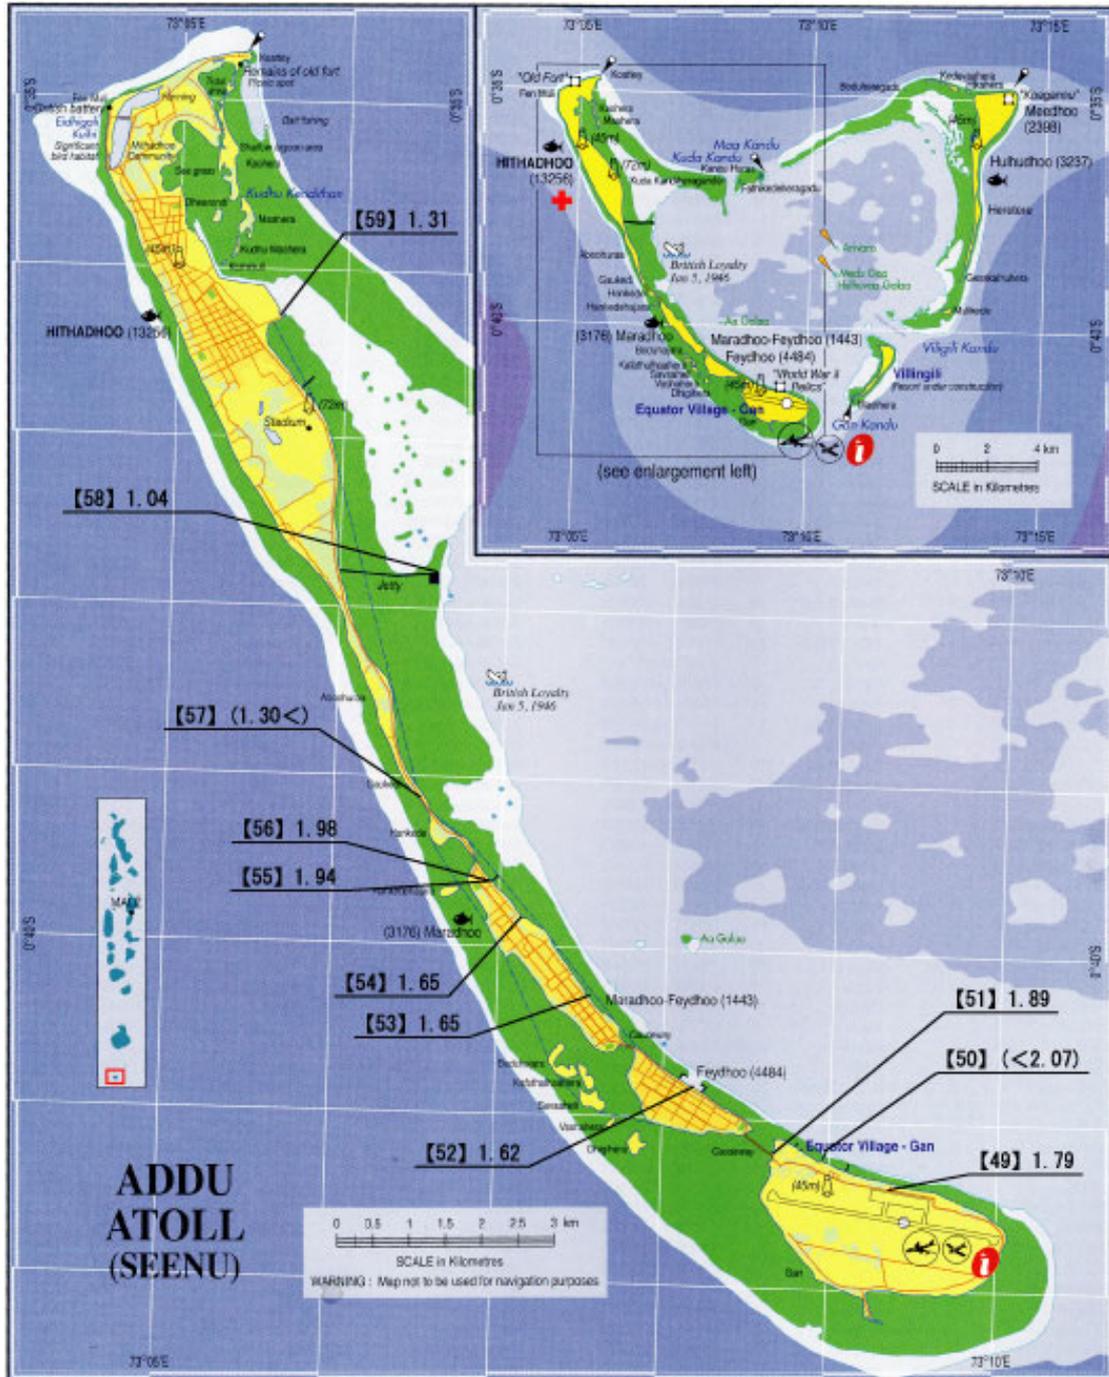
Figure 3.9.6 Tsunami Trace Height

The survey team measured the tsunami run-up and inundation height along the east side of survey area of Gan, Feydhoo, Maradhoofeydhoo, Maradhoo and Hithadhoo, because the tsunami attacked from east side in this area. Run-up and inundation heights were specified at totally 11 points based on interview and traces on walls, etc. The results of the survey at those points are shown in Figure. 3.9.6 as No.49 to 59. In

the figure the marks “<x” and “x<” mean “smaller than x” and “larger than x” respectively. Those results are discussed again by location with damage observation in following sections.

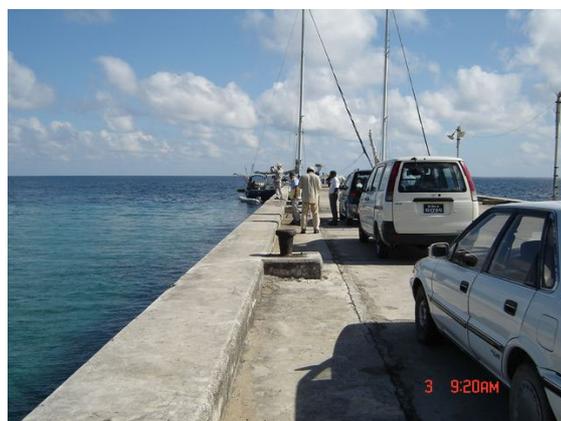
Photo 3.9.3 Jetty in Gan

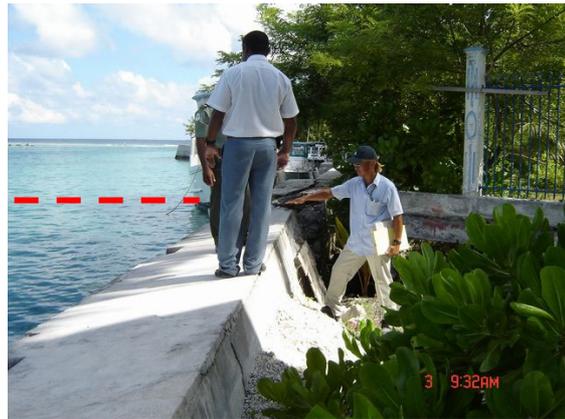
The third survey location was around the junction of the causeway and the northeast seawall. According to the interview to security officers, the water level rise was observed first at 9:00 am on 26th December. The tsunami came from inside the atoll and three main tsunami waves were observed with interval of 5 to 10 minutes. The first one was the biggest. They also said that the tsunami attack was not like wave but like sea level rise and down. The seawall was damaged by the tsunami and the crown part (super structure) have moved to seaward 1.0m from the initial position as shown in Photo 3.9.4. The reason of this damage is considered that back fill of the sea wall was sucked out because of extreme low water level at the backwash phase of the tsunami. The inundation height of this place was about 0.3m above crown level as shown in Photo 3.9.5 by arm of Mr.Sugita. This height was estimated at 1.89m as shown in Figure 3.9.6 as Point No.51 that is just the corner of starting point of the causeway where the crown level was measured.

Photo 3.9.5 Run-up Height at Seawall

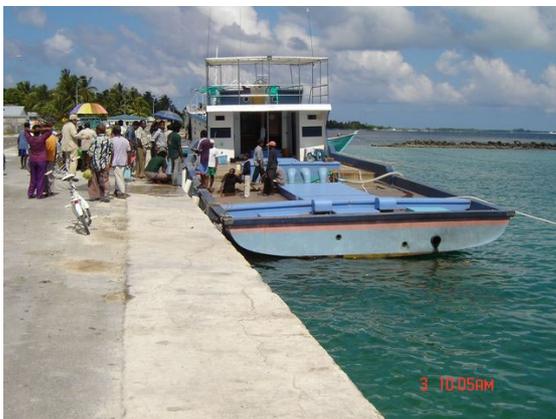
The survey was carried out around the fishing harbour in Feydhoo. The witnesses said that water level in this area moved up and down for 30 to 40 times within the period of 45 minutes from 9:00am. The water level rose up suddenly and kept high level for about 20 to 30 seconds, then suddenly went down. The highest water level reached just above crown of quay wall shown in Photo 3.9.6. The run-up height was estimated at 1.62m as shown in Figure 3.9.6 as Point No.52. At the time of the minimum water level, the sea bottom of 5m below HWL 1.0m above LWL could be seen, resulting turning over of fishing boat which was under repair in ship yard in Hithadhoo. The detached breakwater made of coral stones was partially damaged by the tsunami as shown in Photo 3.9.7.

Photo 3.9.6 Seawall of Fishing Harbour

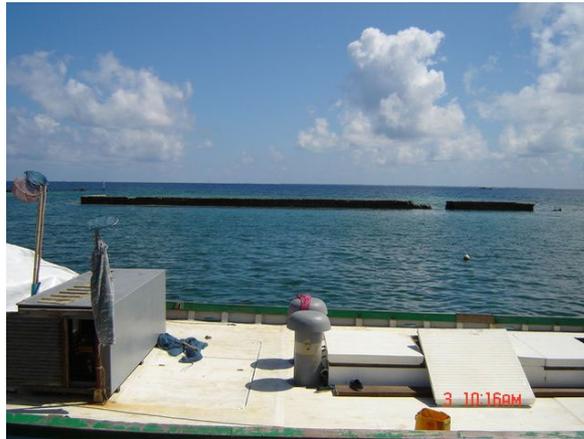
The fishing harbour in Maradhoofeydhoo was surveyed. The witnesses said that the tsunami reached the crown level of the detached breakwater shown in Photo 3.9.8 and run-up height was estimated at 1.65m at the seawall as shown in Figure 3.9.6 as Point No.53. They said that speed of water level rise was almost the same as backwash.

Photo 3.9.8 Detached Breakwater in Fishing Harbour

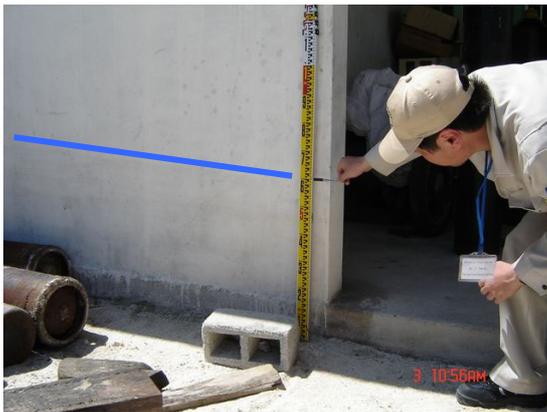
The second location of the survey was around the shipyard. The inundation heights were surveyed at two points. The results were 1.94m at Point No.55 and 1.98m at Point No.56 as shown in Figure 3.9.6. Point No.56 was ship repair yard and there was the tsunami trace on the wall of house near ship repair yard as shown in Photo 3.9.10. Photo 3.9.11 shows the perspective of the wall from seashore.

Photo 3.9.10 Trace of Tsunami

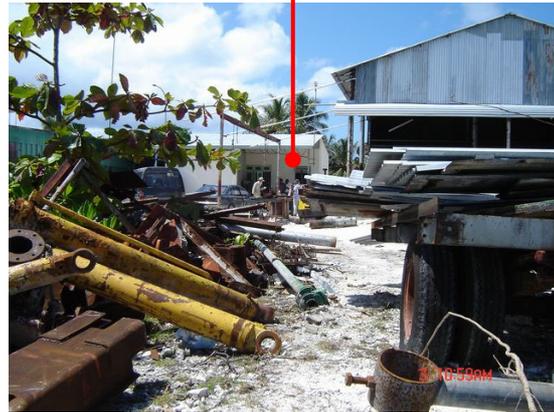
Photo 3.9.11 Perspective from Seashore
